## **Comments on failures of small dams in the Czech Republic during historical flood events**

J. RIHA, Brno University of Technology, Zizkova 17, 66237 Brno, CZ.

**SYNOPSIS.** During the catastrophic floods, namely those in July 1997 and August 2002 and also during local flood events, which occur almost every year in the Czech Republic, more than 100 failures of small dams were identified during last decade. After careful analysis of typical small dam failures, the reasons for dam collapses were found and assessed. During the flood events the most frequent failure of small dams was by breaching due to dam overtopping. The majority of small dam spillways suffer from insufficient capacity, inconvenient structure and arrangement. At some places spillways were blocked by broken gates, clogged jammed racks or floating debris. Moreover, in some cases the bottom outlets were not maintained and out of order. In the paper, several examples of unsuitable spillways and other dam appurtenances are shown.

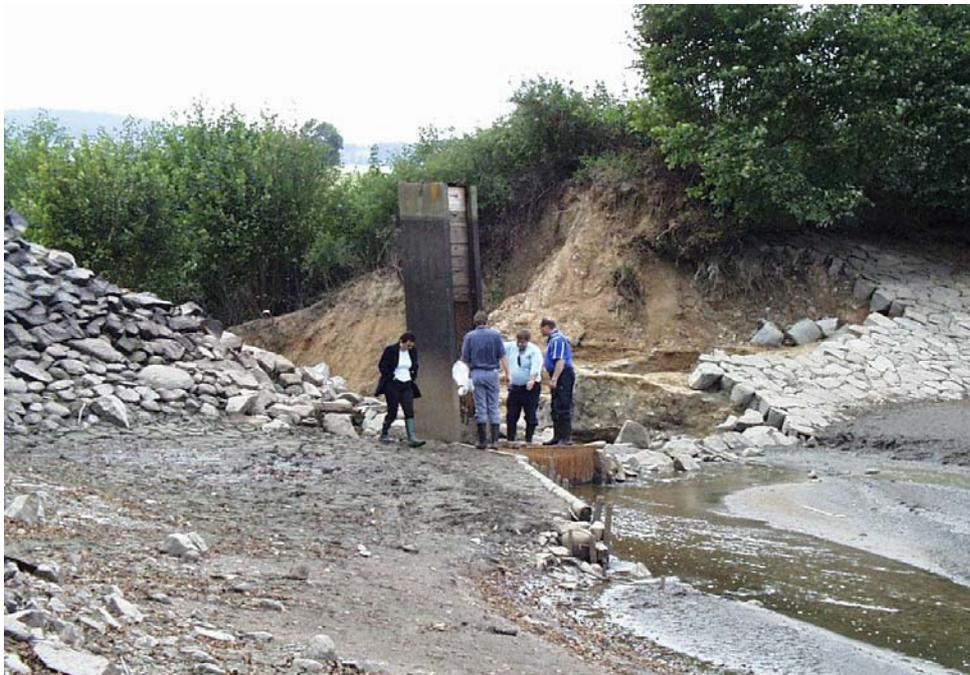
Figure 4: Melin – dam breach with remaining service shaft of the bottom outlet

The Melin dam failure was caused by combined action of leakage through the upper portion of the dam below the dam crest and the wind waves overtopping the dam crest. These factors caused the dam failure in the section of the lowest crest, where its subsidence was probably caused by suffosion of the sandy material into the damaged wooden pipe. The process of breaching was accelerated by slides of the relatively steep downstream face of the dam. The dam break peak discharge at the dam site was estimated to be  $150 \text{ m}^3/\text{s}$  and this was verified by the calibrated flood routing model in the valley downstream of the pond. The resulting dam breach opening was of almost rectangular shape with the 5 m depth and 15 m width.

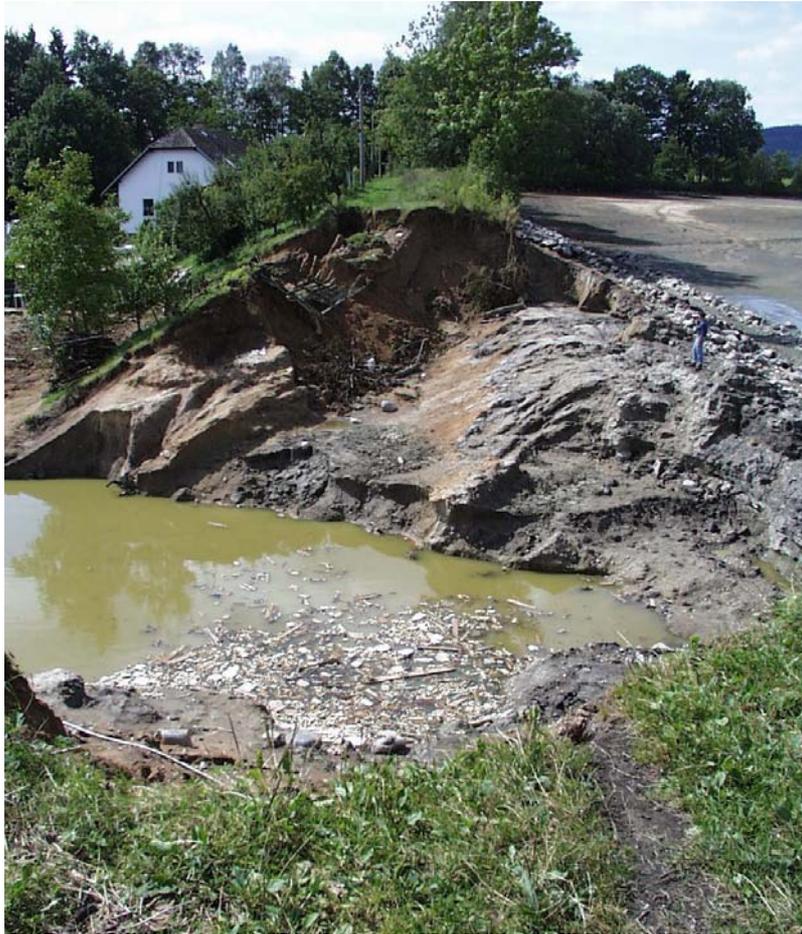
Figure 5: Dam Metelsky - the cross section at the right breach

The detailed modelling of the event showed that the water level during the flood event was about 0.6 m above the spillway crest. At that time the Melin dam break wave entered the Metelsky pond and caused dam overtopping in two places. The resulting peak discharge was about  $550 \text{ m}^3/\text{s}$ , and the total volume of the flood wave was estimated to be 2.3 million  $\text{m}^3$ . The widths of two breach openings were 35 m and 27 m, the breach depth was about

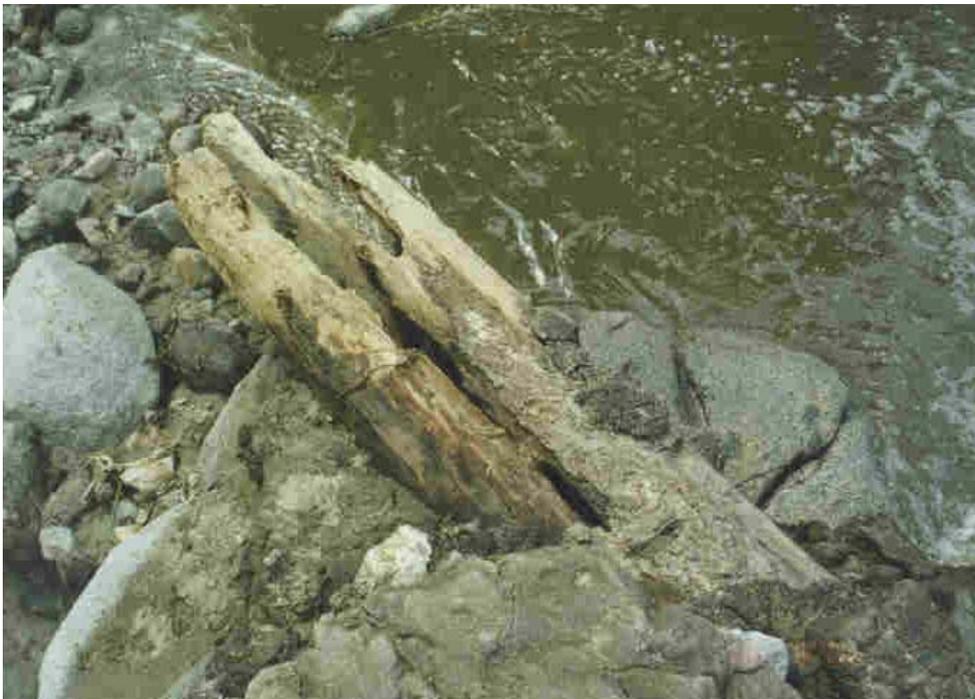
Several additional phenomena contributed to the dam failure and accelerated dam breaching. The 4 hours' action of wind waves of height 0.75 to 0.80 m and local overtopping caused local slides and disturbance of grass cover at the downstream face prior to the dam overtopping and this accelerated the destruction process of overflowing water. Moreover, the upper portion of the dam body was disturbed by the root system of the vegetation and by the action of animals. The left breach opening was located at the place of the old abandoned wooden bottom outlet pipe. The site investigation proved internal erosion and flushing of finer particles to the disturbed pipe (Figure 9) and consequent settlement of the dam body at this location.

Figure 9: The rest of cracked wood bottom outlet

The facts mentioned were not the primary cause of the failure, but accelerated the dam collapse and contributed to earlier overtopping. The important circumstance was inadequate technical safety surveillance of the dam and poor maintenance of dam body and equipment.

- Before the reconstruction of the dams, the revision and careful surveillance of the state of dam bodies should be carried out. The restoration of the ponds cannot proceed in their present state. Careful assessment must be focused also on the design parameters of dam equipment, namely bottom outlets and emergency spillways.
- The reassessment of present safety classification of small dams should be done with respect to potential danger from insufficiently equipped small dams and based on the new dam safety standards and actual hydrological data.
- The manipulation regulations should reflect the optimal function of the entire reservoir system, which consists of approximately 20 small reservoirs in the Blatna region.
- The potential flood prone area specification should contain the inundation due to potential dam failures.
