## **Marmarik Dam Investigations and Remedial Works**

**SYNOPSIS.** Marmarik dam is a multipurpose embankment dam on the Sevan – Hrazdan cascade in Armenia. The dam is situated in one of the most seismically active regions in Armenia and in the vicinity of the reservoir numerous landslides could be seen. The dam was commissioned in January 1975 and twenty days later significant subsidence of the clay core occurred causing 14m settlement of the dam crest. The dam has never been rehabilitated and the reservoir has never been impounded.

The dam was investigated by JacobsGIBB ltd as part of the World Bank funded ‘Technical Investigation of 60 Dams’. In addition to the slope failure, further issues include high regional seismicity, landslides adjacent to the dam and reservoir, inadequate spillway capacity, rehabilitation of the derelict outlet works and concerns regarding the foundation cut-off.

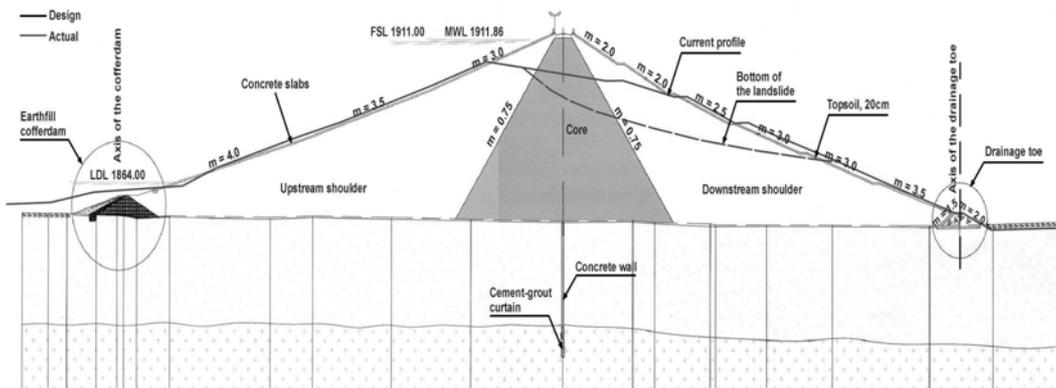
Figure 2. Cross Section 1-1

Marmarik dam, Figure 1, was originally designed as a 64m high embankment with a clay core and compacted fill shoulders. The original dam crest was at 1914masl. The design cross section is shown in Figure 2. The shoulders were originally designed to be built of gravel from a borrow area some 5km downstream of the dam. However, only the bottom 5m of the embankment was constructed from gravel as the further use of the gravel borrow area was not permitted. Thereafter the embankment shoulders were constructed from a compacted sandy silt from borrow areas within the reservoir, but to the original design slopes and with no filters.

The central part of the dam is founded mainly on granular river alluvium and the abutments are founded on a thick layer of cohesive colluvial deposits. The designed foundation anti – seepage measures comprise a cut – off bored secant pile wall constructed up to 30m deep through the central part of the alluvial foundation and a grout curtain through the colluvial foundation at the abutments.

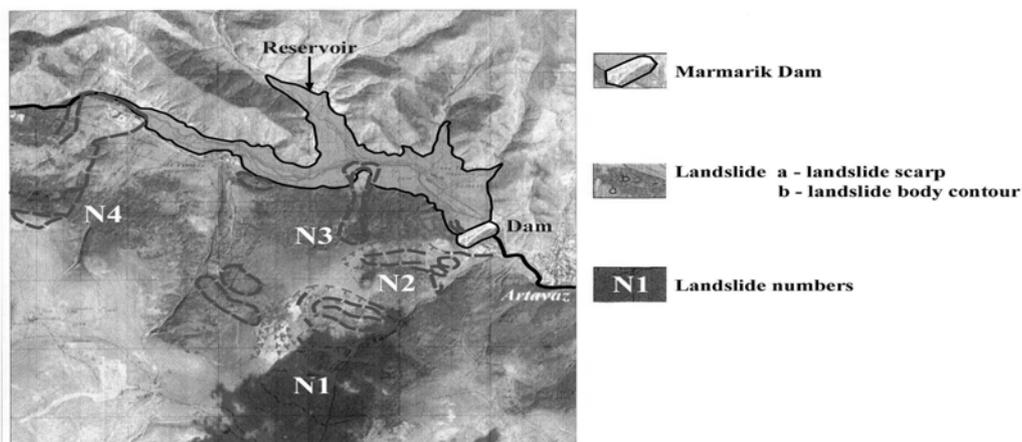
Figure 3. Landslide hazard map for the Marmarik reservoir

Landslides of a seismogenic origin are widespread along the whole length of the southern (right) bank of the Marmarik River canyon. Four potentially hazardous seismogenic landslides were identified within the Marmarik reservoir area that may influence the dam safety, namely landslides N1 to N4. The landslides are shown in Figure 3. Landslide hazard assessment was carried out based on the analyses of satellite images and aerial photos that were taken in 1948, 1976 and 1986 as well as the field surveys carried out in 1975-78 and 2002.

Landslide N2 is located some 250m to the south of the dam. The landslide is situated close to the confluence of Kiarkhana with the Marmarik river. During 1969-1974, the material from the toe of landslide was excavated for construction of the Marmarik dam. The excavation destabilised the landslide leading to a development of presently active secondary landslides. The landslide was investigated during 1975-1978 site investigation. Thickness of the landslide varies from 30 to 80m, total volume is about  $94 \times 10^6 \text{m}^3$ .

Landslide N3 is 1.6km upstream of the dam and it was reactivated a number of times in the past, most recently during dam construction when the soil from the toe of landslide was excavated and used for the fill material. The landslide was investigated during the 1975-1978 site investigation. Thickness of the landslide varies from 40 to 60m, the total volume is about  $16 \times 10^6 \text{m}^3$ .

Landslide N4 is 5.2km upstream of the dam and at its toe, it branches into two landslides separated by some 700m. This landslide is the most distant from the dam, but it is the largest in volume. If it is triggered it could dam the Marmarik River and create a lake which, if the natural dam is breached, could induce a flood inflow into the reservoir. This landslide was investigated during 2003. It was found that landslide comprises a layer of rock debris with a soil matrix up to 50m thick, over a thin slip surface that overlays the in - situ rock.

Four potentially hazardous landslides were identified in the vicinity of the dam. The landslides N1 poses a very low hazard to the dam. The landslide N2 is also likely to pose a low hazard, but because of its proximity to the dam it is recommended that monitoring instruments are installed in two monitoring profiles.

If the Landslide N3 slides into the reservoir it could create a 1.5m high wave and an allowance in the freeboard of 3m is made to accommodate the runup of such a wave. This landslide will also be monitored in two monitoring profiles.

If the landslide N4 collapses, it could block the Marmarik river and create a natural dam which if breached could create a 'dambreak' flood. It is recommended to install 1m high fuse gates (HydroPlus or similar) over the whole length of the spillway crest which could be activated should the landslide occur and the reservoir level needs to be lowered. Alternatively the spillway could remain conventional but the freeboard could be increased to 4m by provision of a 1m high concrete crest wall. It is also proposed to install monitoring instruments on the landslide and monitor the slope movements.

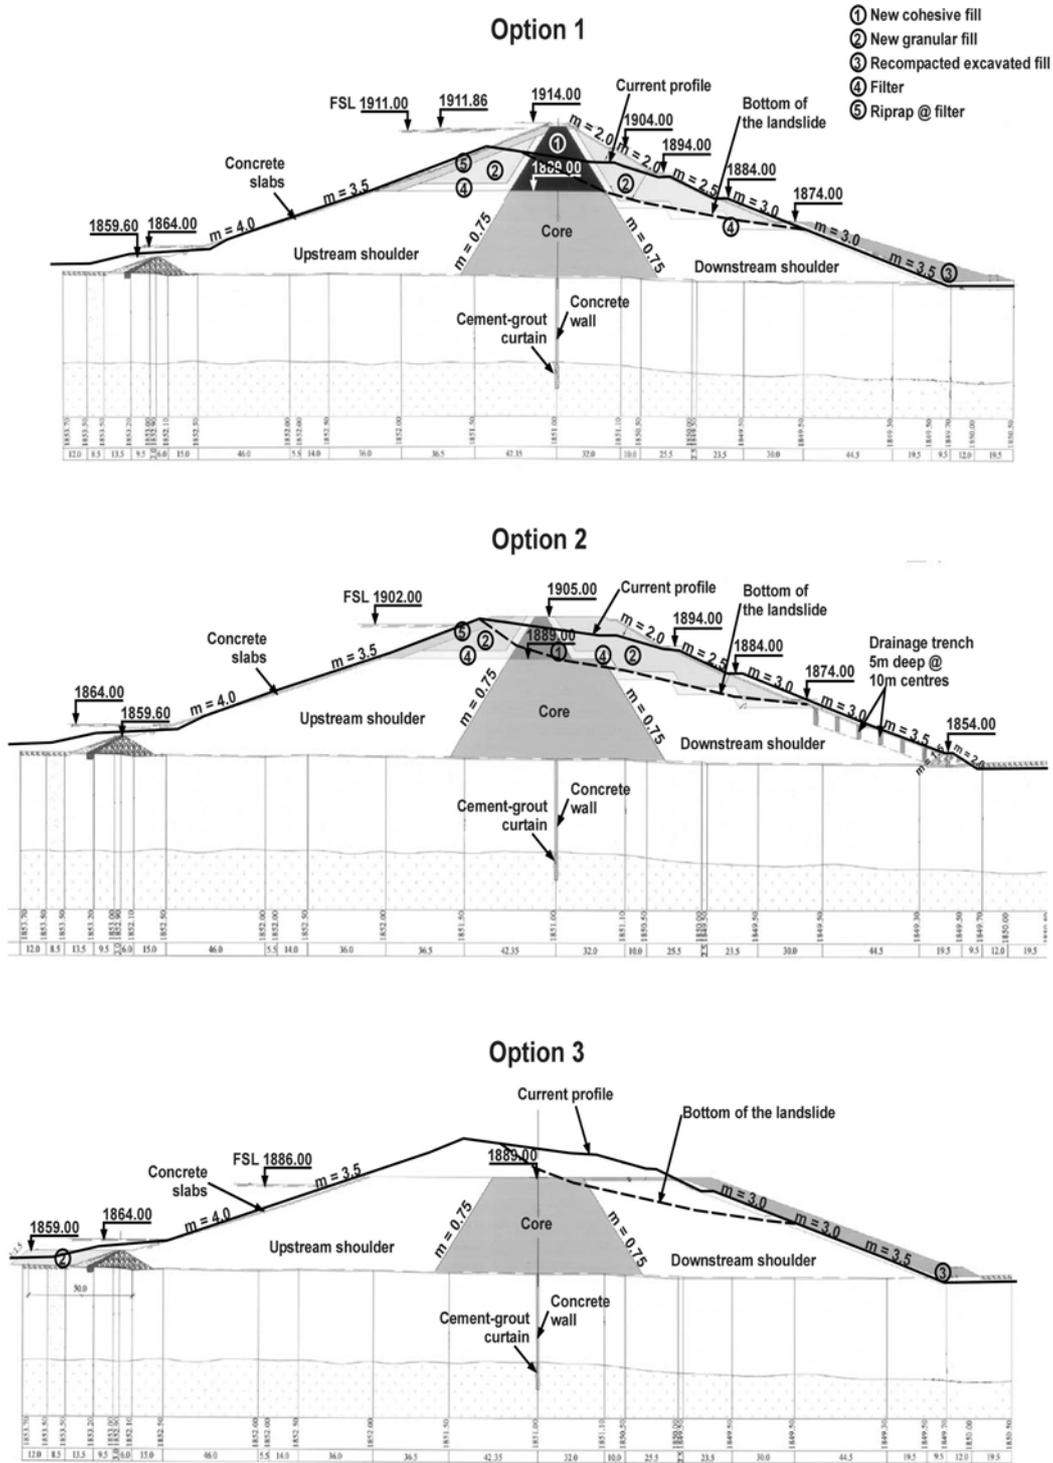
Figure 4. Options for dam rehabilitation

Current crest elevation is approximately at 1900masl for a good part of the dam. Presently the upper part of the failed embankment material forms the top part of the core and the downstream shoulder. There is a very high perched water table within the dam body. Stability analyses demonstrate that the dam is stable in its present condition. However, if impounded to a level 3m below the current crest, the dam would be unsafe during rapid draw down (u/s slope) and steady state seepage (d/s slope). Furthermore, due to the high seismicity of the region, peak ground accelerations at the crest of about 0.6g could be generated. These accelerations are likely to cause liquefaction and strength reduction in the loose landslide material in the top part of the downstream slope and further contribute to the embankment's instability. It is therefore proposed to rehabilitate the embankment to improve its safety. Three options are developed as follows:

- Option 1 - Reinstatement of the dam to the full height with the crest at 1914 masl; Full storage level at 1911masl, total storage volume  $36 \times 10^6 \text{ m}^3$
- Option 2 - Reinstatement of the dam to elevation of 1905masl; Full storage level at 1902masl, total storage volume  $24 \times 10^6 \text{ m}^3$
- Option 3 - Reinstatement of the dam to elevation of 1889masl; Full storage level at 1886masl, total storage volume  $10 \times 10^6 \text{ m}^3$

The earthworks proposed for the above options are shown on Figure 4.
