Barrow Compensation Reservoir Grouting Works

A L Warren, Halcrow Group Ltd
C Hunt, Bristol Water
M Atyeo, Bristol Water

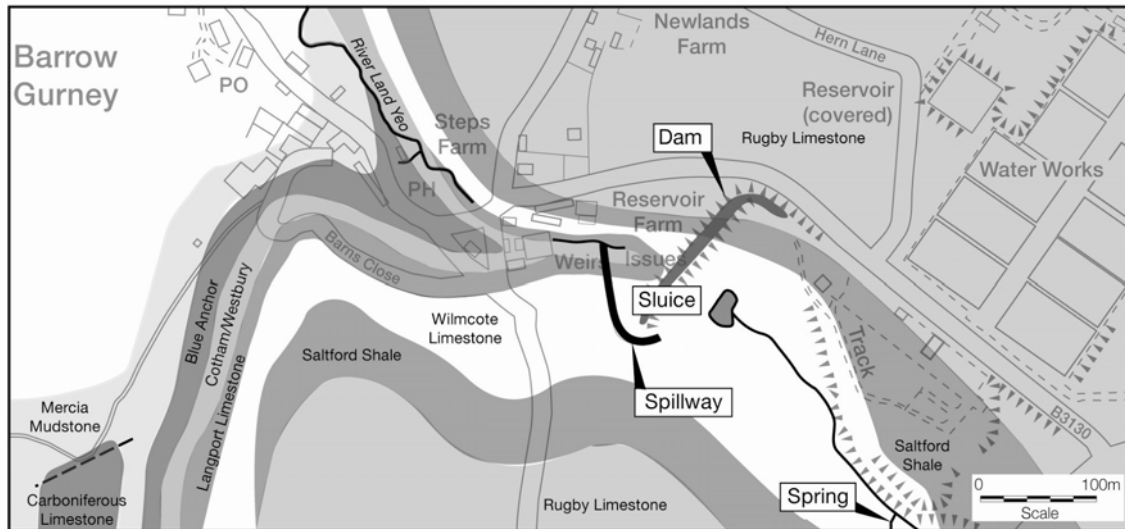
Figure 1: Geological plan of the dam area

The foundation of the dam was found to comprise (in descending order) the following beds, with a shallow dip to the north-east:

- Interbedded limestones and mudstone, weathered to clay in places (the Wilmcote Limestone);
- A thin (<10cm) band of orange gritty calcareous sandstone;
- A white silty limestone, approximately 2m thick, with thin mudstone bands (the Langport Limestone); and
- A dark grey mudstone, weathered to clay (Cotham mudstone).

The initial lugeon tests in the rock foundation yielded values consistently over 100. In some cases it was not possible to attain sufficient water pressure to provide a result due to very high ground permeability. The band of white limestone, in particular, was suspected of contributing to this high

foundation permeability. A geological plan of the dam area is shown in Figure 1 and a geological section through the dam and the foundation is shown in Figure 2.

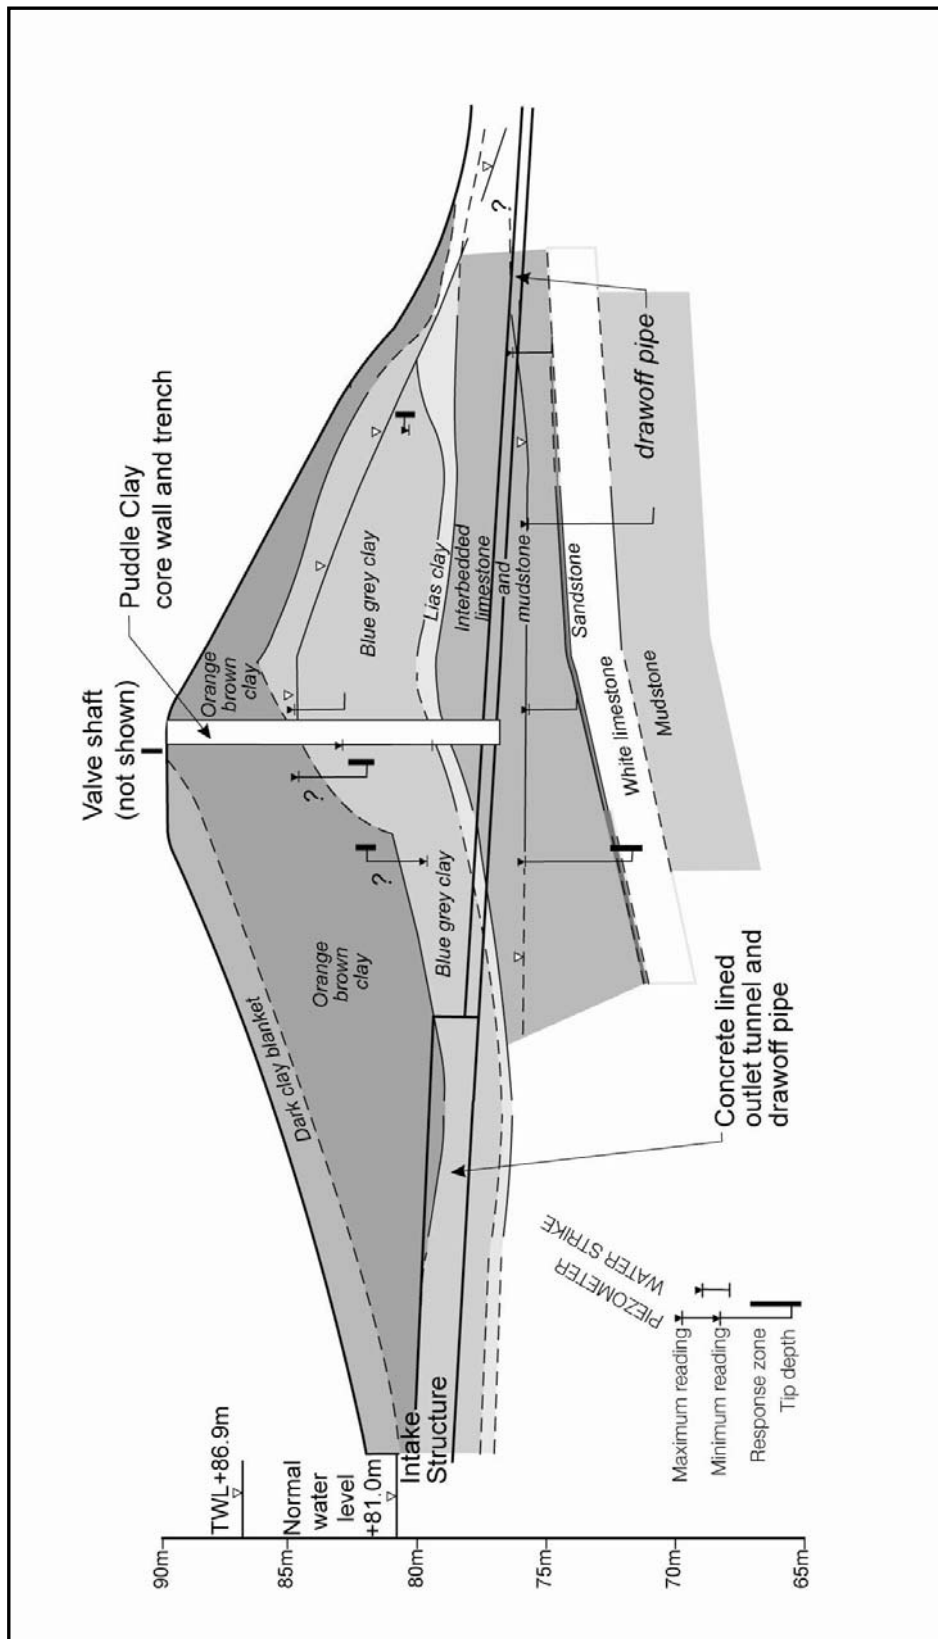
Figure 2: Geological section through dam embankment and foundation on the line of the drawoff works.

The phreatic surface was found to be significantly higher in the downstream shoulder than in the upstream shoulder (see figure 2), particularly adjacent to the left abutment. This was believed to be a result of groundwater inflow from the valley side and was clearly detrimental to stability of the downstream shoulder.

- providing a deep French drain in natural ground adjacent to the downstream shoulder on the left abutment to assist in draining the downstream shoulder and to intercept groundwater flowing towards the embankment.
