Emergency Underwater Rehabilitation of the Poti Main Diversion Weir, Georgia

LJILJANA SPASIC-GRIL, Jacobs, Reading, UK

SYNOPSIS. The Dam Safety Project (DSP) in Georgia, which is a part of the Irrigation and Drainage Community Development Project (ICDDP) financed by the World Bank, was implemented by Jacobs during the period August 2003–July 2004. The DSP project included four irrigation dams as well as the main diversion weir on the river Rioni at the town of Poti, the third largest town in Georgia and currently the busiest Georgian port on the Black Sea.

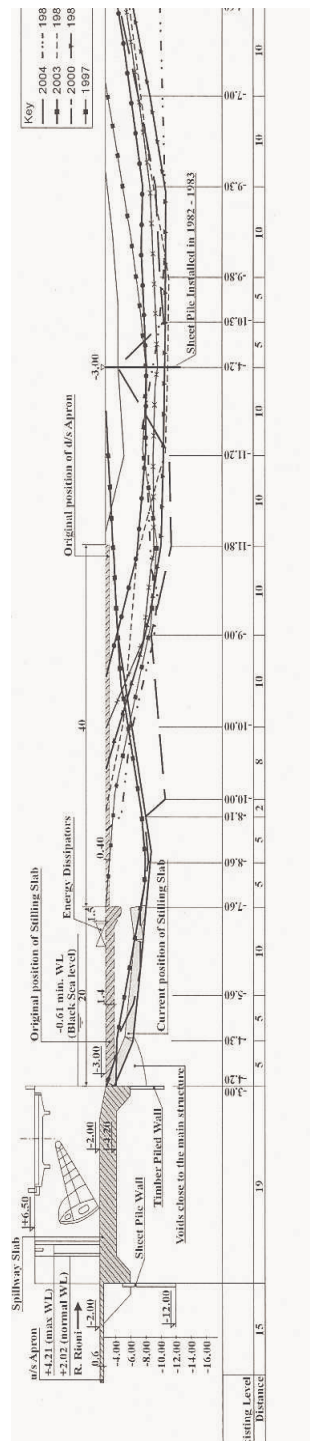
Figure 2: Section Through the Central Opening and Development of Scour

At the end of November 1959, immediately after completion of construction, the first flow was passed through the left bank regulator (400 m³/s) and into the Poti city canal. This flow damaged the downstream apron of the regulator. Scour of the river bed, just downstream of the apron of the main weir was also recorded. During the July 1963 and July 1966 floods the flow in the Rioni reached 3,000-3,400 m³/s. The flood caused up to 6m deep scour downstream of the apron of the main weir, and by the end of 1967 the scour depth reached elevation -10m and was getting closer to the downstream apron.

In the late 1970's, under flood flow of 2,500m³/s, the scour in the river channel immediately beyond the stilling slabs of the main diversion structure came very close to the stilling slabs (see Figure 3). The condition was considered to be an emergency, and in 1981, following the IWIEE recommendations, "GruzGiproVodKhov" (now Georgian Water Project (GWP)) from Tbilisi developed a design for the rehabilitation of the downstream apron. The design comprised the installation of a steel sheet pile wall across the river channel, at a distance of 80m from the weir, and backfilling of the eroded space with large size riprap to the original elevation of -3m. The rehabilitation works were implemented in 1982-83. However, it became apparent in the following years, that these measures did not improve the condition of the downstream apron. On the contrary, they enhanced the scour and further deterioration of the downstream pool (see Figure 3). Data from surveys carried out over the period 1986-1992 showed that the scour continued to increase. The scour was also fostered by incorrect gate regulation during floods of the river Rioni, whereby the river discharges were continuously passed only through the central sections.

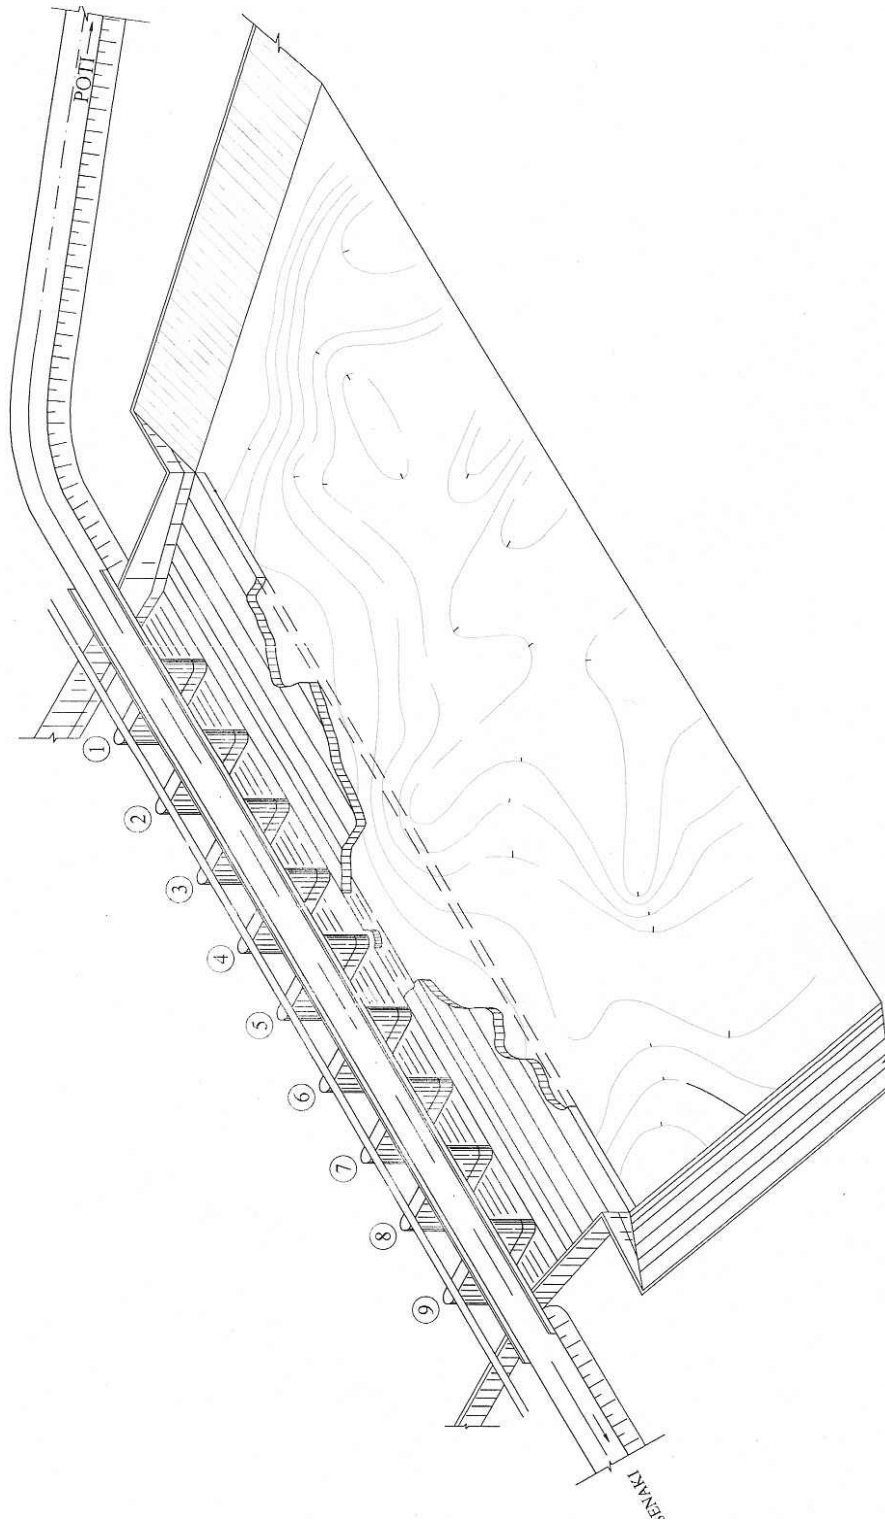
Figure 3: Extent of Damage of the Downstream Pool

In 2001 GWP was commissioned to carry out the design of the emergency rehabilitation measures. The design was put on hold several times due to a lack of funds. The survey carried out in July 2003 showed that the condition of the downstream pool had worsened: the apron was completely demolished over the whole width of the weir and the stilling slabs were demolished in the four central sections (see Figure 3).

- It was found that the downstream erosion line was highly dependent on the operational regime of the gates and the flow of the sediments, related to the volume of the discharged water.
- Scour was taking place at the edge of the main structural foundation in the area of the central sections and pier No 5 where 3-4m deep voids were encountered (see Figures 2 and 4).
- The stilling slabs had been completely demolished in the central sections and partly in the remaining sections.

- The downstream apron had been completely damaged and largely disappeared
- The upstream apron had been damaged in the central part; the last 5m of the apron slab had been damaged over a length of 100m
