The failure of the Mostiště embankment dam

JAROMÍR ŘÍHA, Brno University of Technology, Czech Republic

JIŘÍ ŠVANCARA, AQUATIS a.s., Consulting engineers, Czech Republic

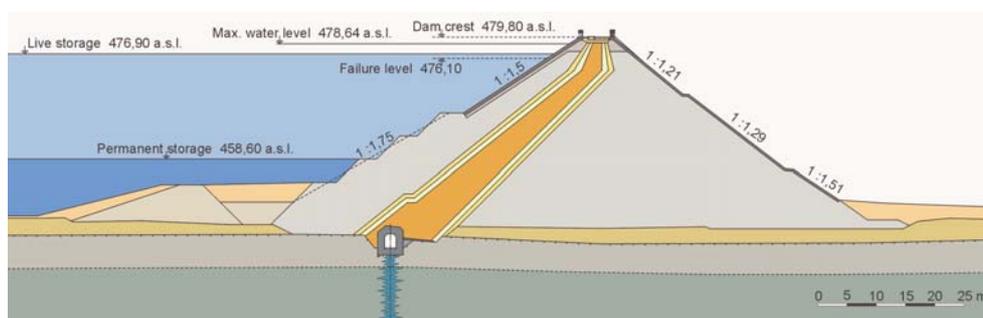
Figure 3: Typical cross section of the dam

The dam is composed of compacted quarry-rock fill with a thin loess soil core (Fig. 3). In the upper part the core is vertical; in the lower portion it is inclined close to the upstream face. The dam core is keyed to the sub-base by a grouting gallery. The sub-base was grouted along a single line of grout holes.

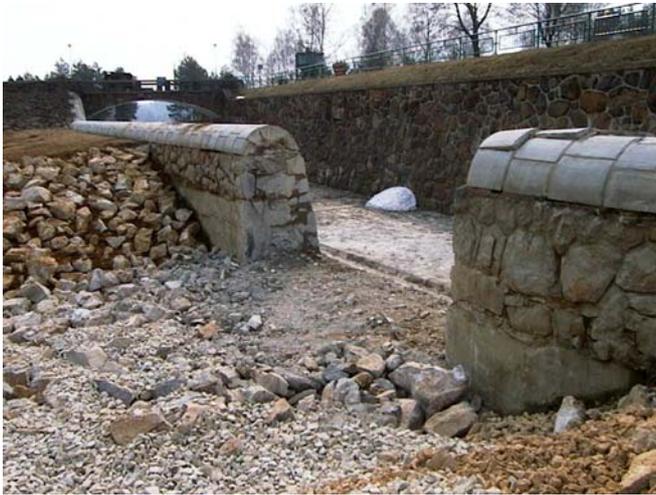
With respect to the extreme snow cover in the catchment area during spring 2005, a 7 m long section of side spillway wall was temporarily removed (Fig. 4). This part of the wall was blasted out in its entire height to release an additional discharge of $14 \text{ m}^3/\text{s}$ without exceeding the critical water level in the reservoir.

Figure 4: Emergency spillway - partial removal of spillway wall

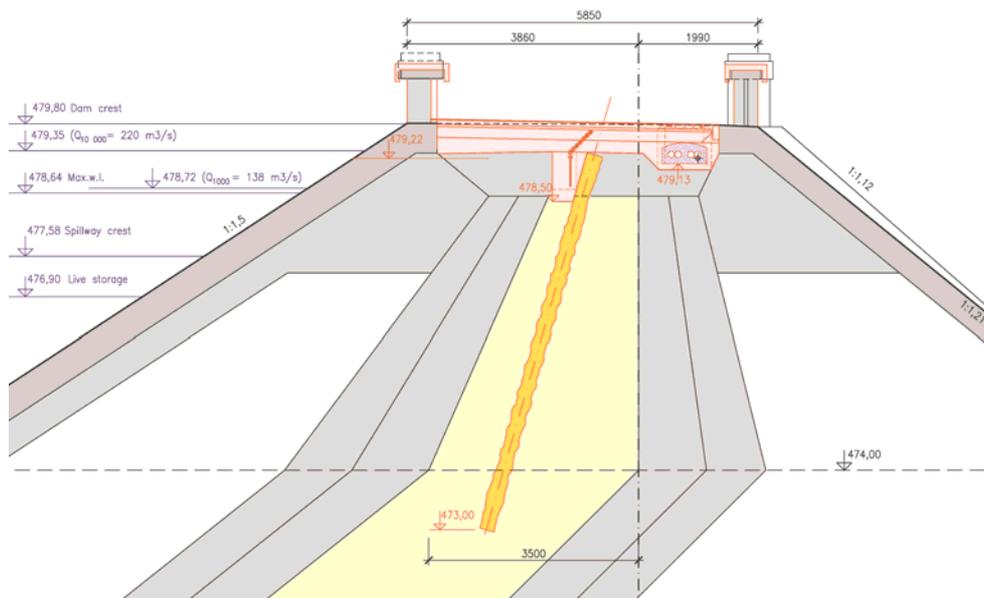
Figure 5: The sealing element in the dam core made by jet grouting technology

The repair consists of the development of a continuous inclined sealing element (seepage barrier) along the entire length of the dam (292 m) to the depth of 7 m (to the level of 473.00 m above SWL - Baltic system), close to the upstream face of the impervious core (see Fig. 5). As the sealing membrane could not be vertical (due to the inclined part of the core), it was decided to use the technology of jet grouting from the dam crest (see below). The total area of the seepage barrier was about 1700 m².

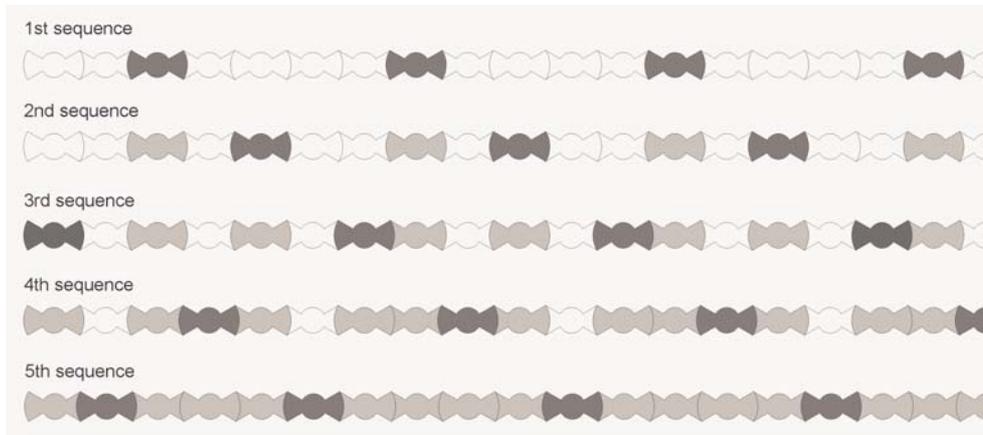
Figure 6: Procedure of jet grouting in five sequences

Jet grouting technology was applied in five sequences with reference to the restricting requirements based on the results of stability calculations (Fig. 6).

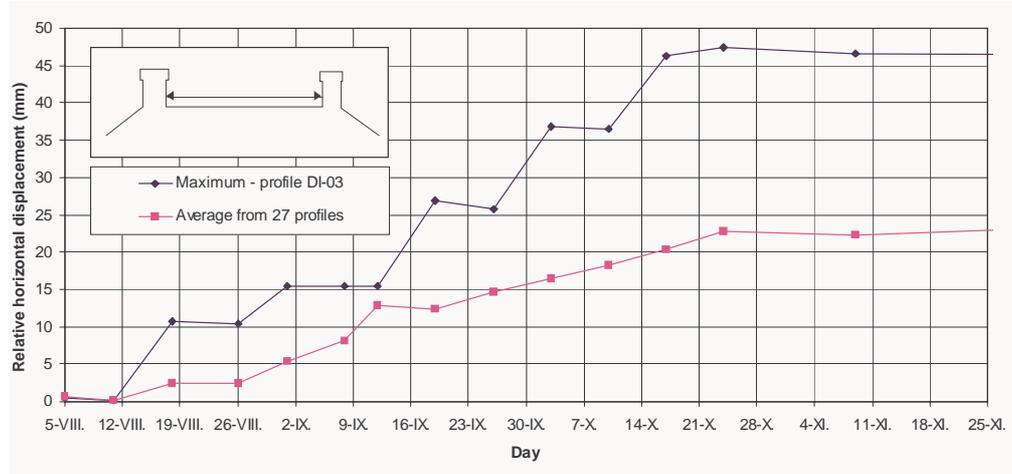
Unfortunately, the prescribed displacements were not gained during construction, and the measured deformations, both vertical and horizontal, exceeded 45 mm in some observation profiles (Fig. 8). The following stability analysis indicated higher pressures in the drills, which in combination with weakened zones in the dam core were the reason for the relatively high displacements. The additional calculations showed that the safety factor of the repaired dam could, at certain locations, have been slightly decreased to the value $SF = 1.25!$

Figure 8: The development of horizontal displacements of the dam crest in individual sequences

Therefore, the recommendations for the trial reservoir filling procedure and parallel careful monitoring of displacements and seepage were set up by consulting engineers. The effect of the trial filling and the consequent sudden drop of reservoir water level on dam stability was numerically modelled in advance before the repair procedure. The modelling results
