Llwyn-On Reservoir Scour Valve Refurbishment

SYNOPSIS. This paper has been prepared as a case study looking at the refurbishment of critical valves that had previously been declared to be beyond economical repair. It describes the inspection and repair of two 900mm diameter Larner Johnson valves installed some 80 years ago. There were considerable challenges in gaining safe access to enable the valves to be removed from the outlet tunnel and taken back to the factory for refurbishment. Once the valves had been removed the gears and plunger were refurbished, bronze liners were cast and fitted, all iron surfaces were coated with epoxy paint and all bolts were replaced with stainless steel ones. The valves were successfully reinstalled and commissioned.

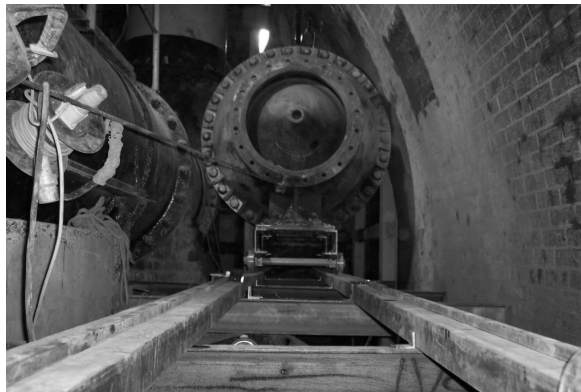
Fig 7: Valve on temporary rail system

- A free standing lifting frame was built and load tested within the base of the chamber to lift and move the 8000kg valves
- A temporary rail track and supporting steelwork was constructed within the outlet tunnel. This was free standing and did not exert any load on the existing outlet pipe steelwork. The valve was moved on purpose-made bogies along these rails. The rail system was dismantled and moved forward as the valve was moved along the 80m tunnel.

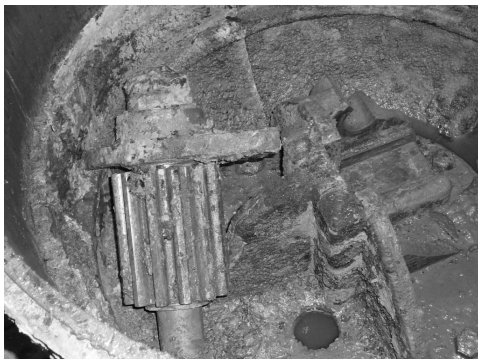
- It was concluded that this valve had stopped functioning and could not be repaired in situ due to the following sequence of events:
 - Infrequent operation, coupled with a poor design of bearing surfaces have caused the valve to seize.
 - The mechanism has been subjected to a very large torque at the handwheel. This has loaded the gear bracket in a tensile direction to a stress beyond its capability and failed. The bracket may have survived a load in a compressive direction.

Fig 8: Gear bracket as found.

- The gear bracket that had fractured was remanufactured from a casting in a superior material. Design changes were also made to improve its strength. FEA was not available in 1923!
- The vertical gear rack was remade in stainless steel.
- Bronze liners were cast and fitted to the bearing surface of the inlet section.

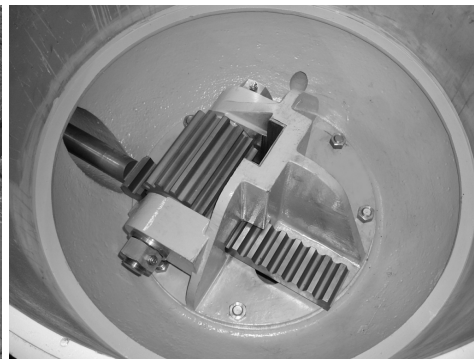
Fig 9: Refurbished gear bracket

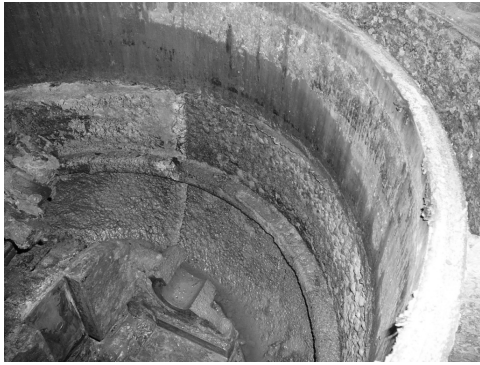
- West (Right Hand) Valve.
 - Internal Chamber: The operating mechanisms all appear to be in acceptable condition for an 82 year old valve.
 - Plunger guide: These valves were produced without non-ferrous bearing liners, the cast iron bearing surface was found to be badly corroded and severely pitted. The plunger and pilot valve were found to be capable of achieving full travel.
 - Upstream guard valve: appears to be in good condition.
- East (Left Hand) Valve – Previously over torqued.
 - Internal Chamber: Some damage could be seen to the teeth on both vertical and horizontal racks. The pinion wheel connecting the two racks was missing, the mounting bosses for the pinion shaft on the gear bracket were seen to be sheared off.

- The seat leakage is due to the loss of support and guidance of the plunger afforded by the poor bearing surface condition. The operating mechanism cannot generate sufficient thrust to force the plunger up the seat face to seal.
- There is severe corrosion to valve ancillaries. A cavity has formed behind the discharge section seat ring; this must be repaired before further corrosion exacerbates the situation.

Fig 10: Plunger cavity as found.

The valves could then be stripped, blast cleaned and prime painted. Significant internal surfaces such as the seat ring and flange faces were re-machined to restore their surfaces. The cavity above the seat ring was repaired using metal filled epoxy repair compound. The main advantage of performing a full factory refurbishment was that the valves could be both restored and brought up to a higher standard than they were originally.

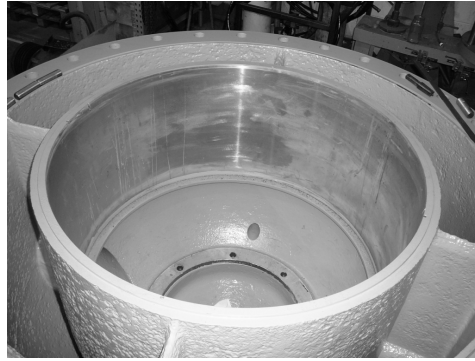
Fig 11: Refurbished plunger cavity

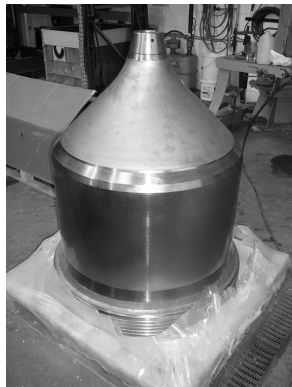
Fig 12: New plunger.

- The plunger was previously made of cast iron with small strips of bronze providing bearing surfaces. The seized plunger had to be machined out of the inlet body such was the level of corrosion between the two components. A complete new plunger was made from stainless steel casting.
- All iron surfaces were coated in a modern three coat epoxy paint system.

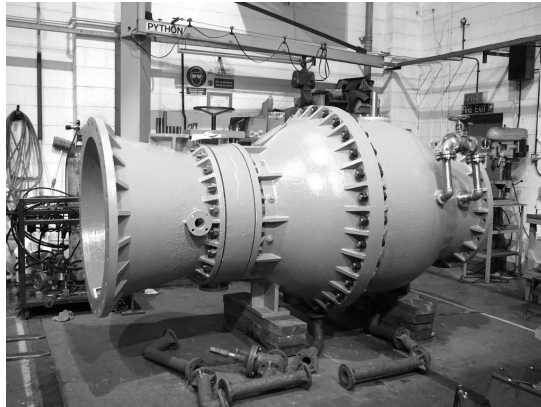
Fig 13: Complete refurbished valve.

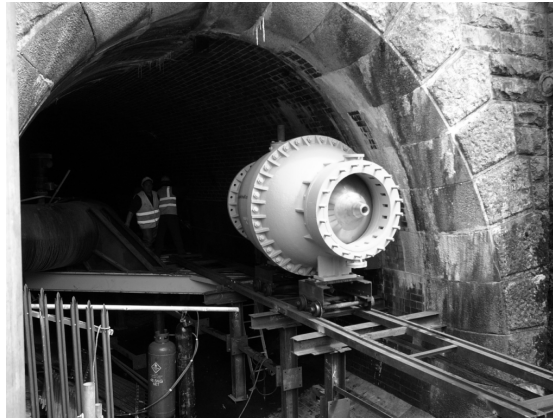
Fig 14: Refurbished valve returning into tunnel.
