Session 3

GEOTECHNICAL ASPECTS OF DAMS

An investigation and assessment of embankment stability at Daer Reservoir - R Morrin and M Sullivan

An investigation and assessment of embankment stability at Daer Reservoir

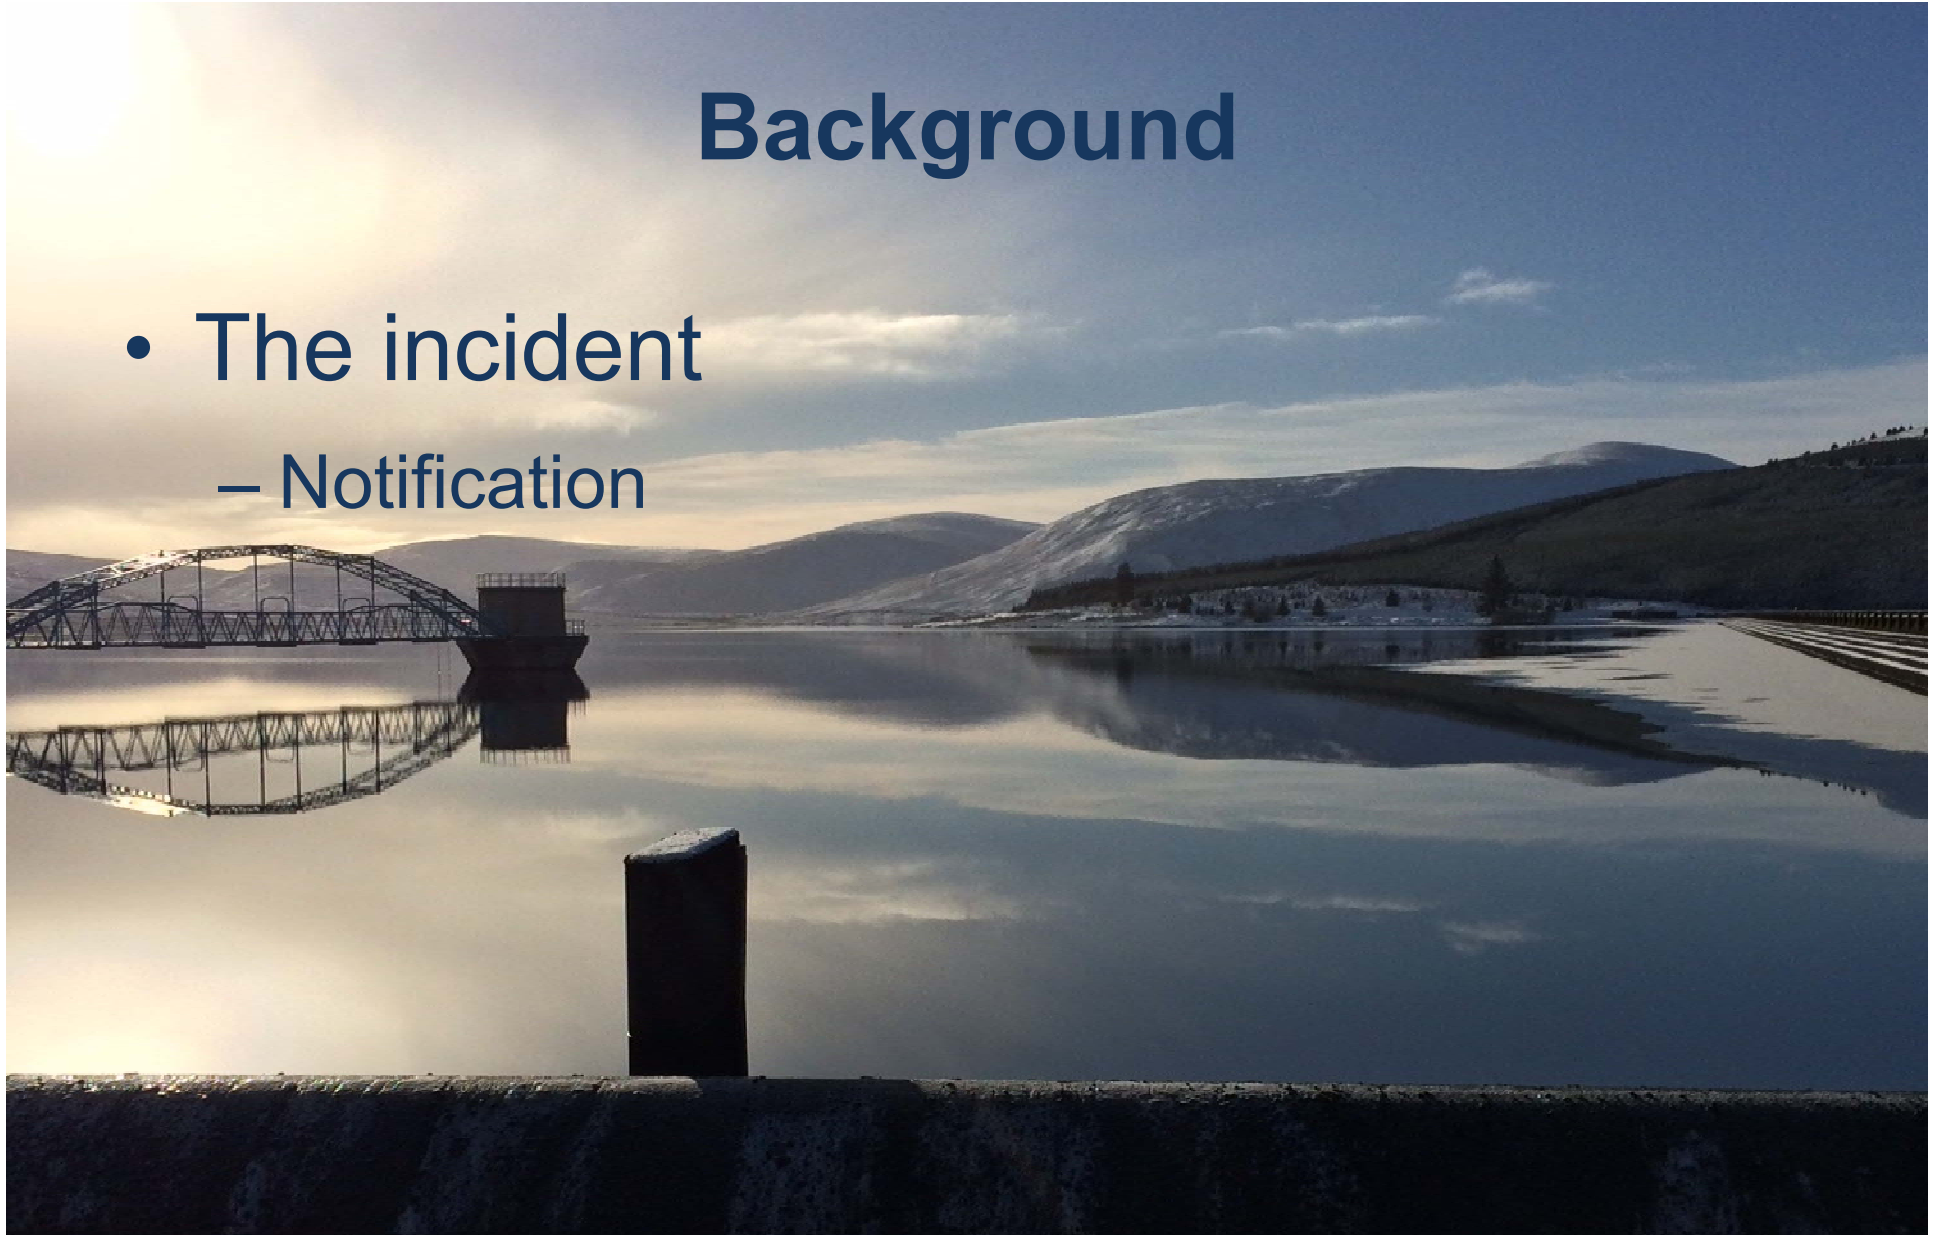
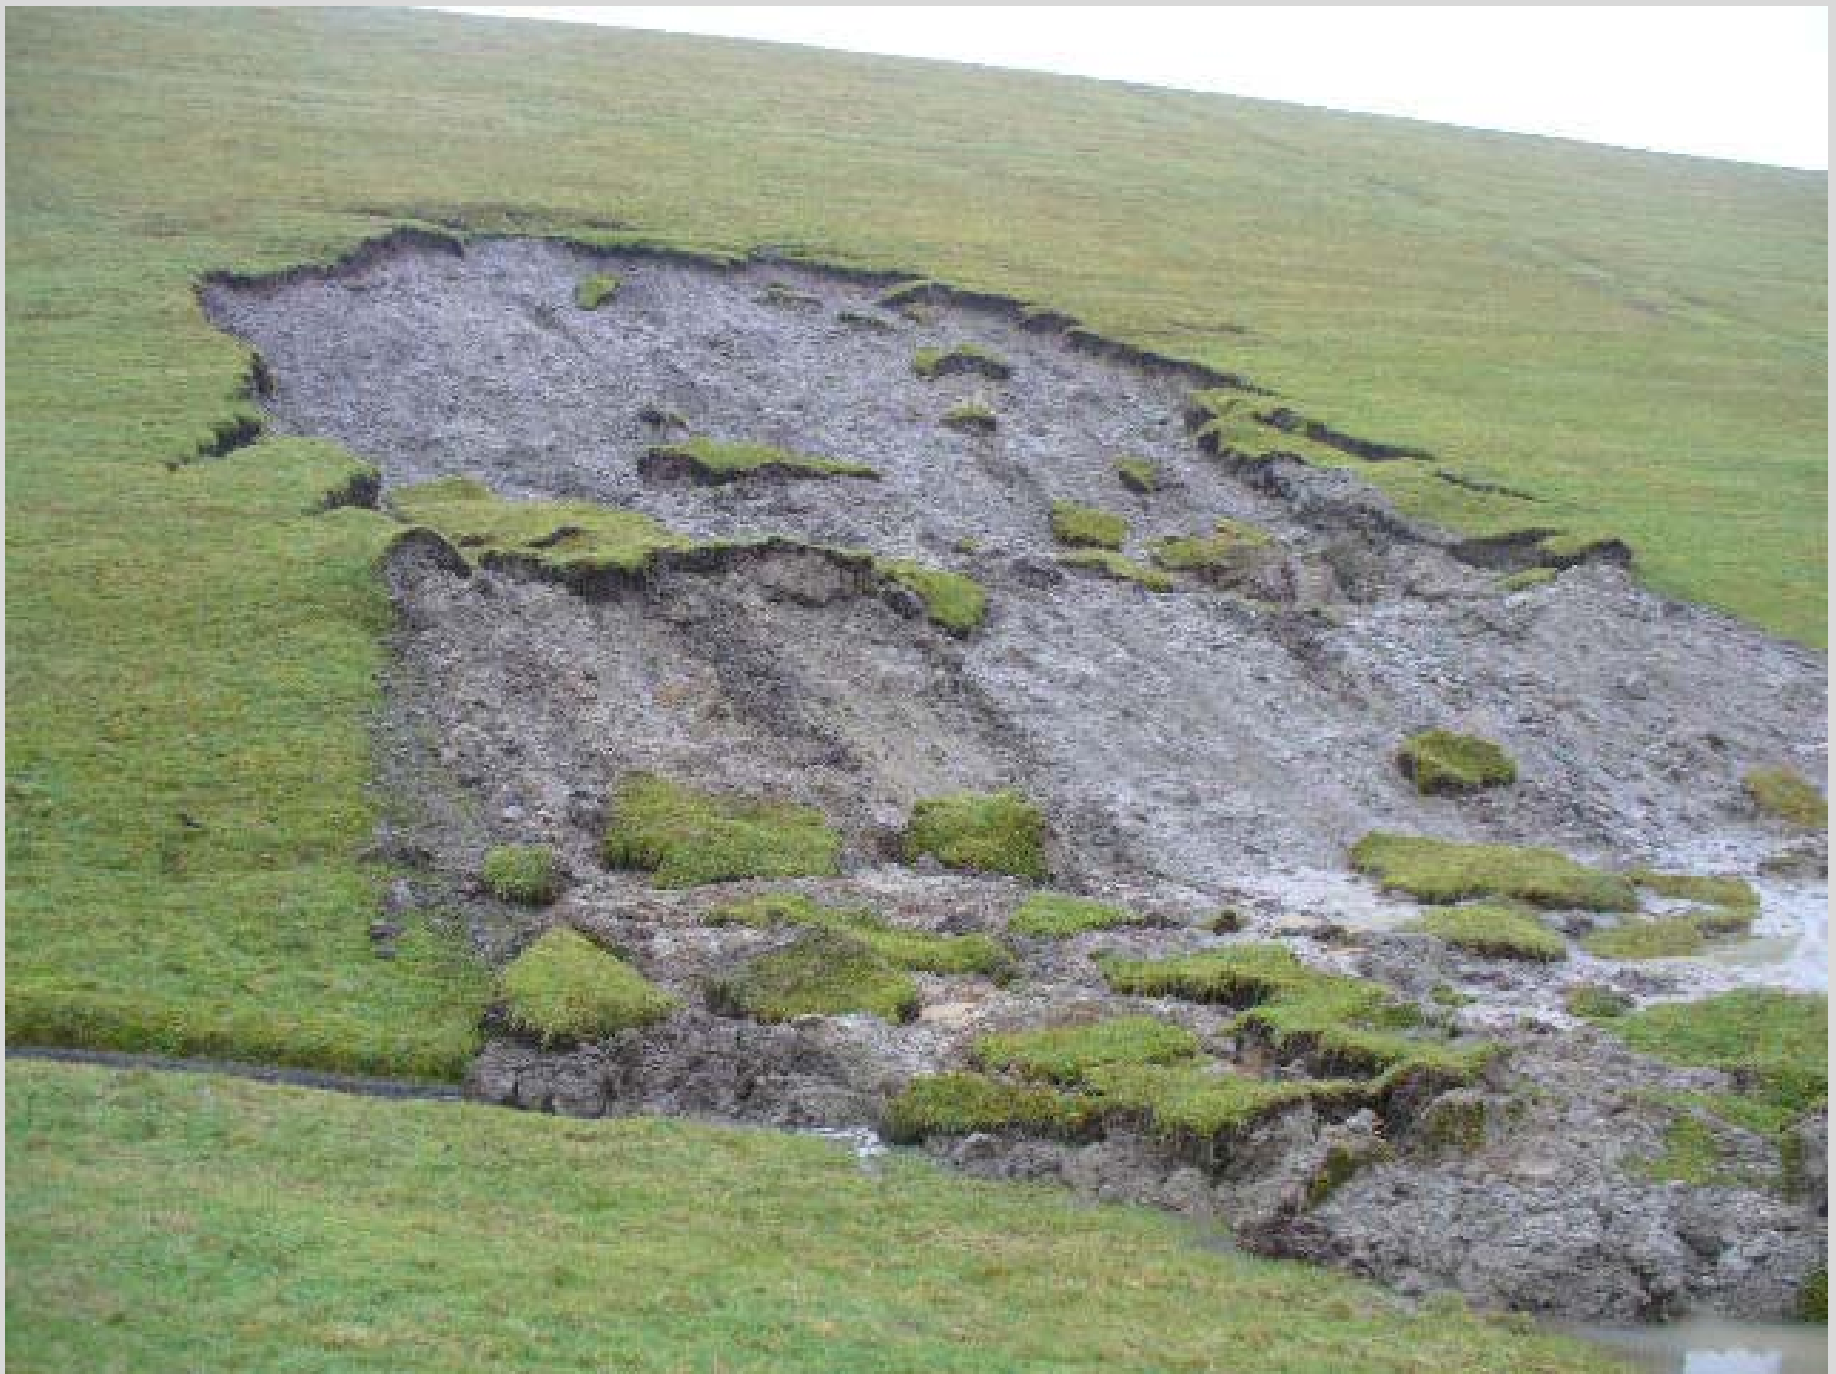
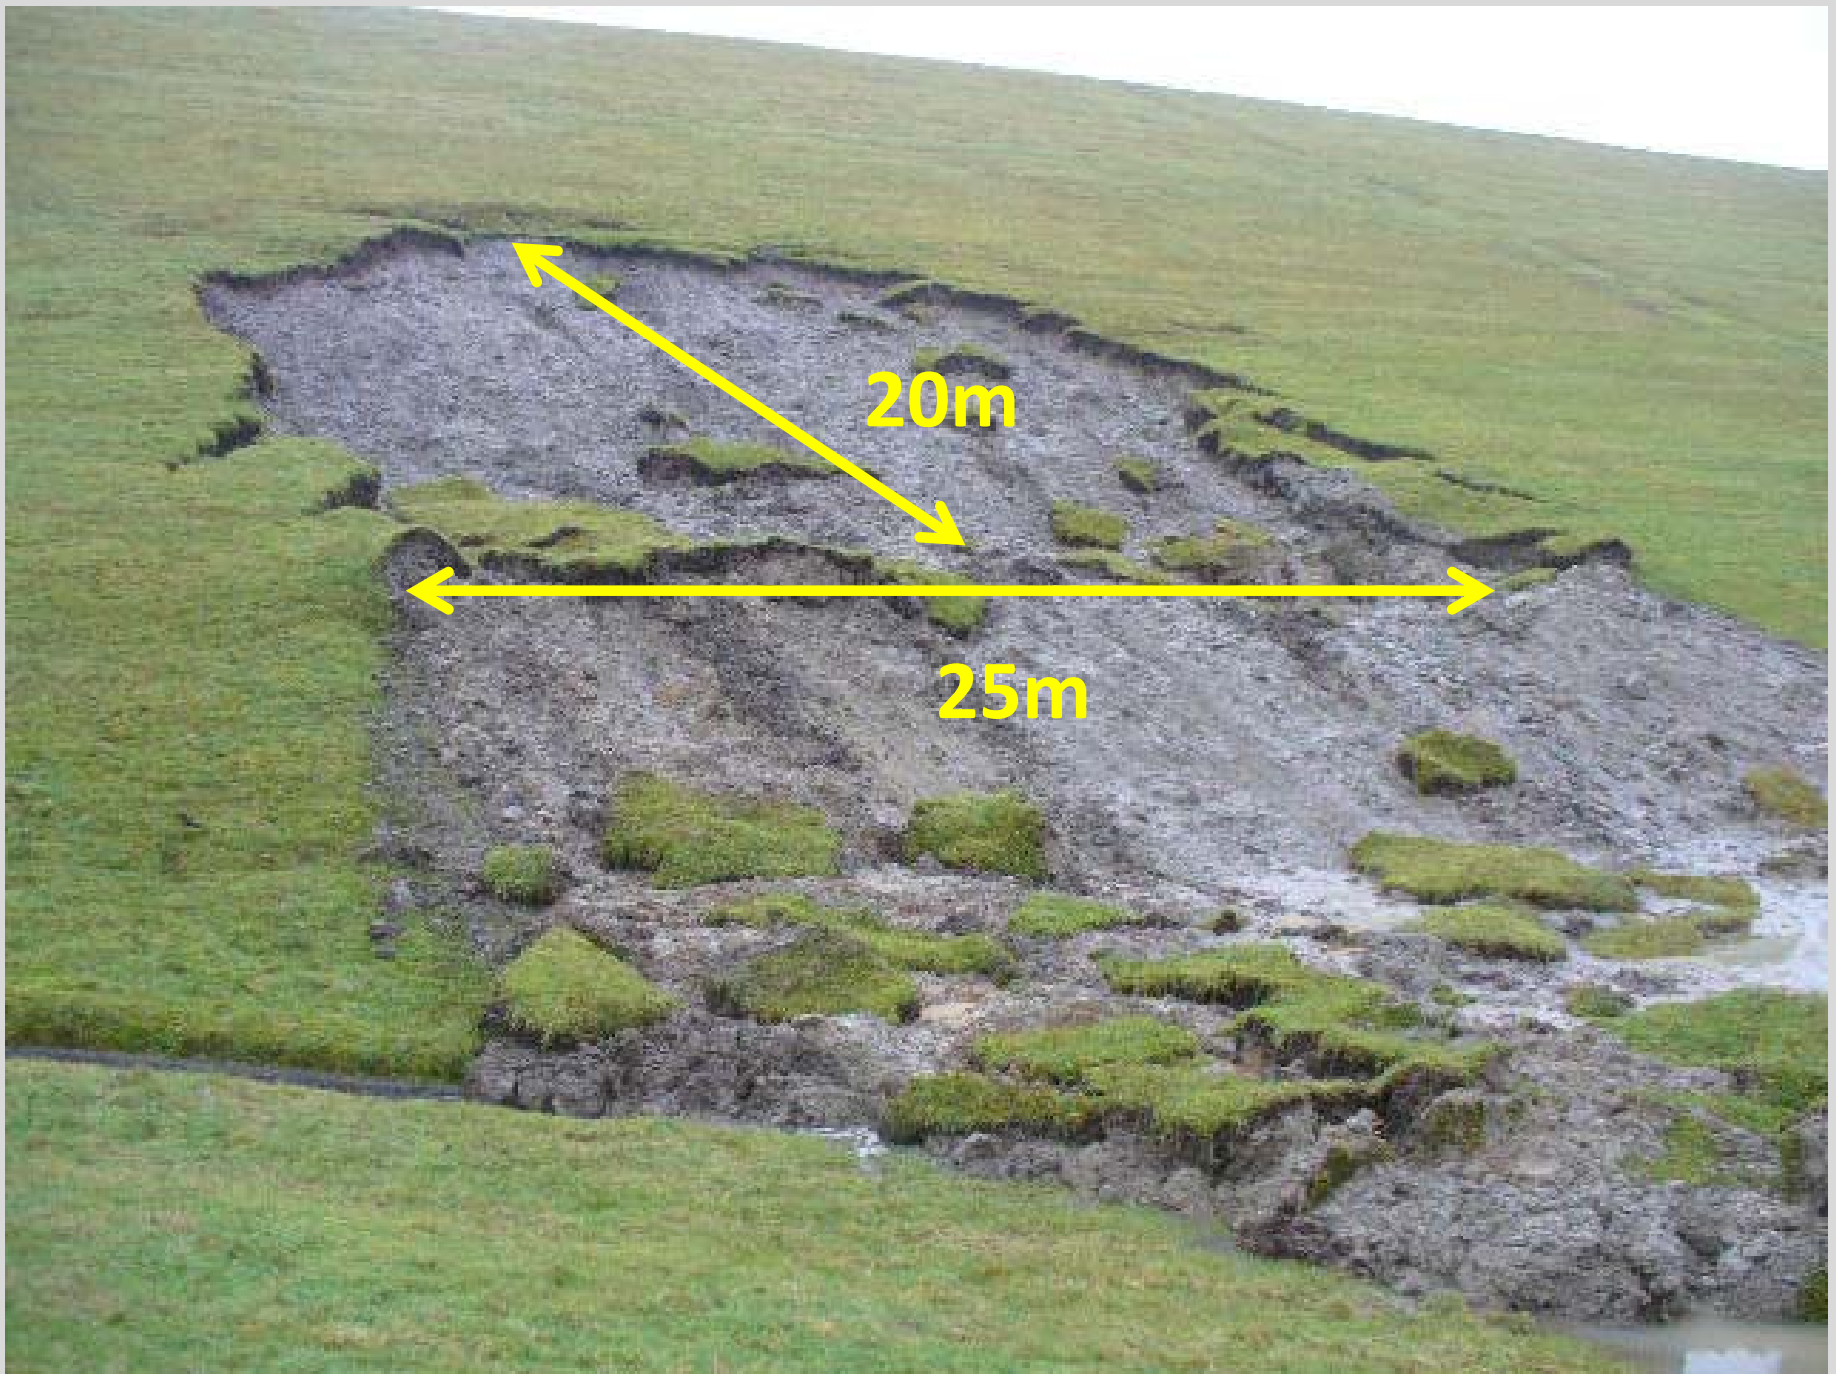
- The incident
 - Notification

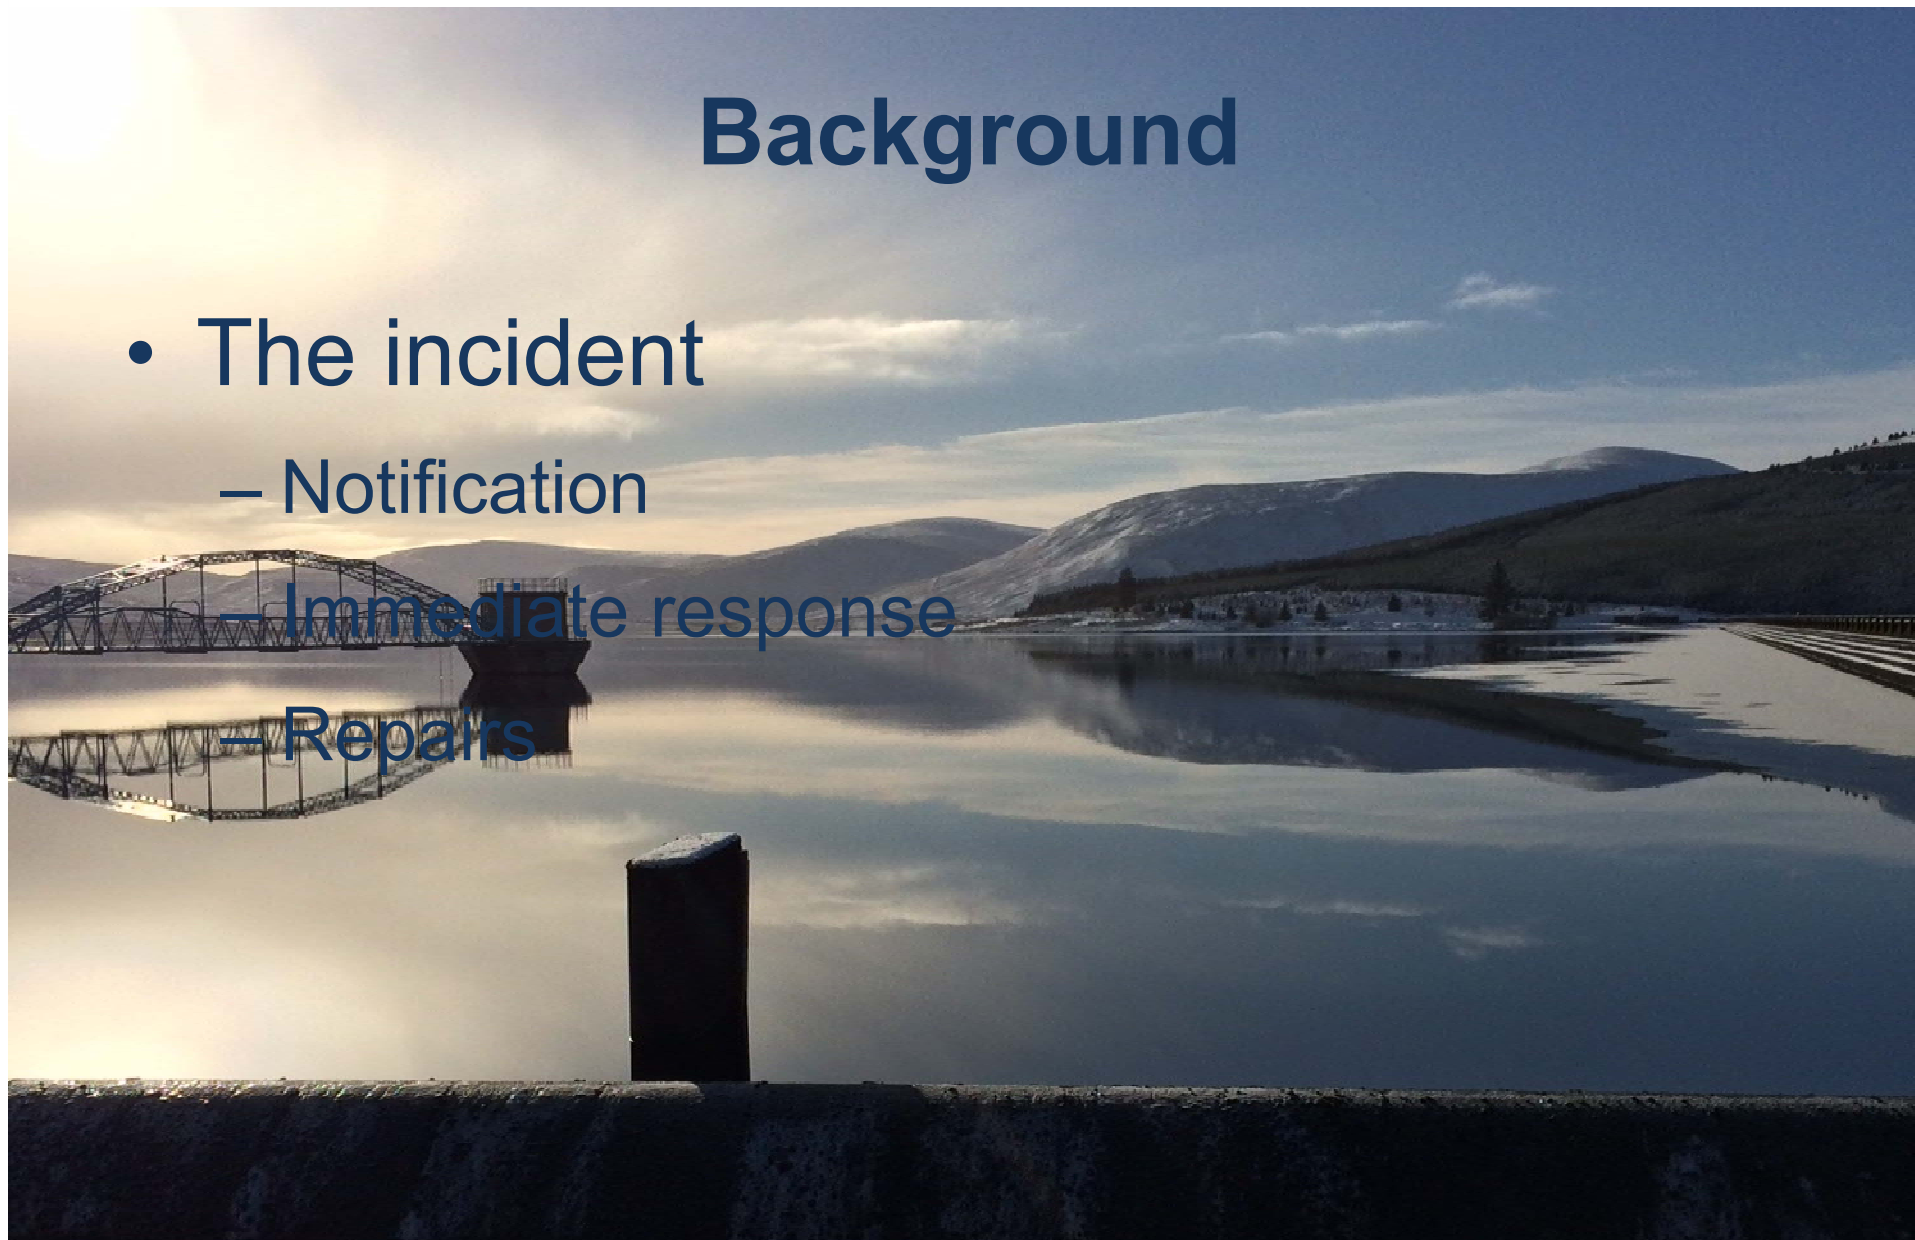
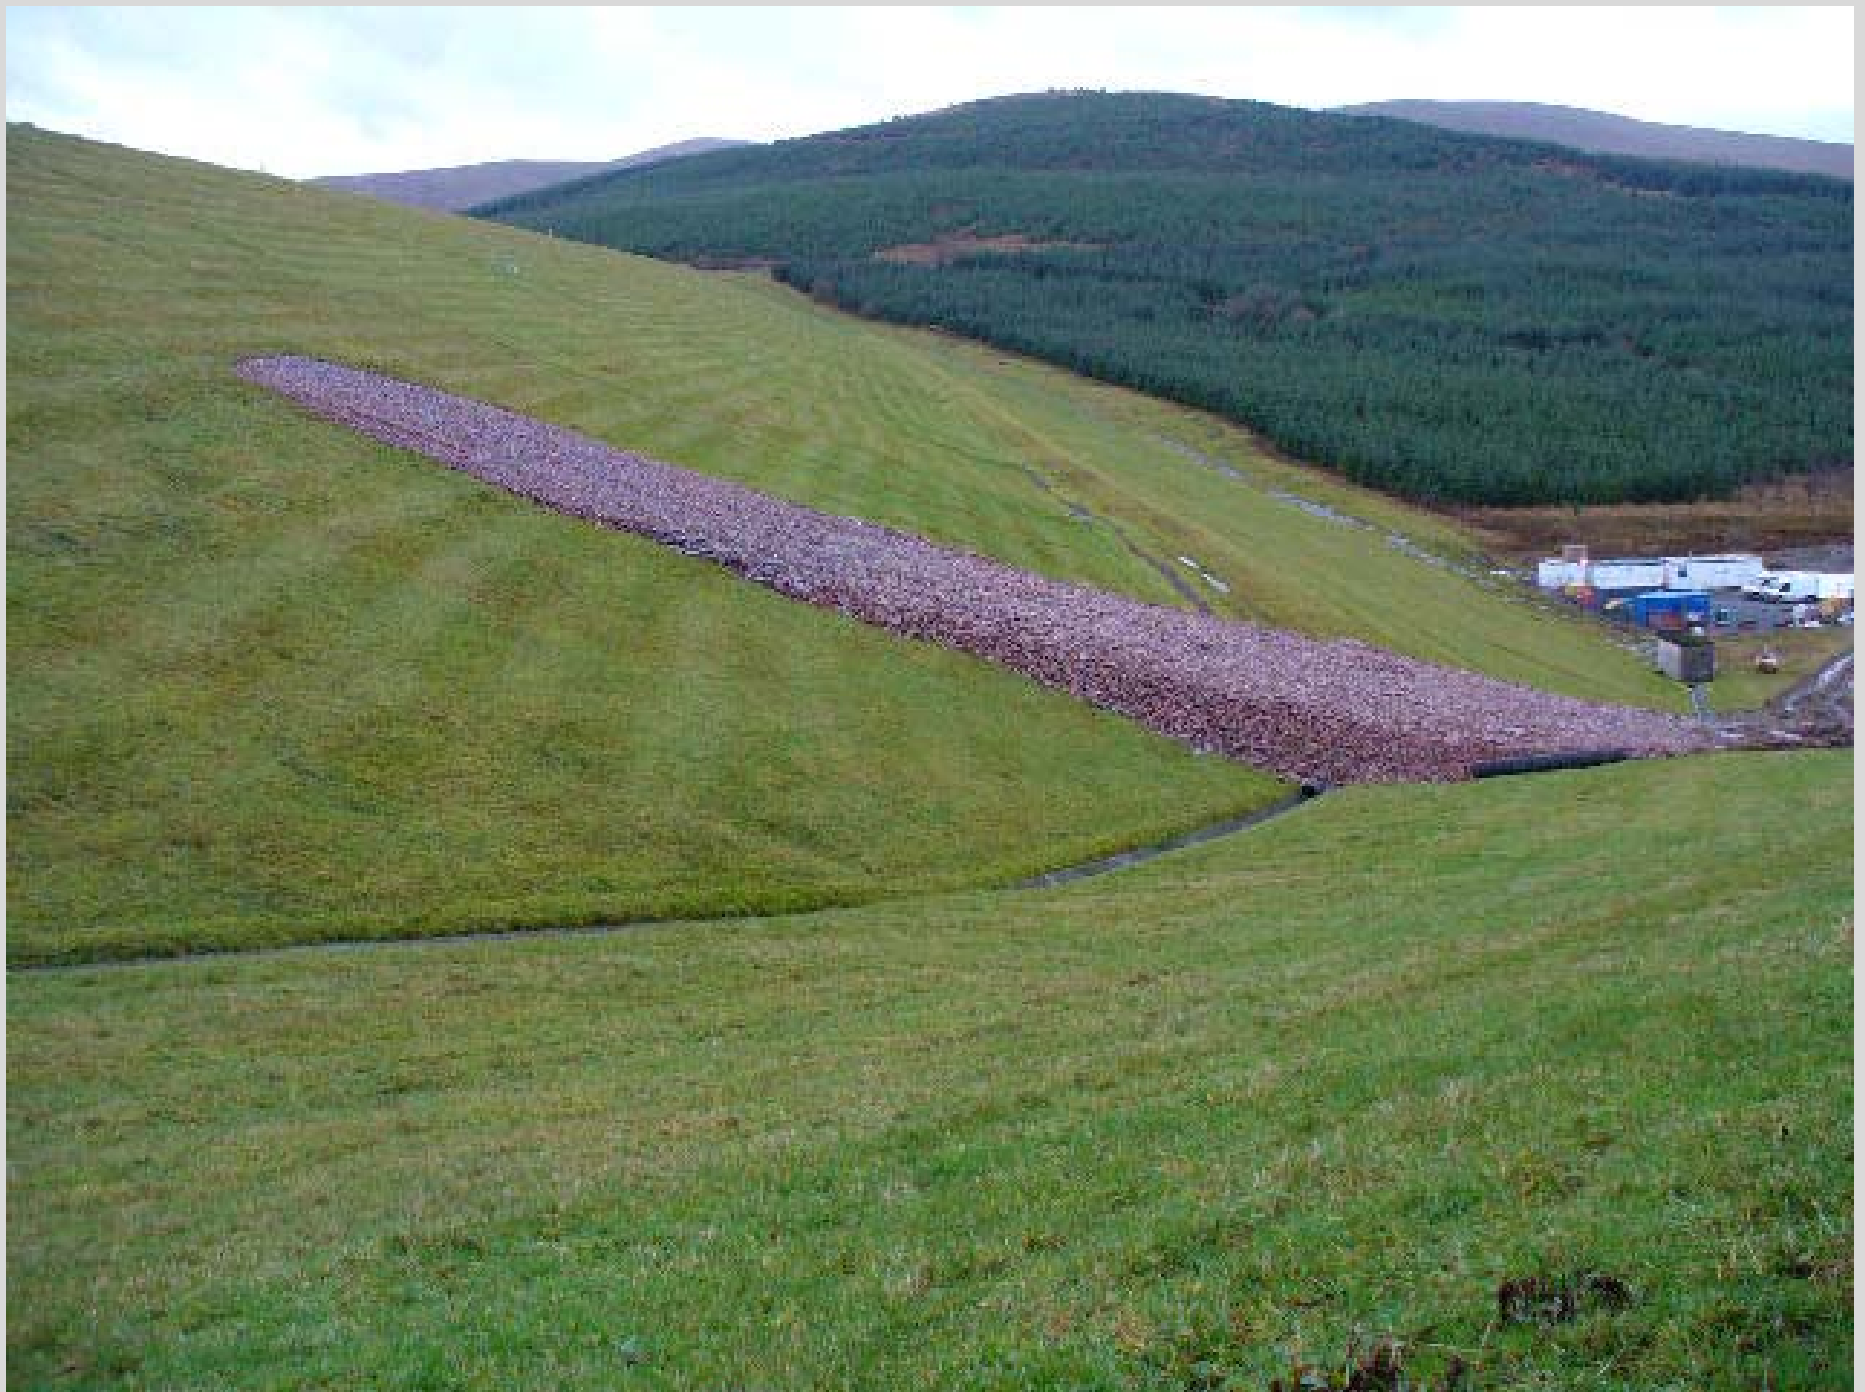
- The incident
 - Notification
 - Immediate response
 - Repairs

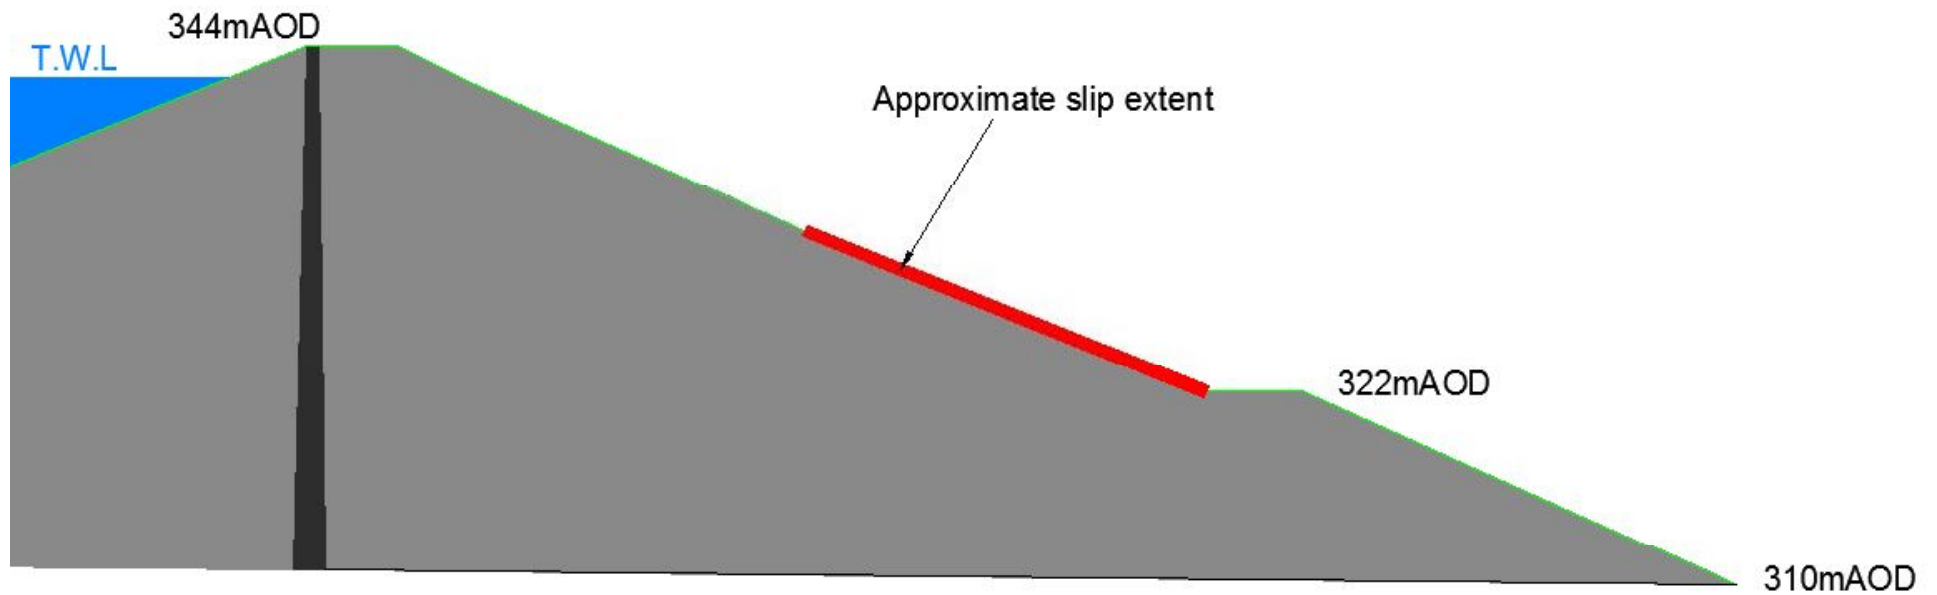
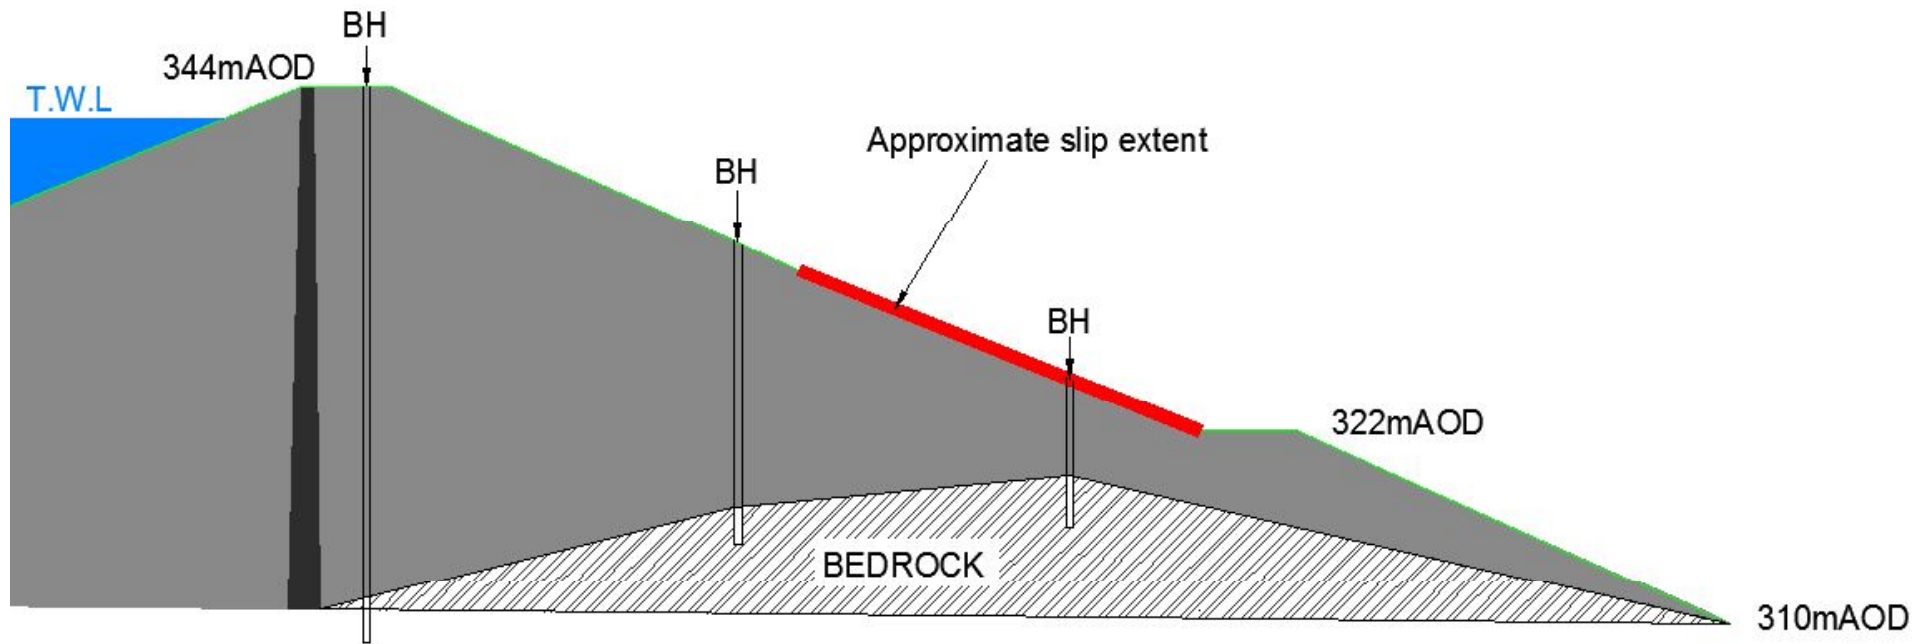
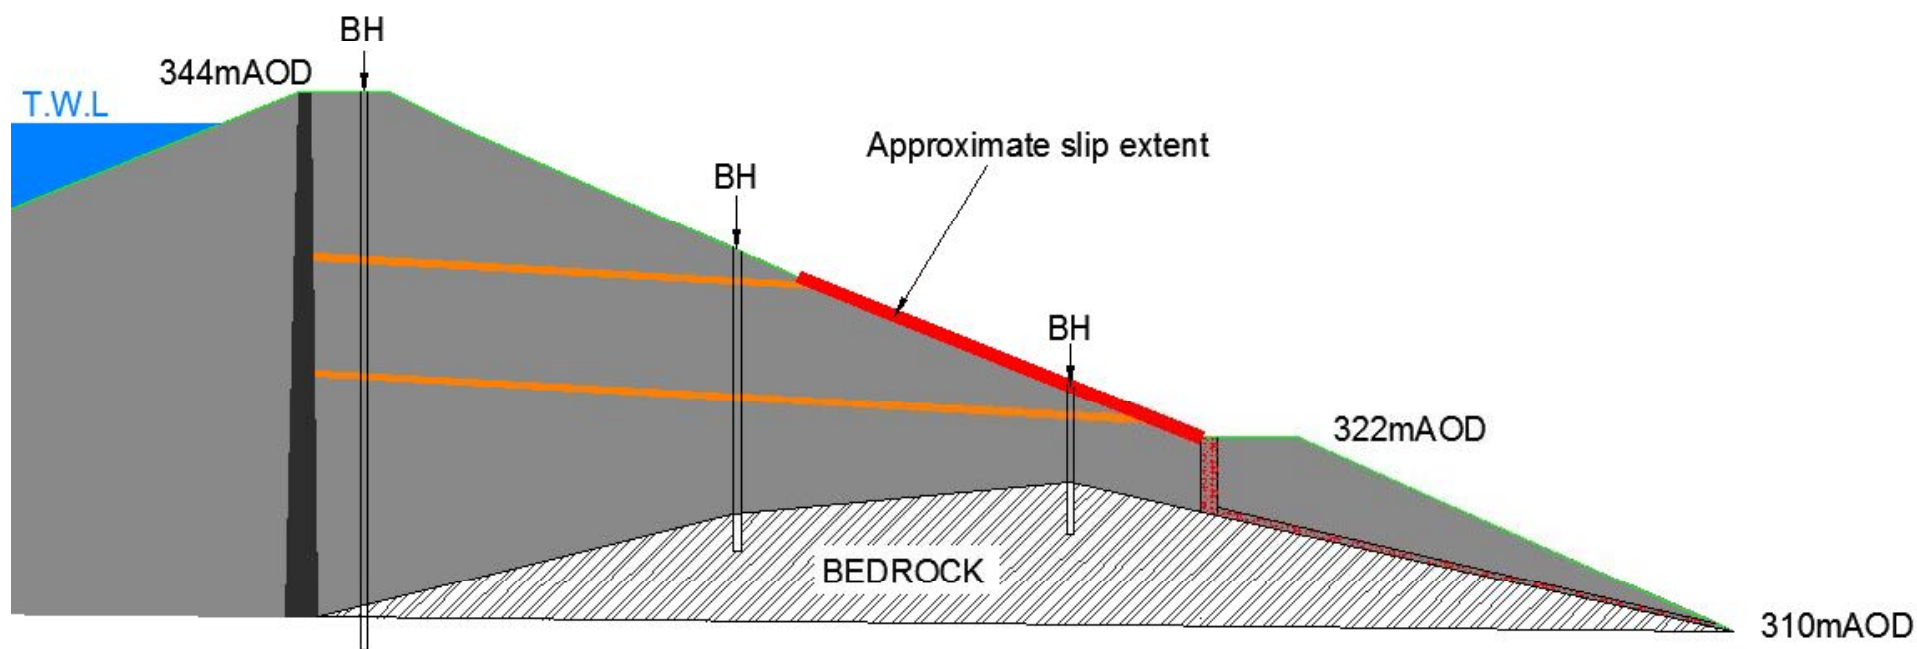
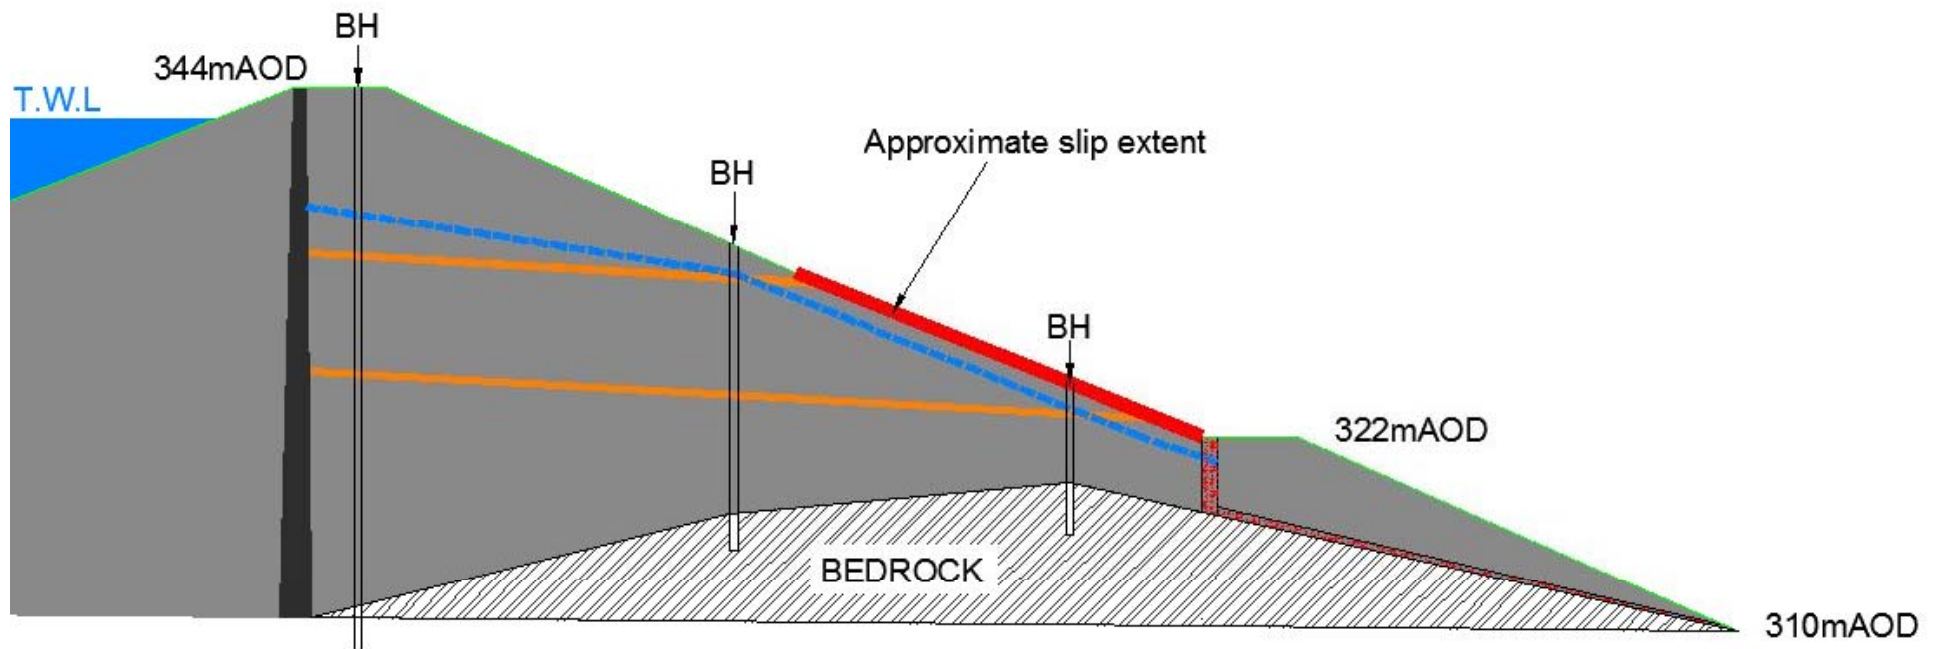
Cross Section – area of slip

- Leakage of water through core wall
- Limitations of drainage system
- Embankment (area of slip):
 - thick topsoil layer;
 - near surface saturated zone;
 - re-worked granular glacial fill.
- Groundwater:
 - generally low phreatic level;
 - shallow, perched groundwater
- Shear strength properties
- Postulated leakage pathway

- Willowstick survey
 - 3 distinct leakage paths identified
 - Leakage below the concrete core
- Drainage improvements
 - New herringbone drainage system
 - Pillar drains and berm drain
 - New drainage collection chamber

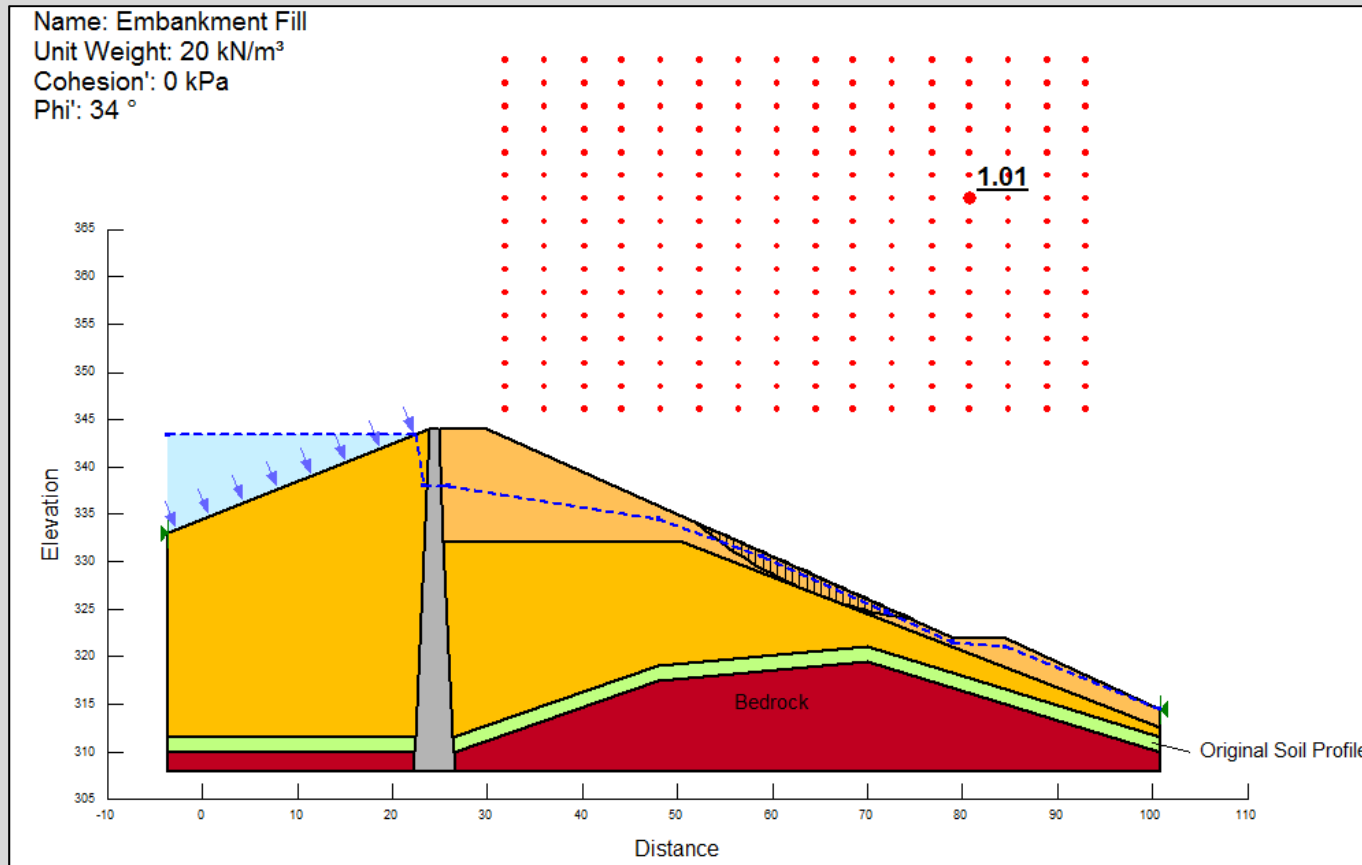
Postulated failure condition

- Shallow surface slip
 - $\phi=34^{\circ}$ (conservative lower value from borehole correlations) – FoS 1.01
 - $\phi=32^{\circ}$ (worst case from borehole correlations) – FoS 0.93

1. Period of heavy rainfall and high reservoir water level;
2. Water seepage through core wall (and below core?);
3. A resulting significant increase in core wall drain water level;
4. Seepage flow into the embankment at a relatively impermeable seasonal construction horizon;
5. Seepage flow to downstream face;
6. A thick layer of topsoil;
7. Surface saturation of thick topsoil (seepage flow and rainwater).

Shallow failure along topsoil / embankment fill interface

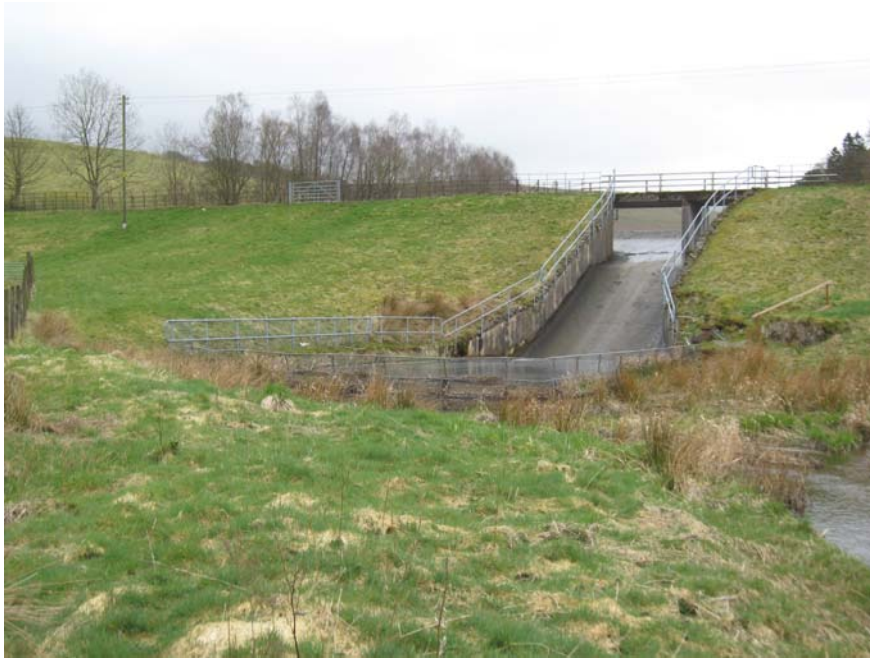
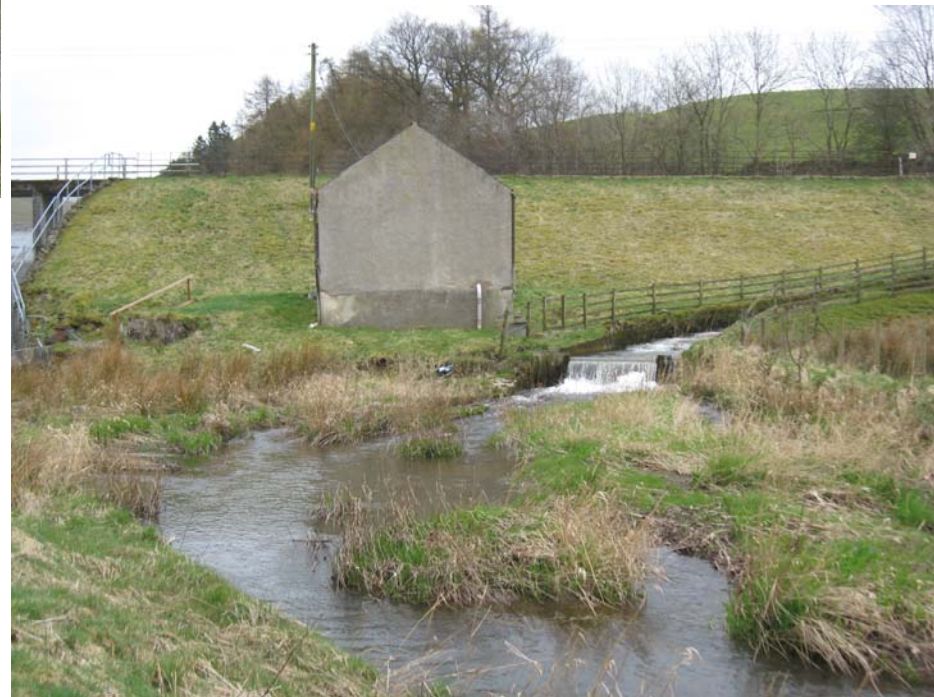
Localised wet patches and extensive reed growth around stilling basin and toe of embankment

Total of 10 drains/pipes installed over the years to monitor seepage on the downstream face

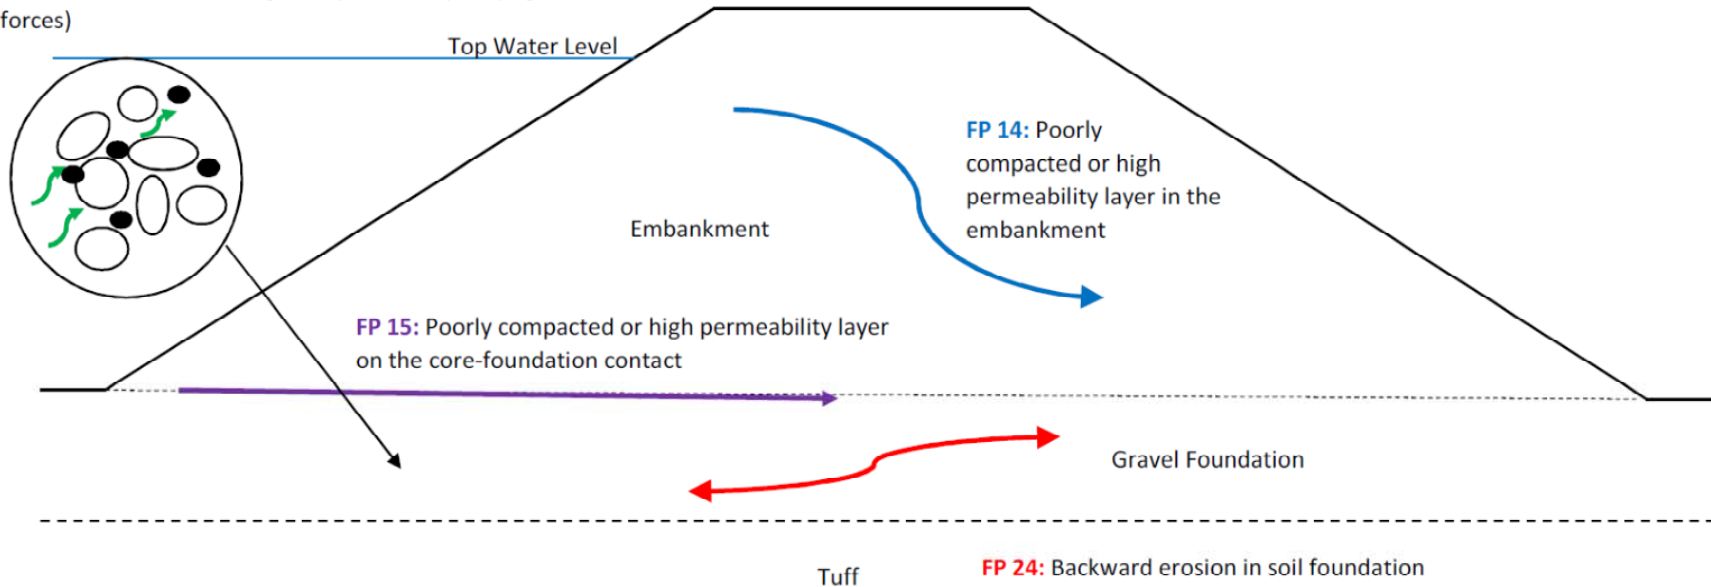
FP 25: Suffusion in soil foundation (suffusion process by which finer soil particles are moved through constrictions between large soil particles by seepage forces)

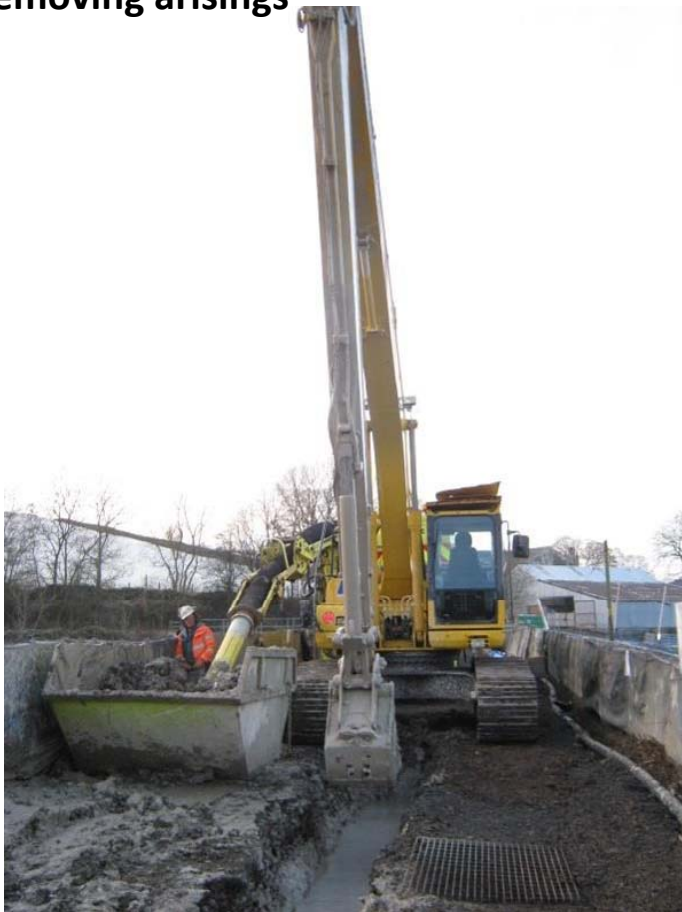
Long reach excavator installing slurry trench with vacuum excavator removing arisings

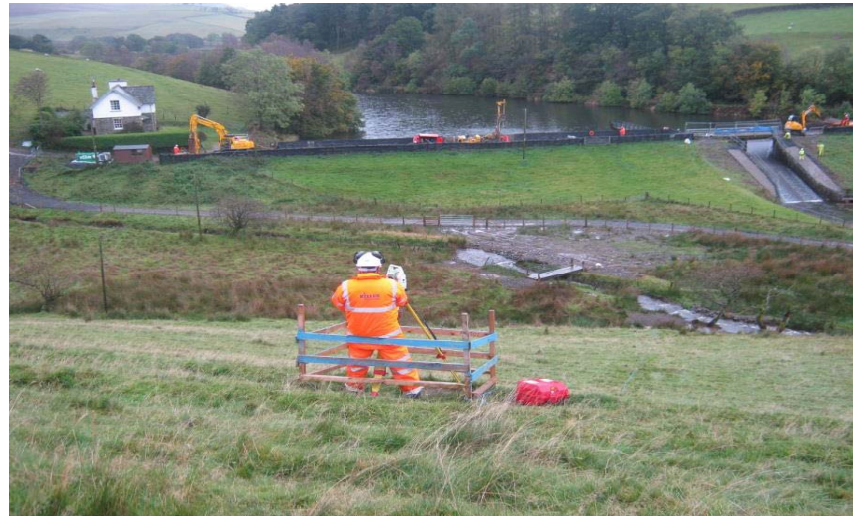
TaM grouting across central spillway, reservoir level maintained

The slurry trench wall did not extend across the central spillway so we had a slurry wall on either side of the spillway and additional grout holes drilled diagonally which overlapped beneath the central spillway. There is an area against the spillway wall which could not be reached by the sheet piles so we did additional grouting in this area also.
