Session 3

GEOTECHNICAL ASPECTS OF DAMS

An investigation and assessment of embankment stability at Daer Reservoir - R Morrin and M Sullivan

An investigation and assessment of embankment stability at Daer Reservoir

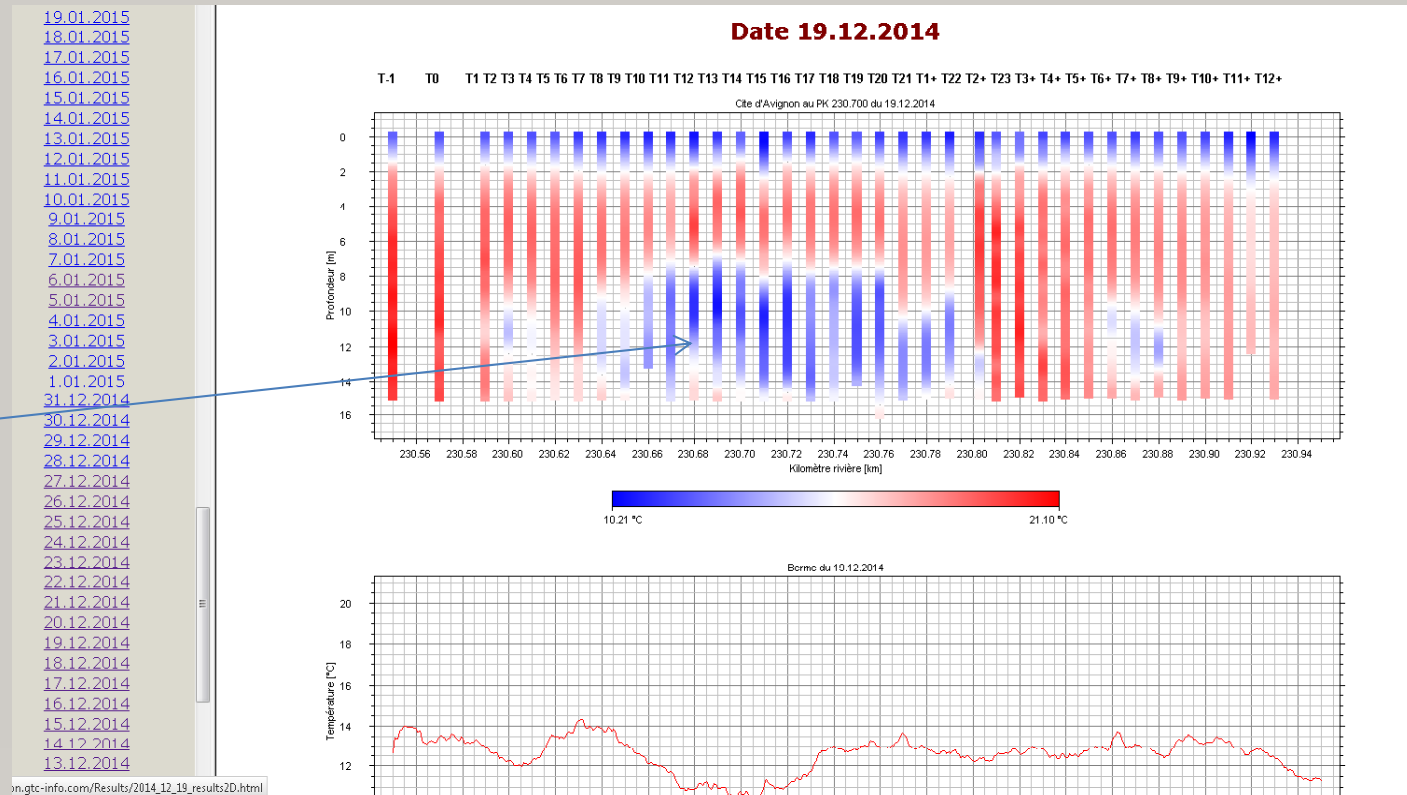
Clear indication
of significant
leakage of 'cold'
river water in
December 2014

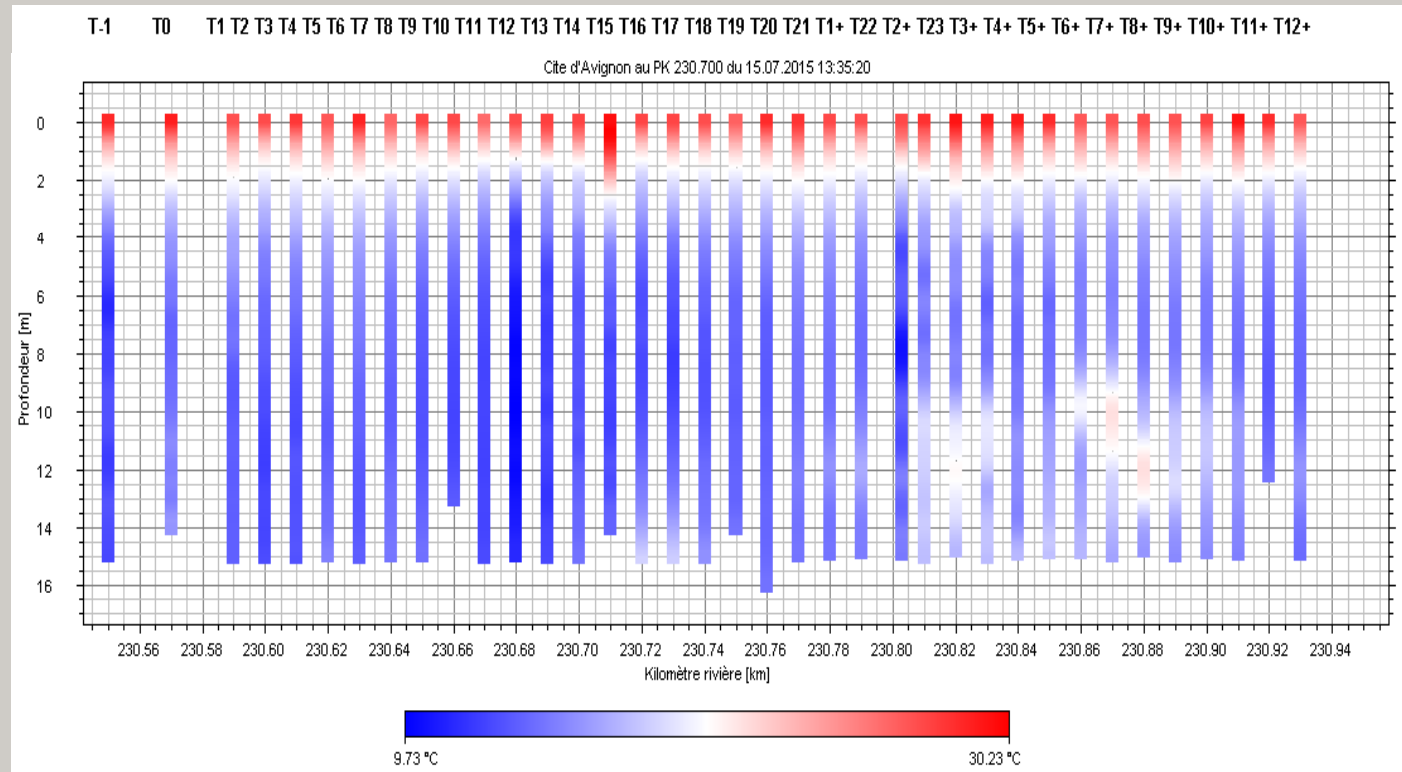
Following the construction of a new cut-off wall to seal the embankment in spring 2015, the recorded temperature distribution in summer 2015 shows no leakage through the embankment or its foundations
