Walthamstow Reservoirs No. 4 & No. 5 embankment protection

C.B. PECK, Thames Water RWE, UK

SYNOPSIS.

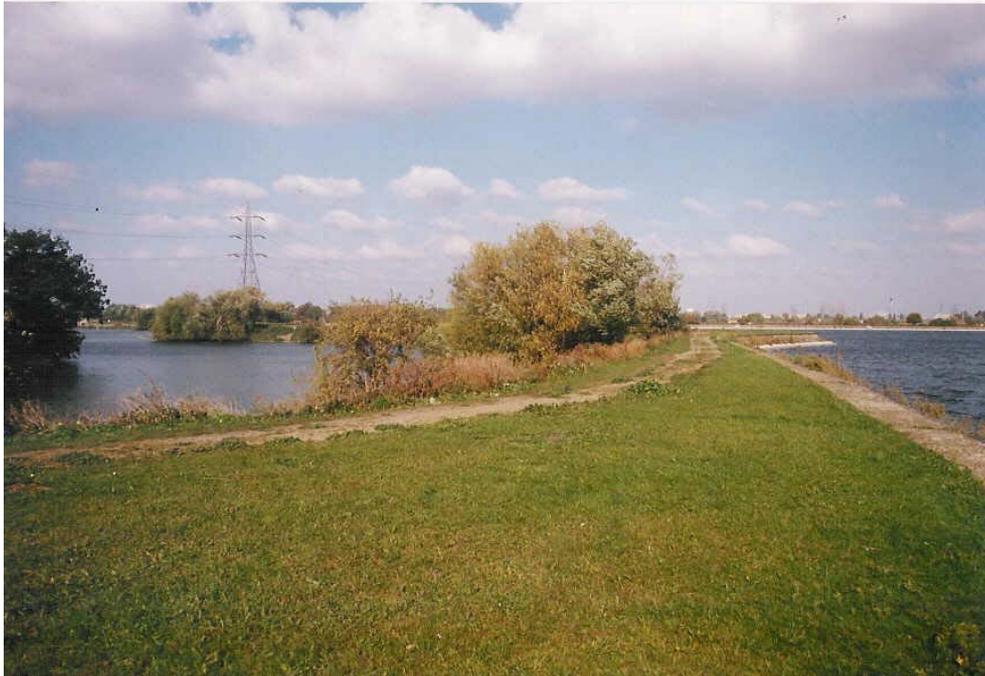
Fig. 2 General view of Reservoir No. 2 next to Reservoir No. 4

Reservoirs Nos. 4 and 5 are statutory reservoirs, falling within the provisions of the Reservoirs Act 1975, and have a common top water level and share a common embankment with Reservoirs Nos. 2 and 3, which lie at a lower level (Fig. 2). Reservoirs Nos. 4 and 5 are operated as raw water storage reservoirs and provide a key supply route for stored water to Coppermills water treatment works, as the final two reservoirs in the gravity chain. Reservoirs Nos. 2 and 3 are used as settlement lagoons for washwater from Coppermills water treatment works and are not classified as statutory reservoirs due to the volumes they hold. These two lagoons were in danger of becoming “silt” bound.

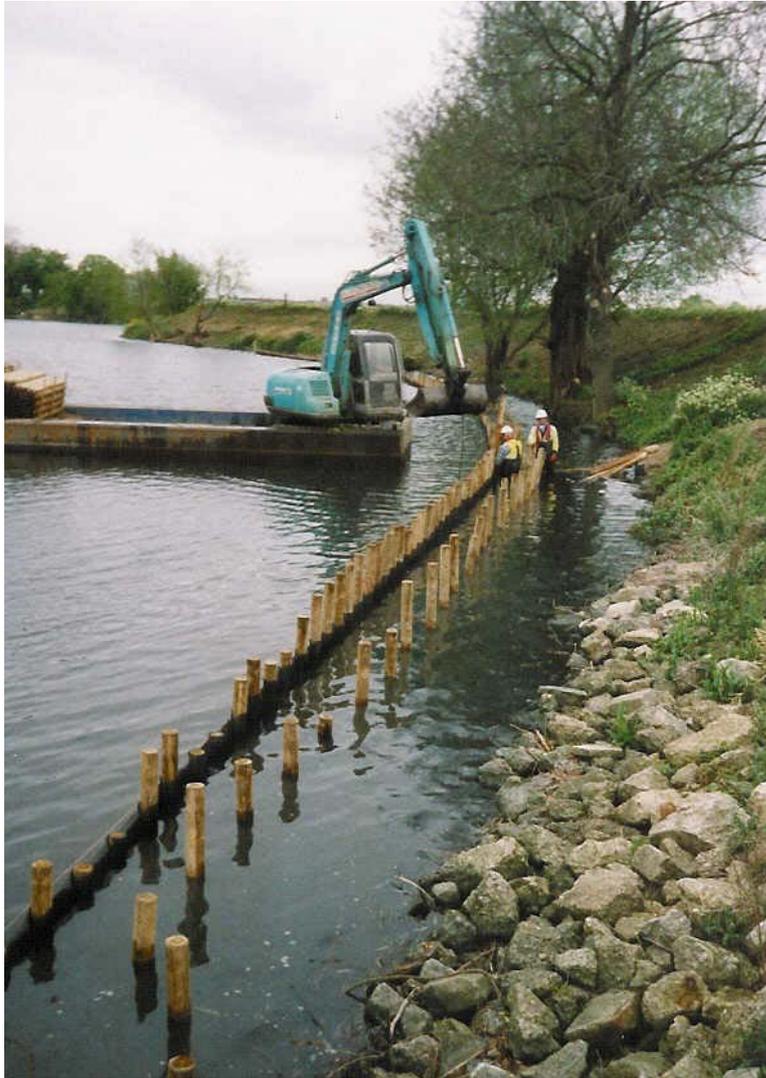
Fig. 5 View of revetment system being placed

A “nicospan” revetment system supplied by MMG, retained the “silt”, which formed the 3m wide dredged “silt” planting shelf for the reed beds on the reservoir embankments. The retaining system utilised a geo-mesh lining retained by sinking a chain of timber stakes 3m from the lower toe. “Nicospan” is a prefabricated, double weave revetment fabric made from strong UV stabilized monofilament yarns that are heat sealed to form a series of open pockets each having a width of 220mm, so that posts can be placed into them. The geo-mesh was selected to allow water to pass through but retain the “silt” (Fig. 5).

The posts for the “nicospan” revetment were driven in using a small piling hammer, converted for 100mm posts, mounted on an excavator. The posts were driven, at 500mm centres, into individual pockets of the “nicospan” to progressively “tighten” the revetment. The line of the revetment was agreed with Thames Water’s site staff to offer maximum toe restraint to the embankment, but also offer the most ecological benefit. Anchor poles were

driven to the rear of the “nicospan” at 100mm centres and, wired to the “nicospan” using galvanized fencing wire. The excavator, used to install the retaining system, was secured to a floating pontoon (Fig. 5).

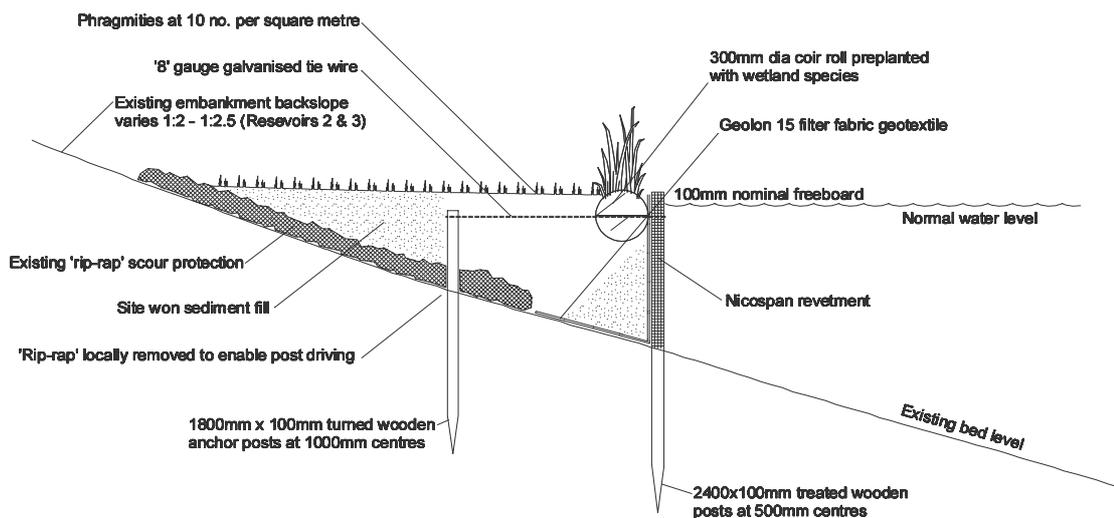
Fig. 6 – Section of “silt” shelf

The Contractor designed the form and retaining system for the “silt” shelf (see Fig. 6) and Thames Water’s Geotechnics Group checked whether the new shelf would affect the stability of the reservoir embankments. The analyses were undertaken for slope angles of 1 in 2 and 1 in 3 using the methodology suggested by Morgenstern and Price (1965) and conservative soil parameters ($c' = 0\text{kPa}$ and $\phi = 37$ degrees for the gravels and $c' = 3\text{kPa}$ and $\phi = 20$ degrees for the London Clay). The results for failure surfaces

The conclusion was that the effect of the “silt” shelf on FOS was minimal and that even with the most onerous combination of a steeper slope and with the failure surface entirely in the London Clay, an acceptable FOS was obtained.

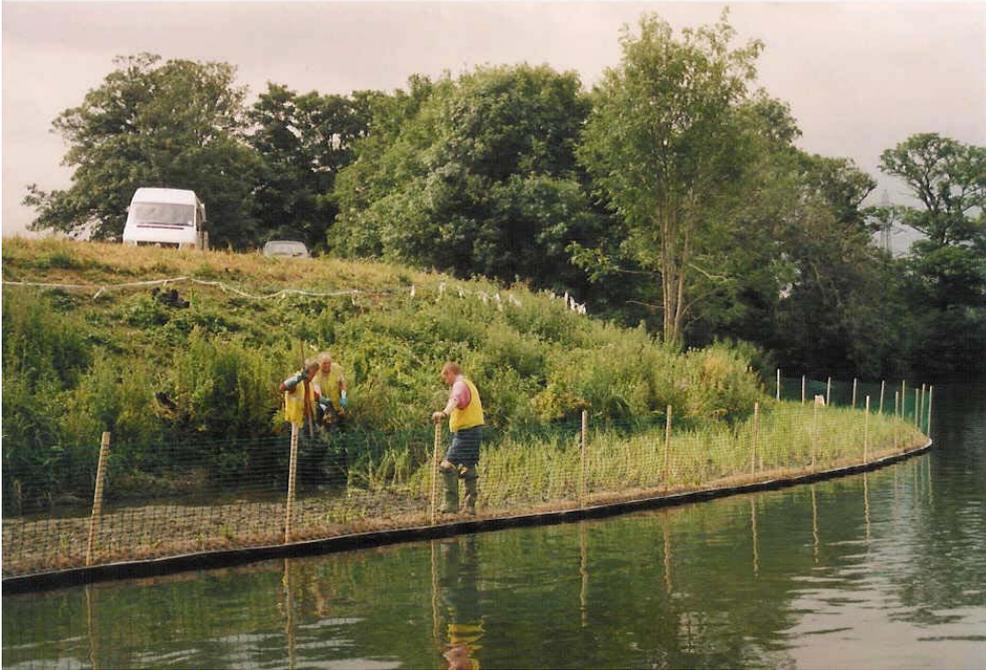
Fig. 8 Planting of reed beds

The depth that the reed beds sit in the water was important to their surviving and maturing, and the Contractor formed the “silt” shelf to a level of 8.00m AOD, which allowed for 0.20m settlement of the “silt” shelf. This level ensured that the roots of the plants were always submerged. The finished level of the “nicospan” revetment was 50mm above the top water level. The density of the reed beds planted was ten plants per square metre. The reed beds were planted during May, which was the best time of year for their establishment (Fig. 8). Also the Contractor’s design included the use of pre-planted reed “coir” rolls and mattresses, which minimised the chances of die back or natural waste of the reeds.

There is a thriving bird life on the Walthamstow Reservoirs, and the newly planted reeds would be susceptible to damage by the birds, therefore to minimise the damage, netting was placed over the reeds as protection. This type of netting is proven to deter wildfowl interest.
