Session 7

CASE STUDIES OF DESIGN AND CONSTRUCTION

AGEING SERVICE RESERVOIRS

An increasing burden or scope for innovation?

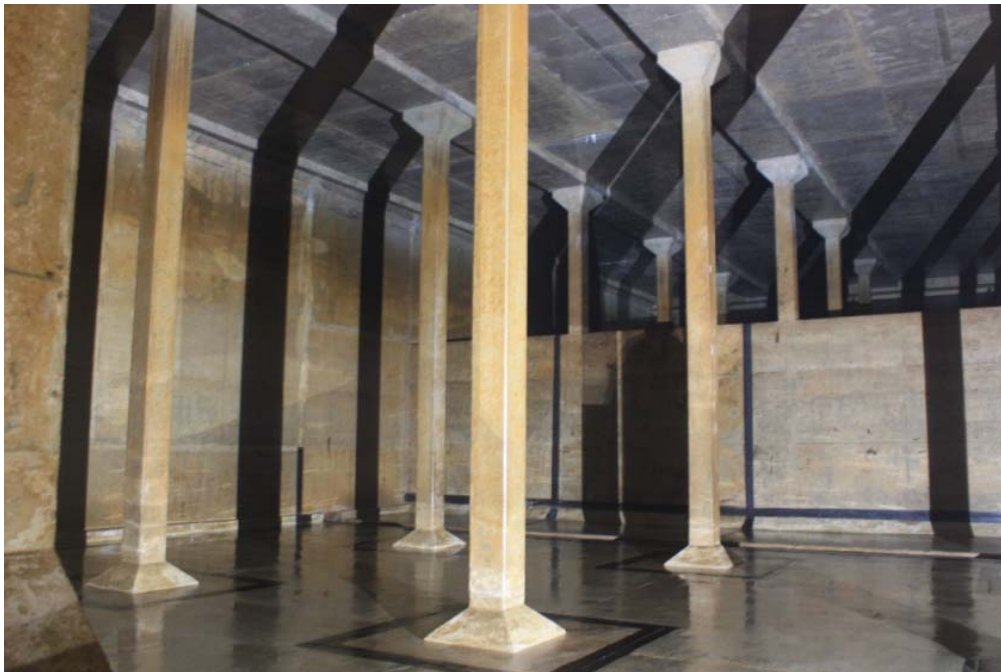
Strelley SR

- Two examples of reservoirs with part height division walls which limit operating capacity to 25%:

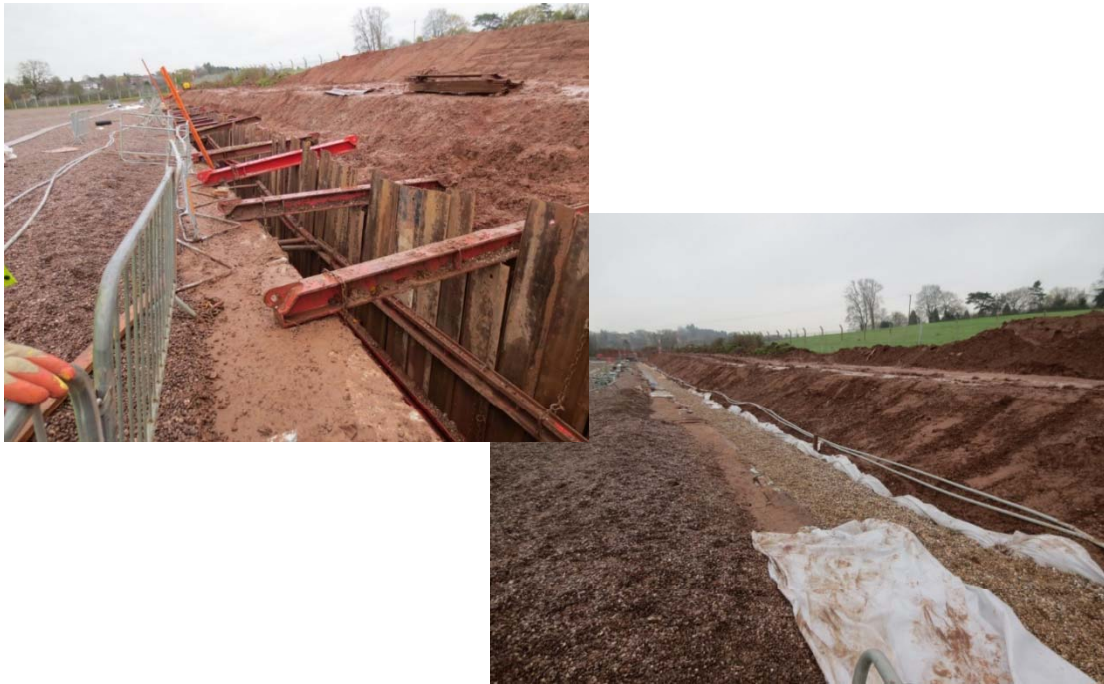
Frankley Treated Water Reservoir 2014

Installation of wall drainage and membrane
at Frankley PWR1 – Cost ~£0.5M

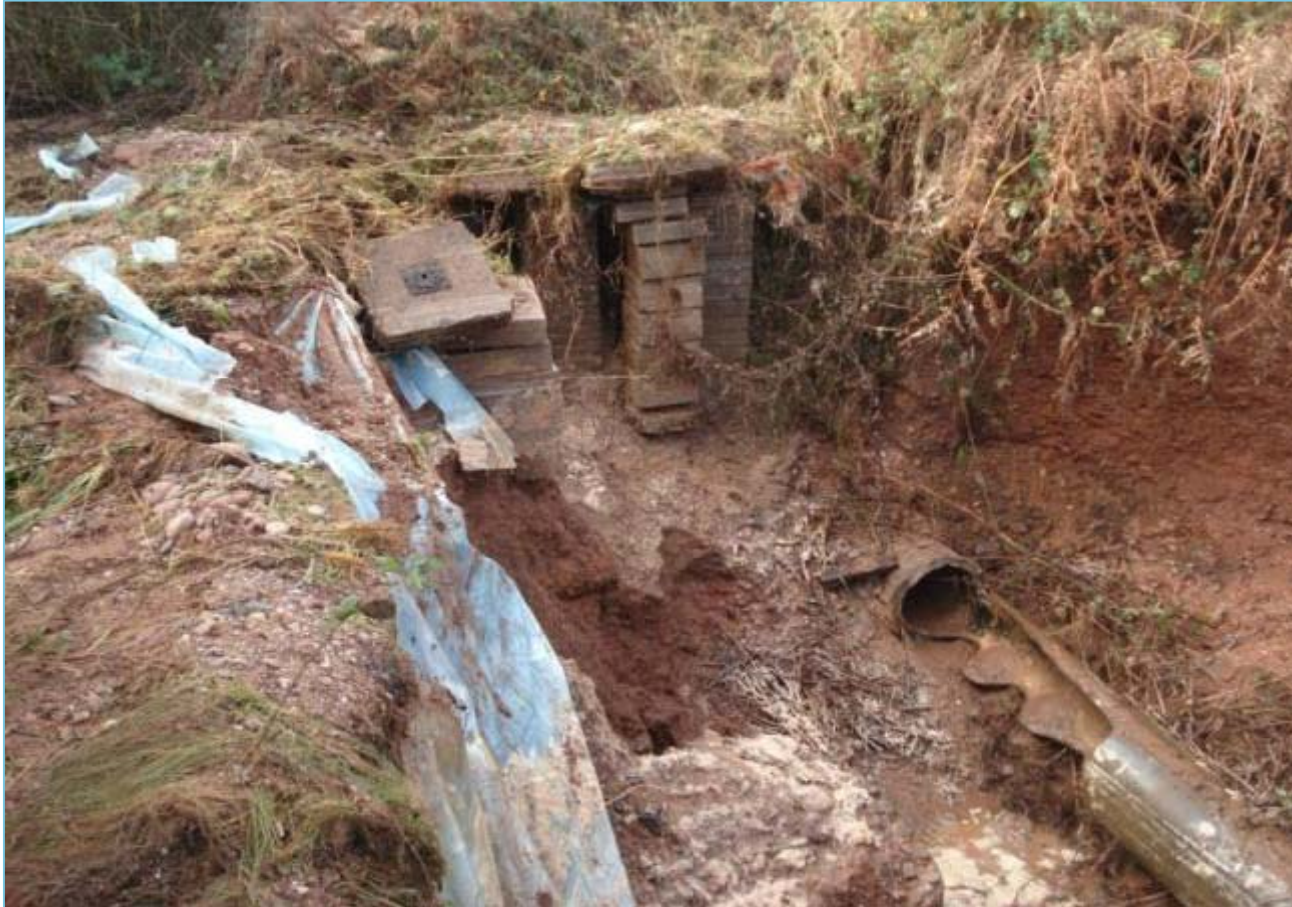
BARR BEACON SR

Cause of flooding - 18" diameter main leading from SR had burst

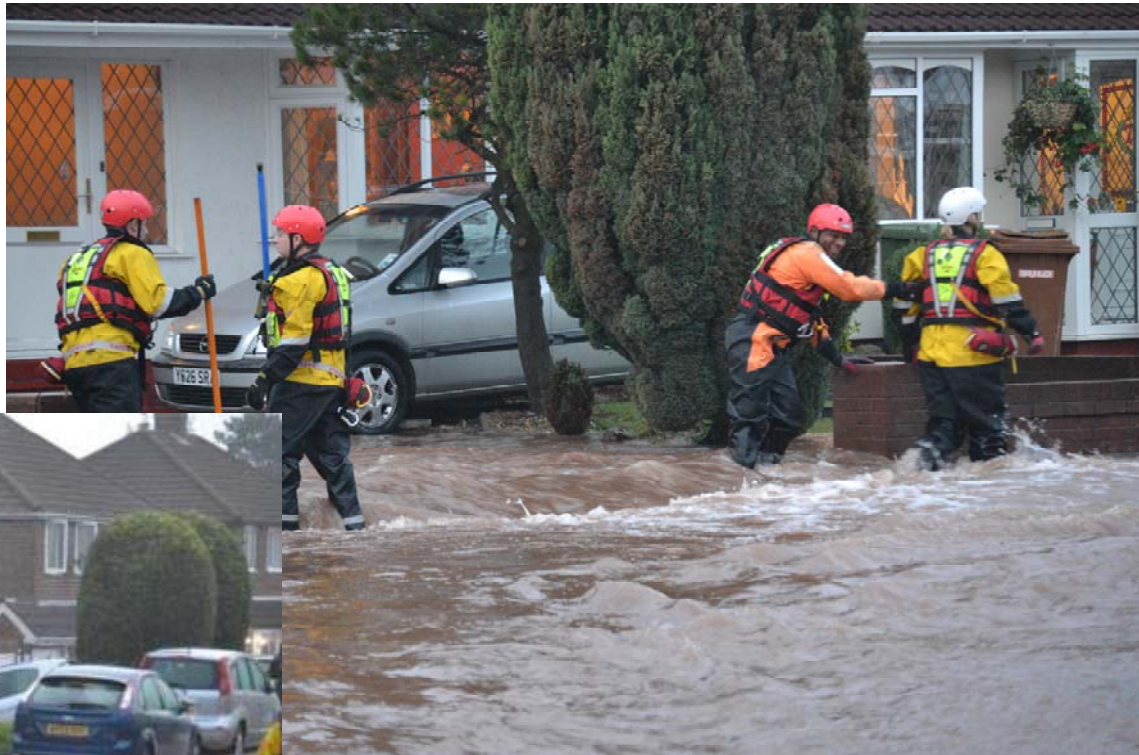
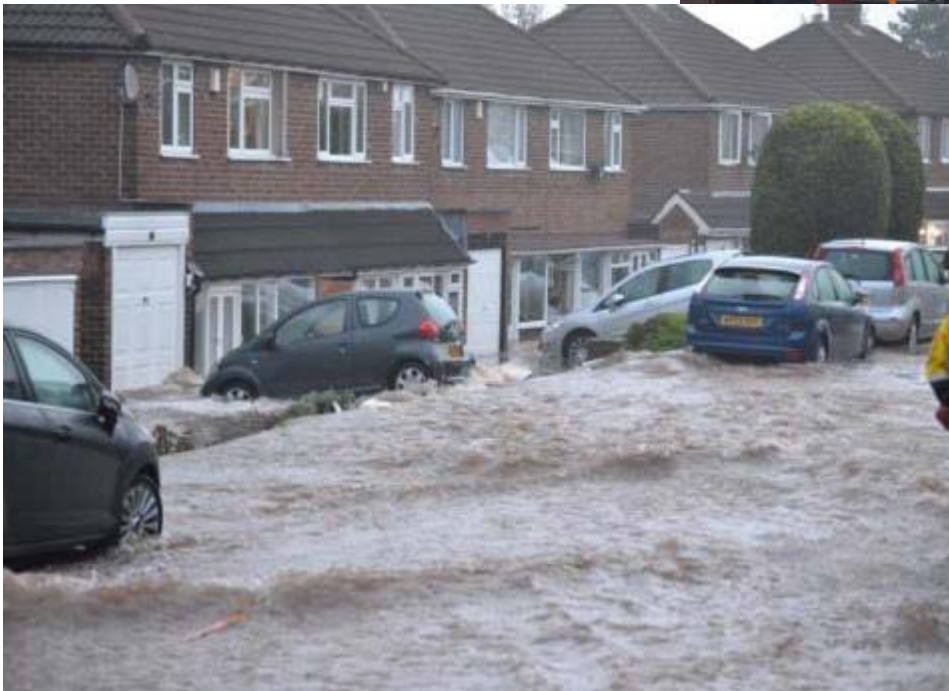
- Considerable damage following mains failure
- Despite extensive damage and disruption South Staffs Water banked social capital in the community by their response

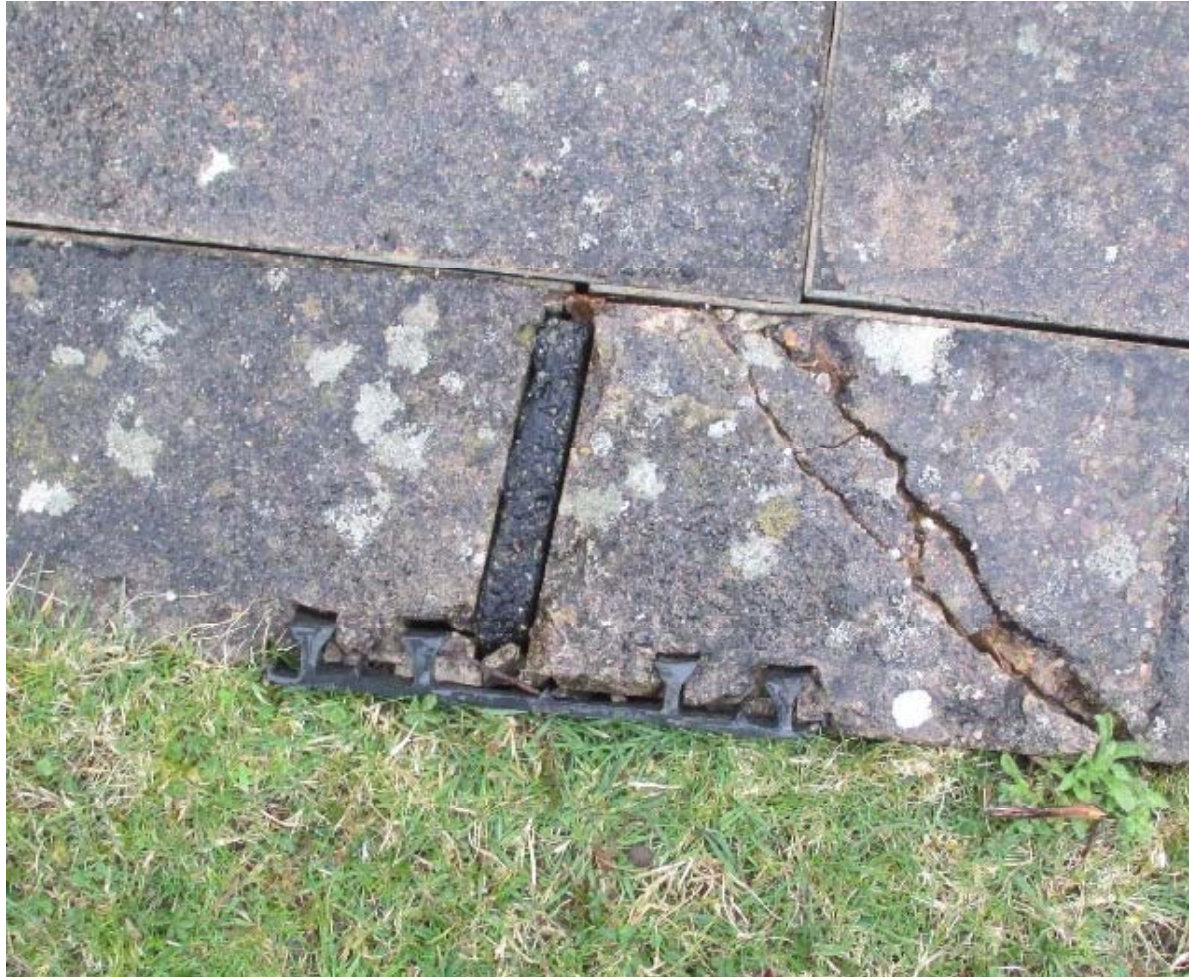
SOURCES OF BACTERIOLOGICAL FAILURE

A vertical expansion joint with rear guard water stop

- 1. Movement during construction
- 2. Very poor detailing - wrong application of rear guard waterstop

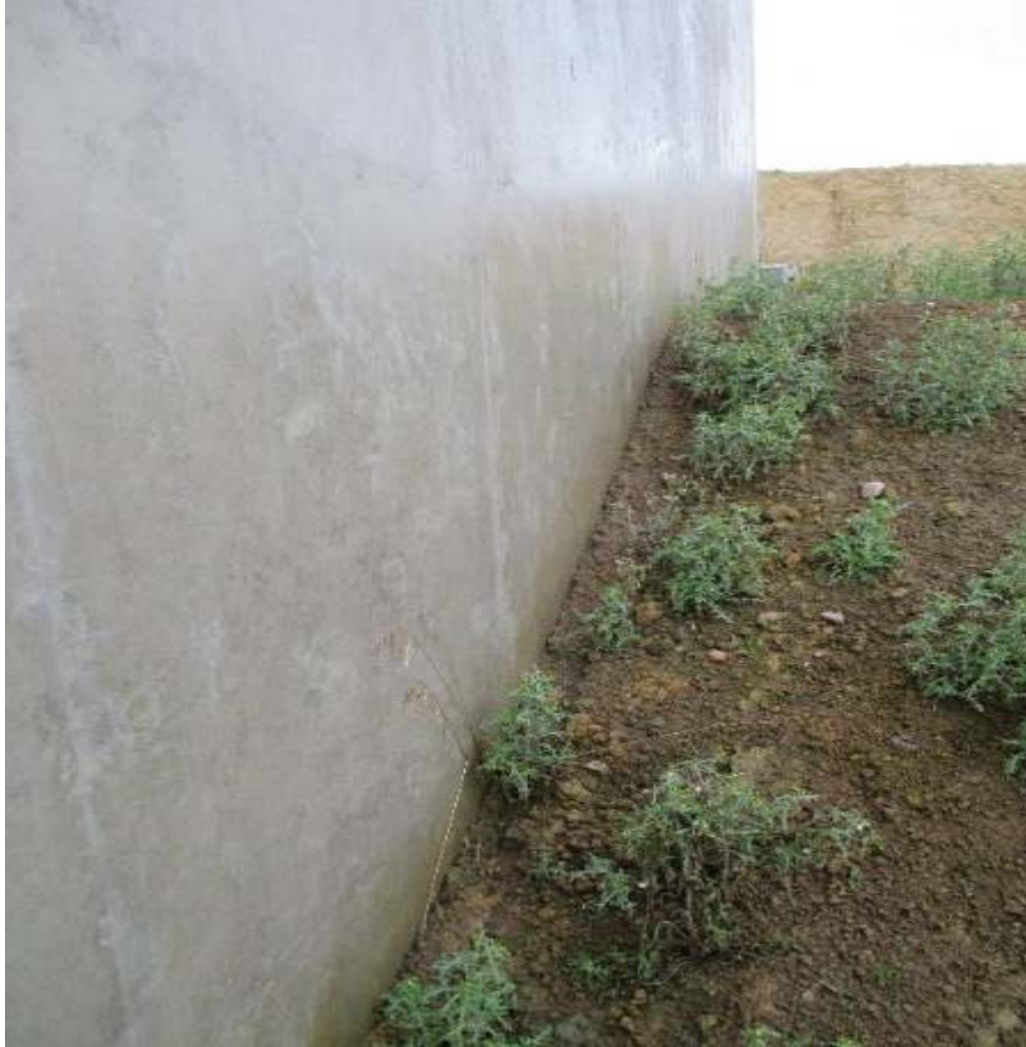
CONTRACTOR SELF ASSURANCE?

- Backfilling on a new SR without drainage membrane, contrary to specification, allowing a positive water table with a potential for ingress.

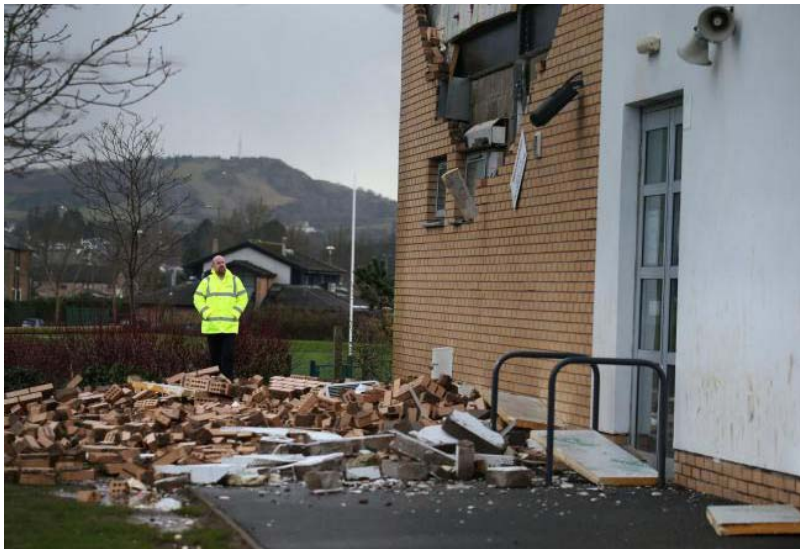
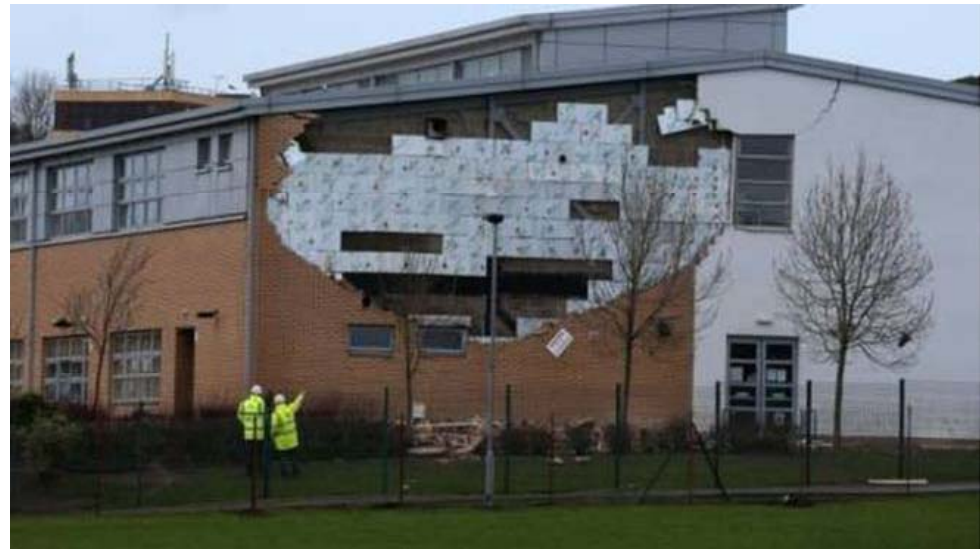
FAILURE OF SCHOOLS IN EDINBURGH

Simple omission of tie bars that arguably a Clerk of Works would have detected.

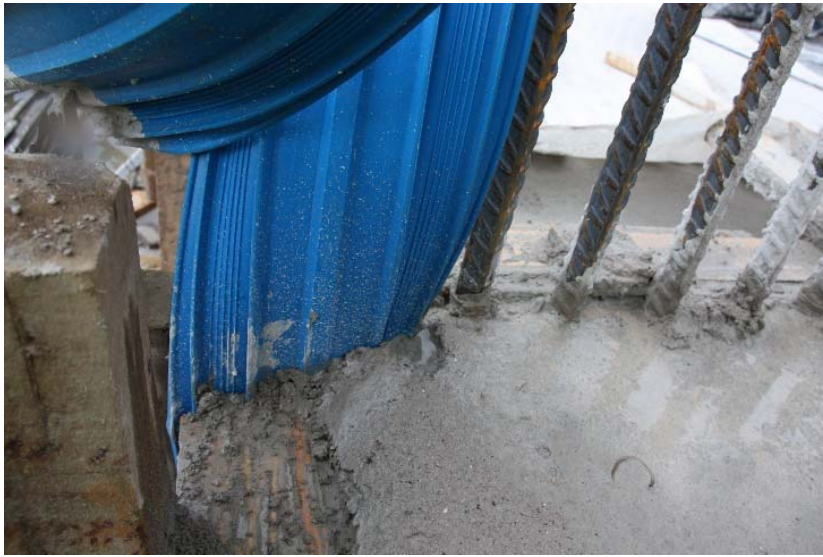
WORKMANSHIP – WATER BAR

If not picked up, would this have been hidden by the next concrete pour?

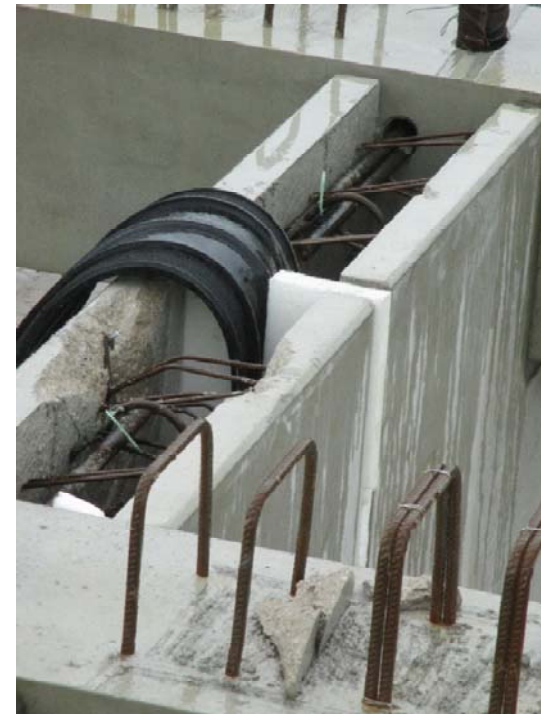
Properly restrained prior to concrete pour?

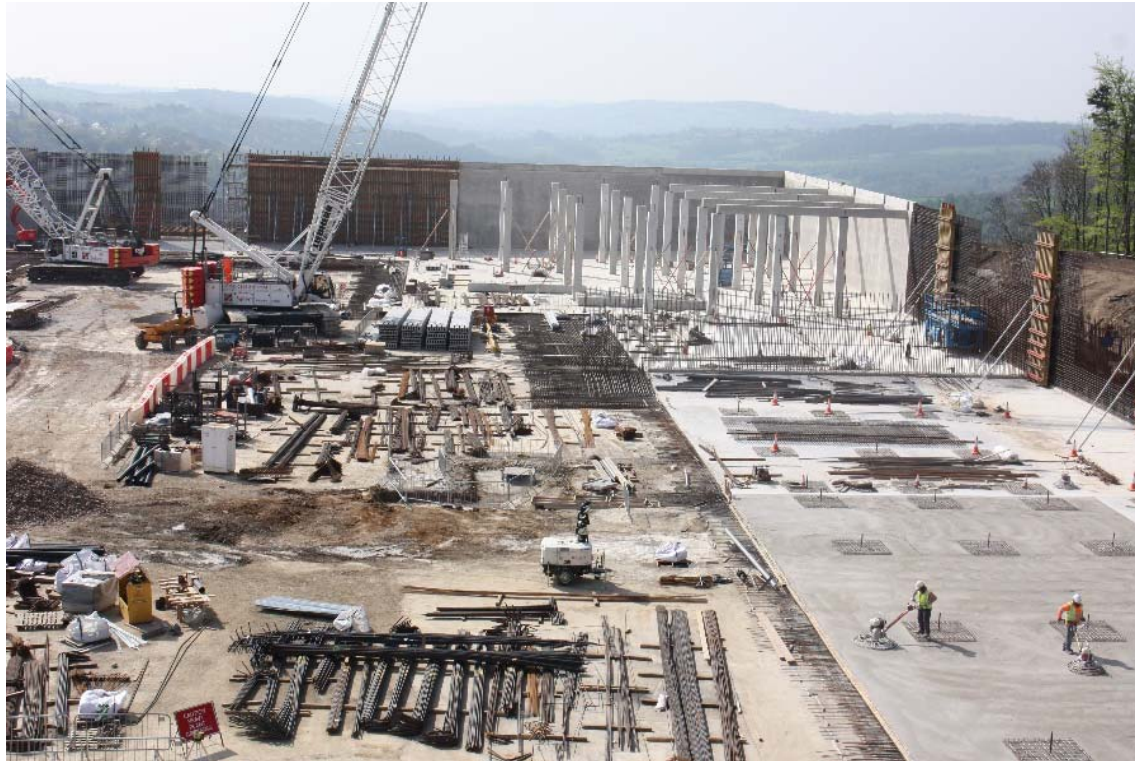
AMBERGATE RESERVOIR – CONVENTIONAL CONSTRUCTION

- Ambergate No. 1 under construction using conventional methods
- Ambergate No. 2 will occupy the existing Ambergate reservoirs location employing DfMA techniques

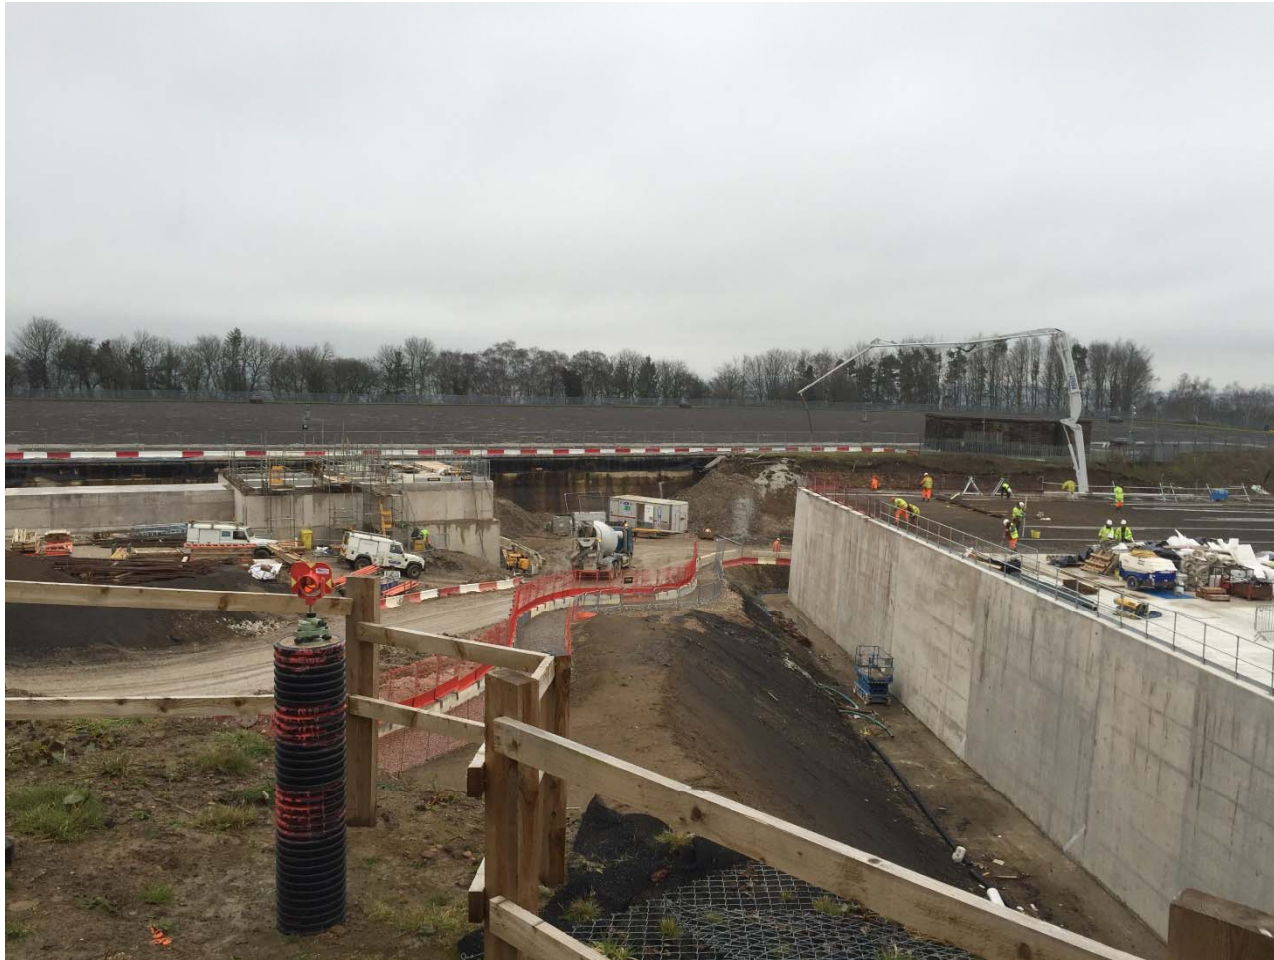
NEW AMBERGATE RESERVOIR

New Ambergate reservoir prior to water test

I totally agree with your point about the robustness of approach with regards to adopting the *in situ* wall solution. The new reservoir at Ambergate is in fact constructed using *in situ* walls and precast column and roof units where applicable. The photos shown in the presentation were for a reservoir at Grafham Water, which was an Anglian Water project. Severn Trent has a programme to replace a further six reservoirs; on two of these we are considering using precast wall construction. We have challenged the designers in terms of quality of approach - in particular I am concerned over the hydrophilic strip to establish a watertight seal. The two issues there are first of all the life of the joint material, that I have been assured is in excess of 80 years; the other is whether fluctuations in water level would allow the hydrophilic strip to dry out and potentially permit ingress in from outside. I have also challenged the need to backfill against reservoir walls to ensure that we get to a workable solution to prevent ingress into the reservoir. In terms of an overall asset life from the economic view point, we would be looking at 60 years but would hope for longer.

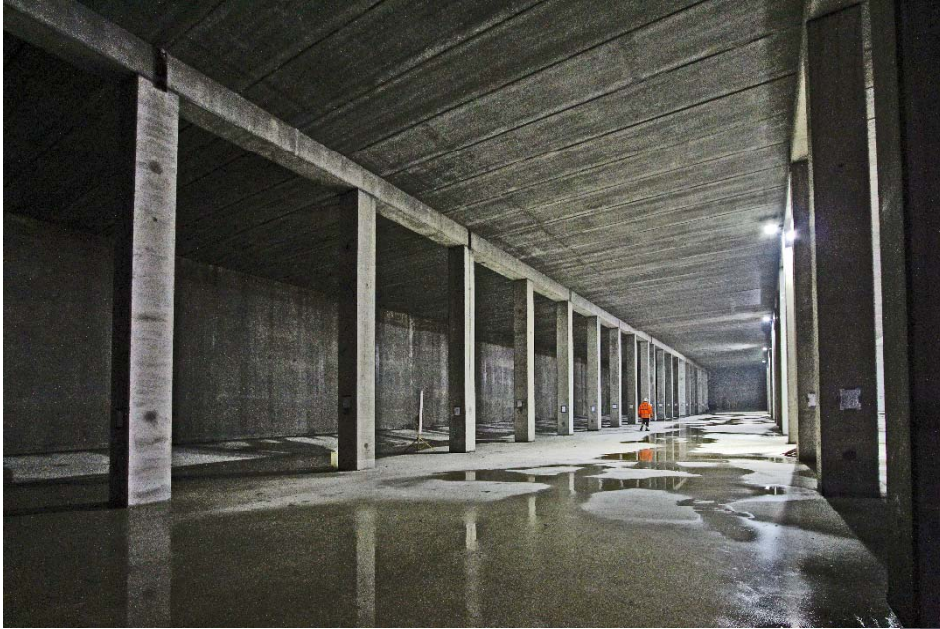
Reservoir prior to water test

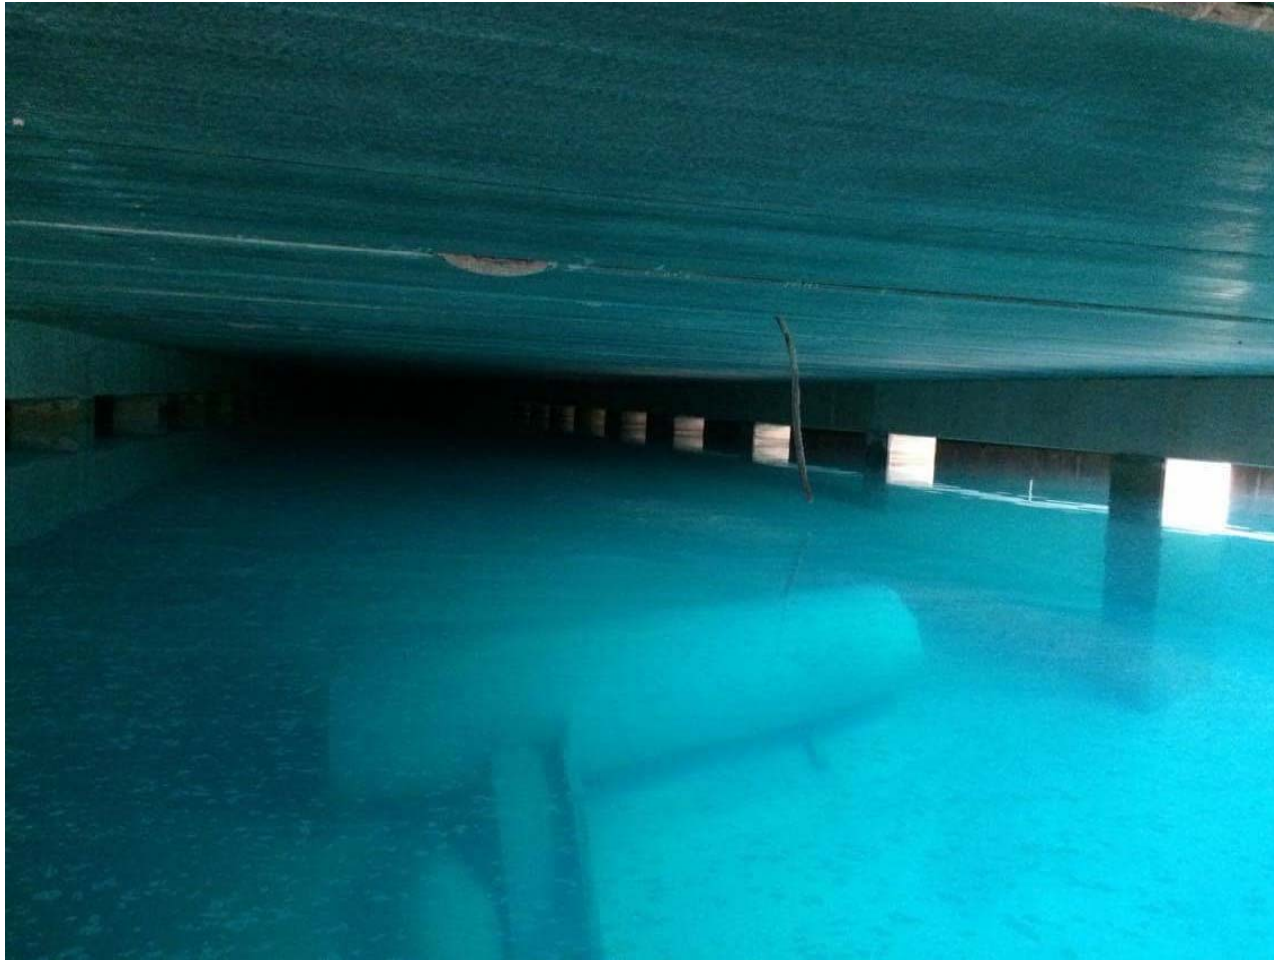
NEW AMBERGATE RESERVOIR – CESWI WATER TEST

Reservoir under water test

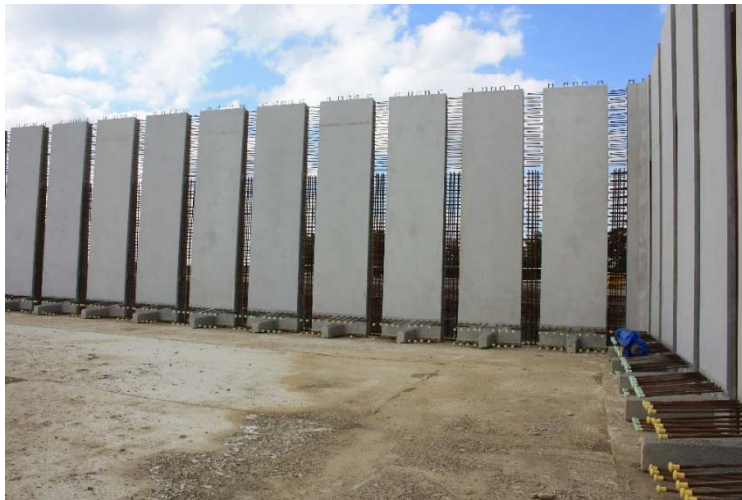
Grafham treated water reservoir

- Hydrophilic water stop which swells following contact with water
- Significantly more joints – more potential failure points.

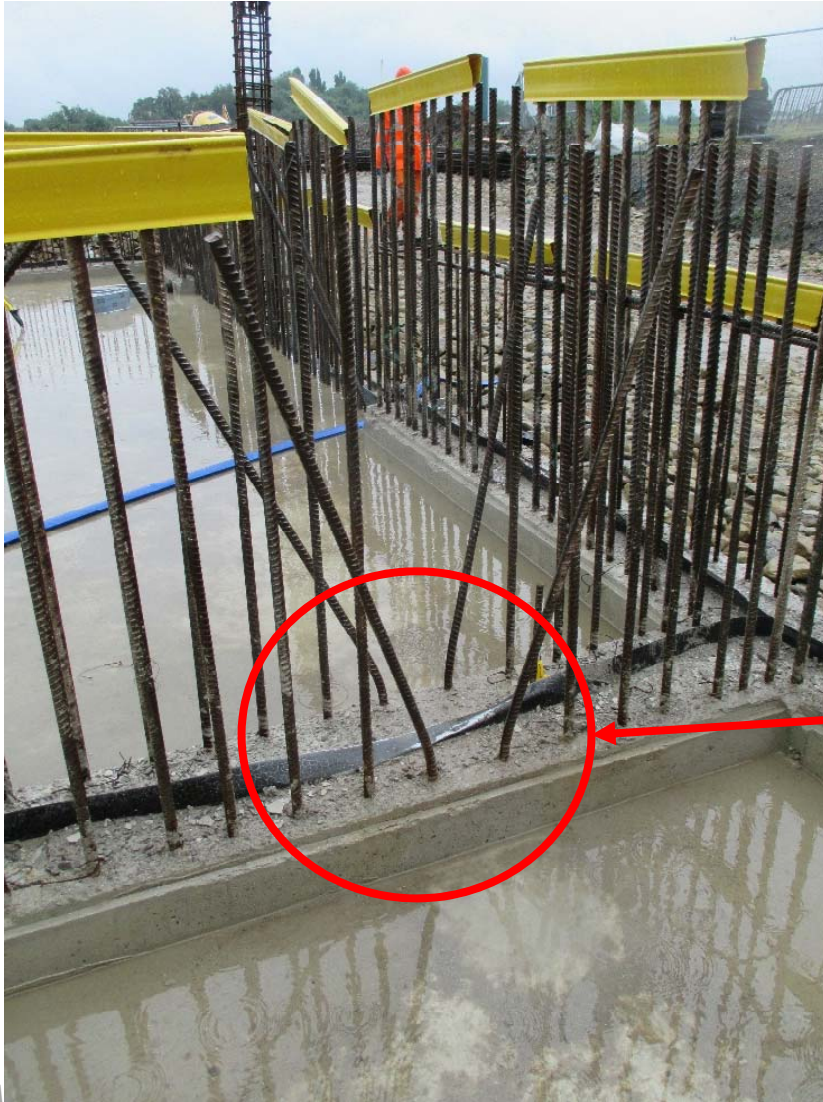
LACK OF ATTENTION TO DETAIL - 2016

- The water stop on the kicker has been damaged to allow access.

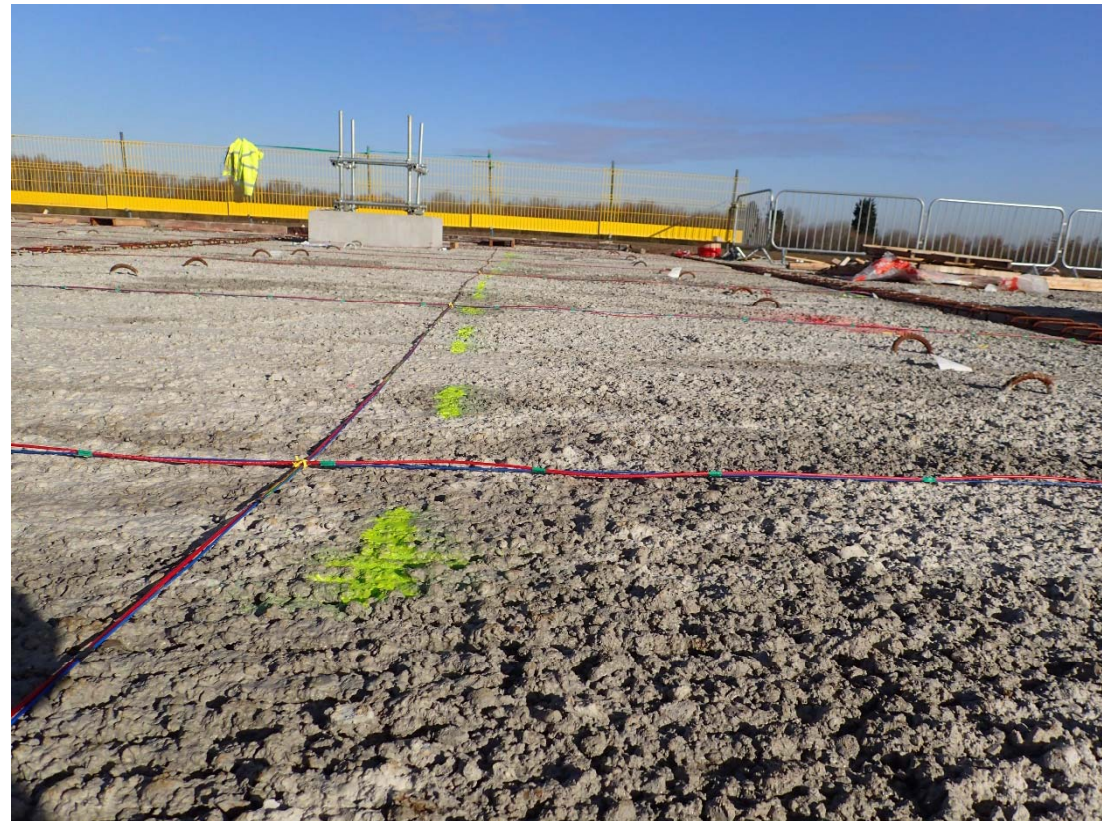
EMPLOYING NEW TECHNOLOGY: FIBRE OPTIC MONITORING

- Fibre optic cables can detect changes in strain and temperature, indicating deformation or leakage respectively
- This allows both:
 - Construction monitoring
 - Operational integrity monitoring

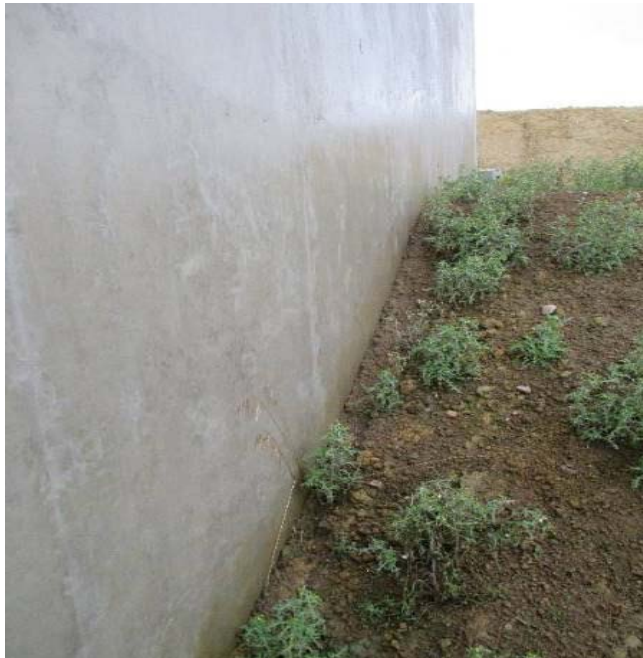
- Why backfill against reservoir walls?
- Why not use surplus spoil for landscaping away from the reservoir?

Unnecessary risk – Barby SR

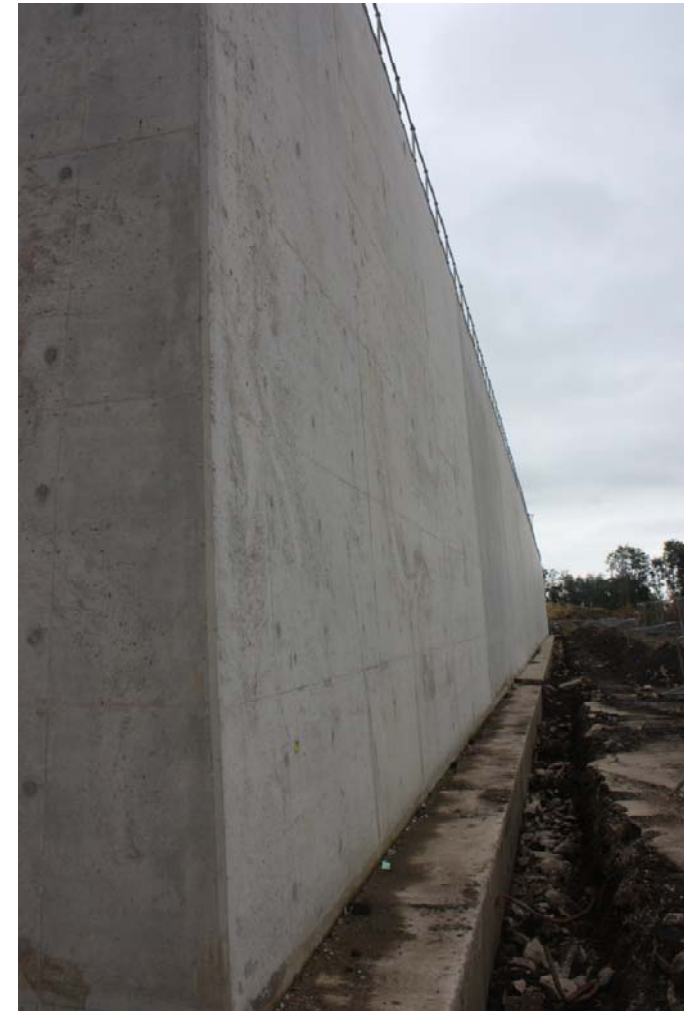
Final finish – Ambergate SR

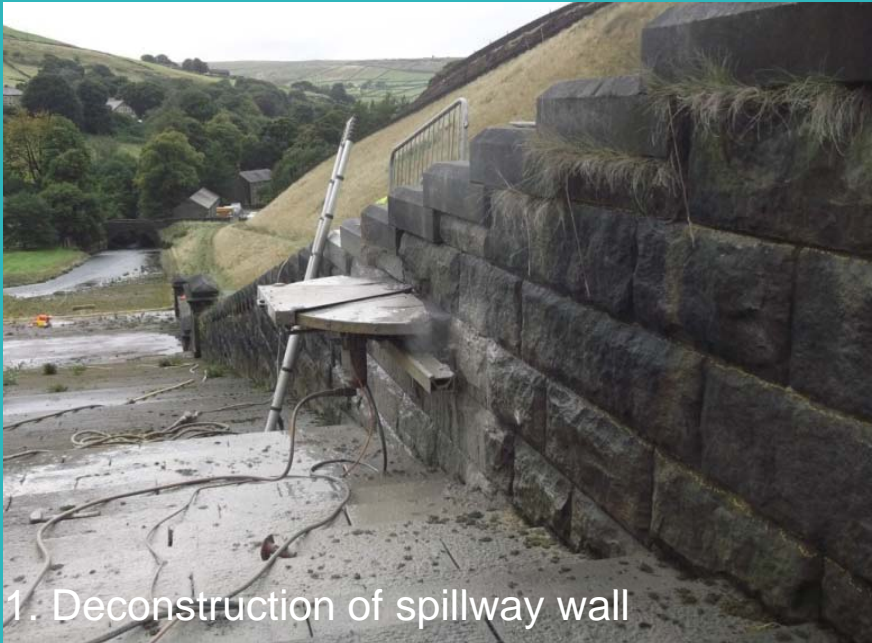
Appendix B – LH Spillway Wall, Trial Pit Ref. TP BR04

1. Deconstruction of spillway wall

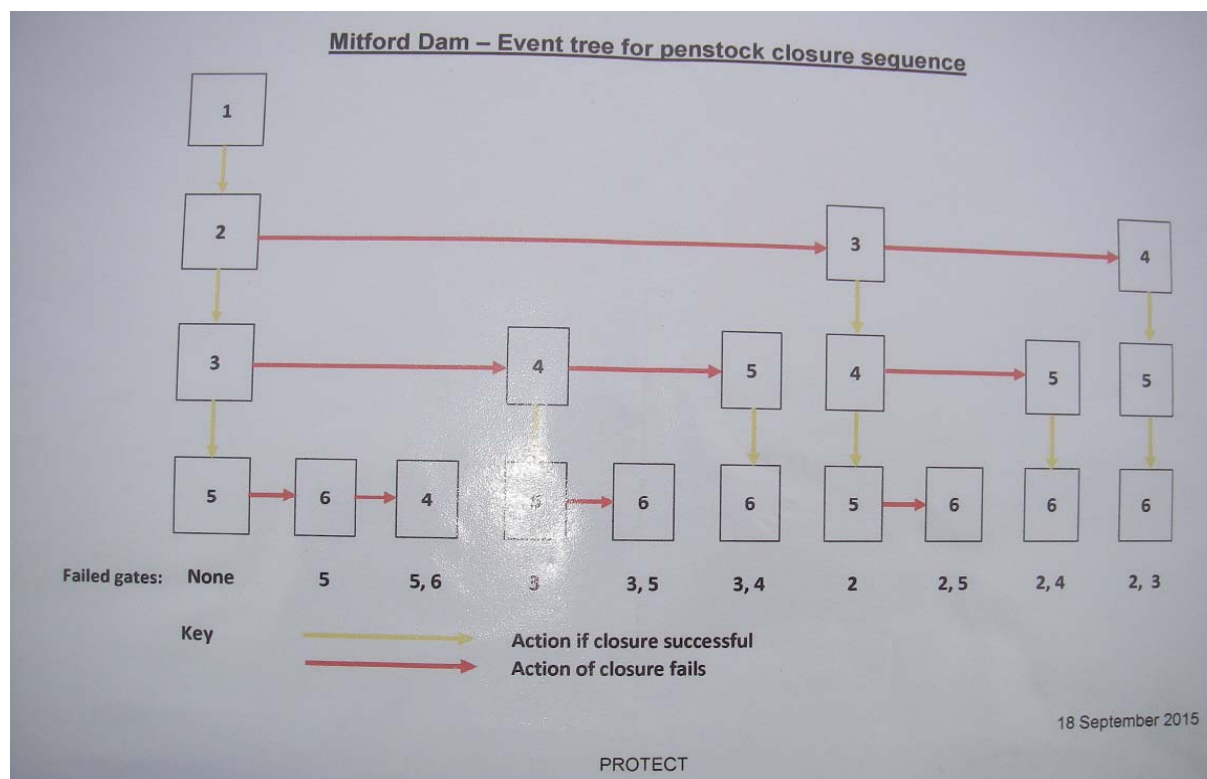
Gate control

- Hydraulic actuators on all gates
- Permanent electricity supply with back up generator
- Gate closure sequence programmed to vary if gate is inoperable

Gate closure level (mAOD)

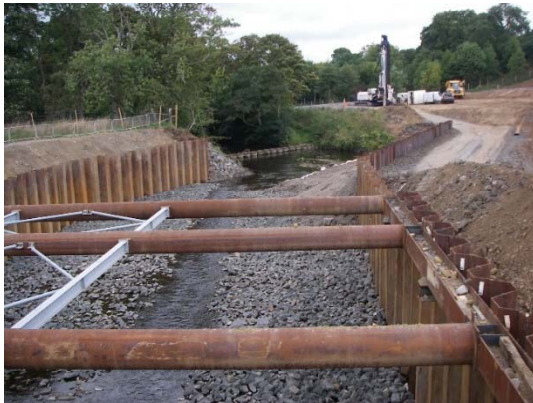
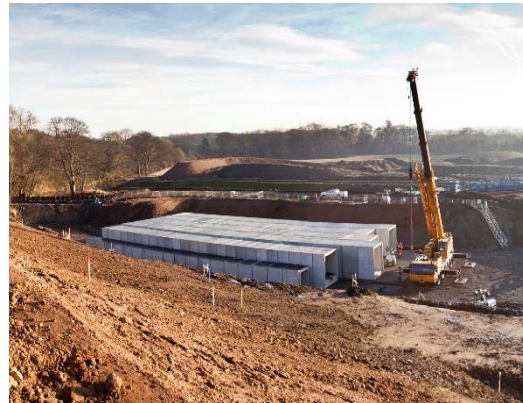
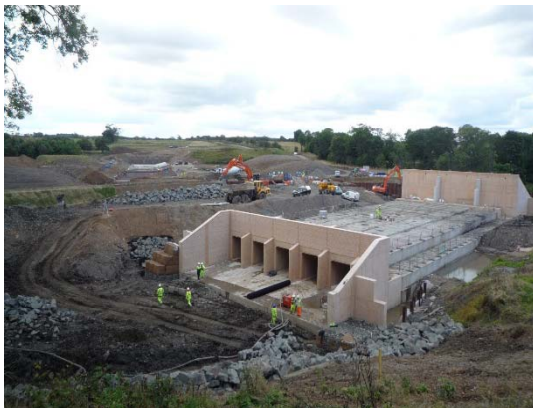
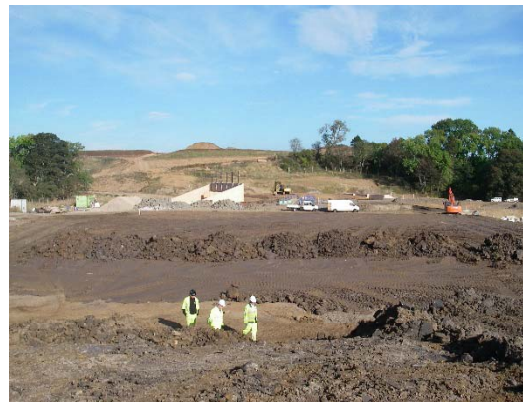
Culvert construction Method

- River diverted to temporary channel
- Precast culverts constructed online
- River diverted through culverts and embankment completed

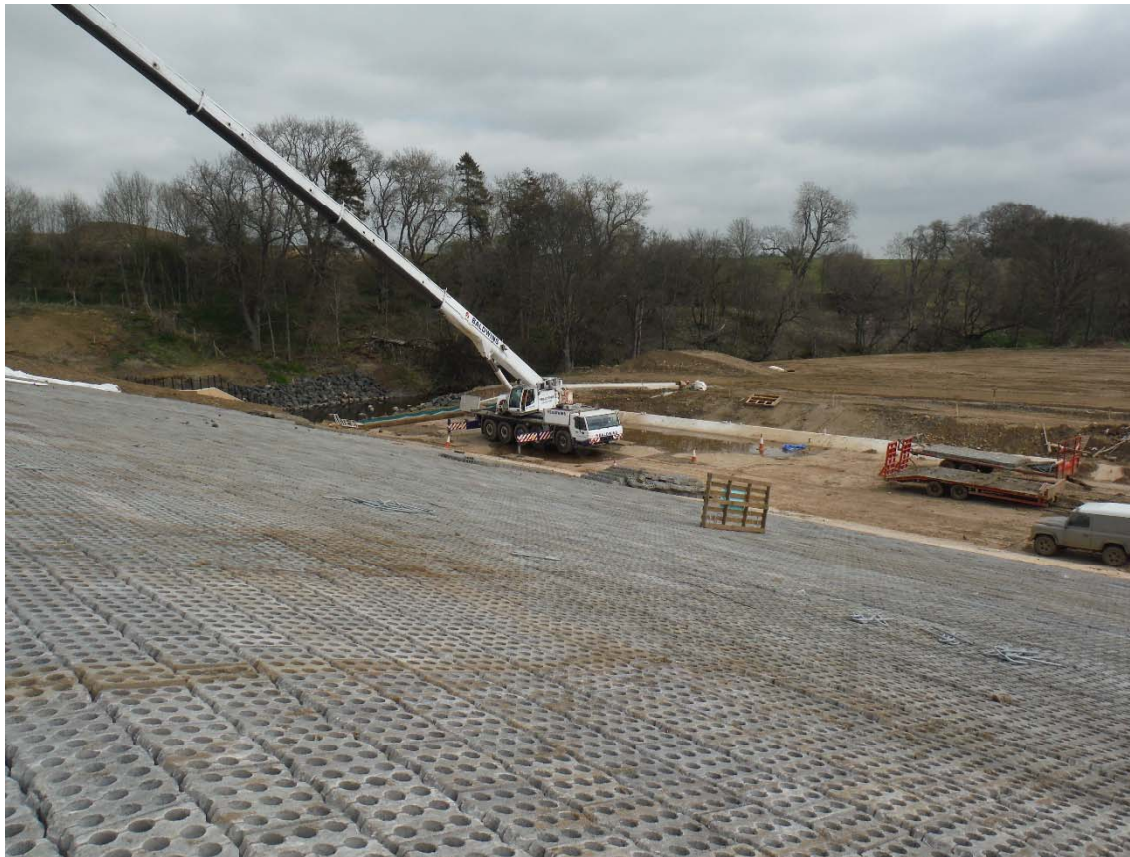
Spillway

- Max velocity approx 9m/s
- Dycell cable tied blocks
- Reinforced concrete stilling basin

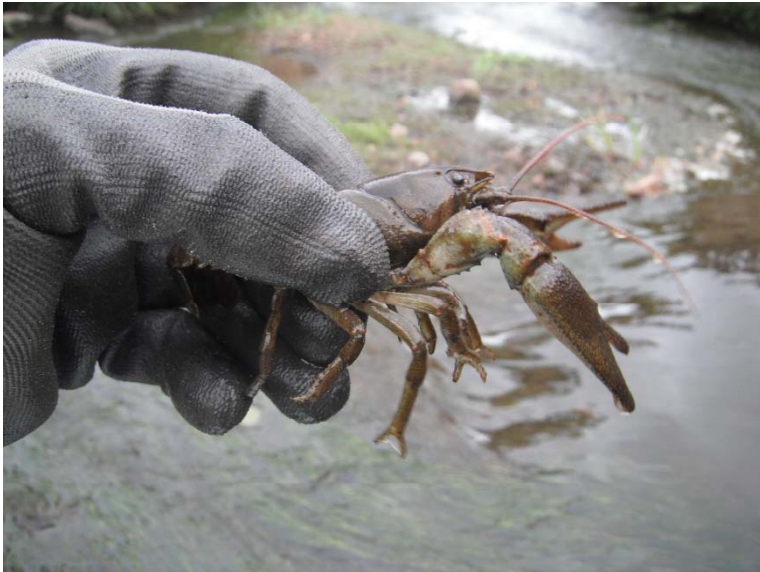
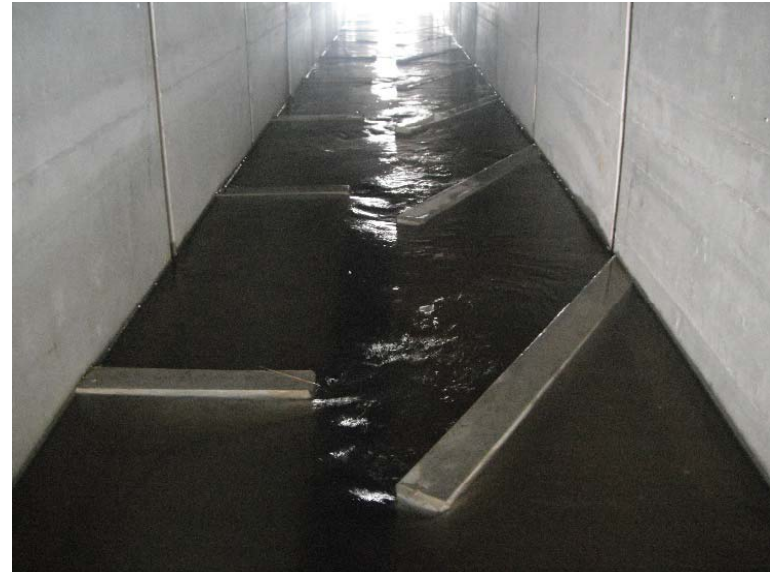
Environmental Aspects

- Important river for native white clawed crayfish
- Geomorphological characteristics to be retained
- Impact on upstream movements to be minimized
- Crayfish culvert closes when flow exceeds $30\text{m}^3/\text{s}$
- Offset baffles provided to manage velocities

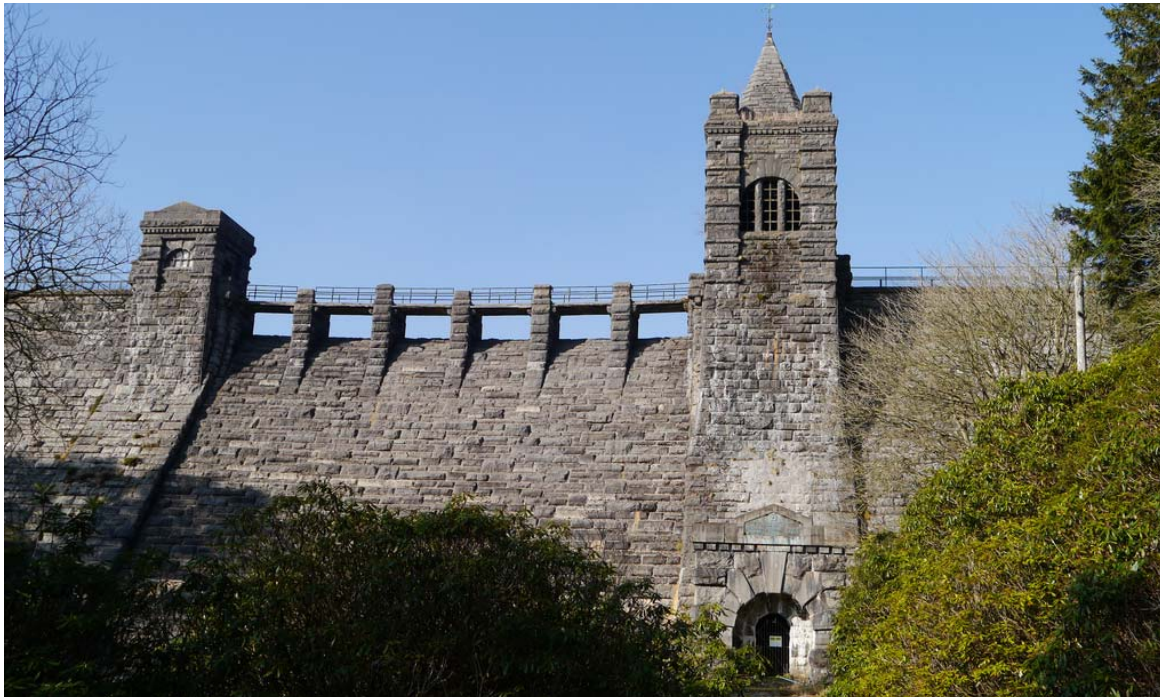
Form of dam

- Masonry flanking embankment dam with cyclopean concrete infill
- Central mass gravity spillway section
- Narrower flanking sections relying on downstream embankments for stability
- A history of issues with seepage and movement, and concerns about stability
