Session 7

CASE STUDIES OF DESIGN AND CONSTRUCTION

AGEING SERVICE RESERVOIRS

An increasing burden or scope for innovation?

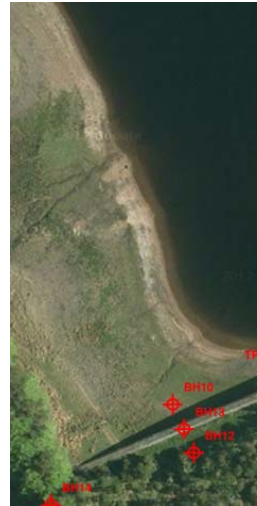
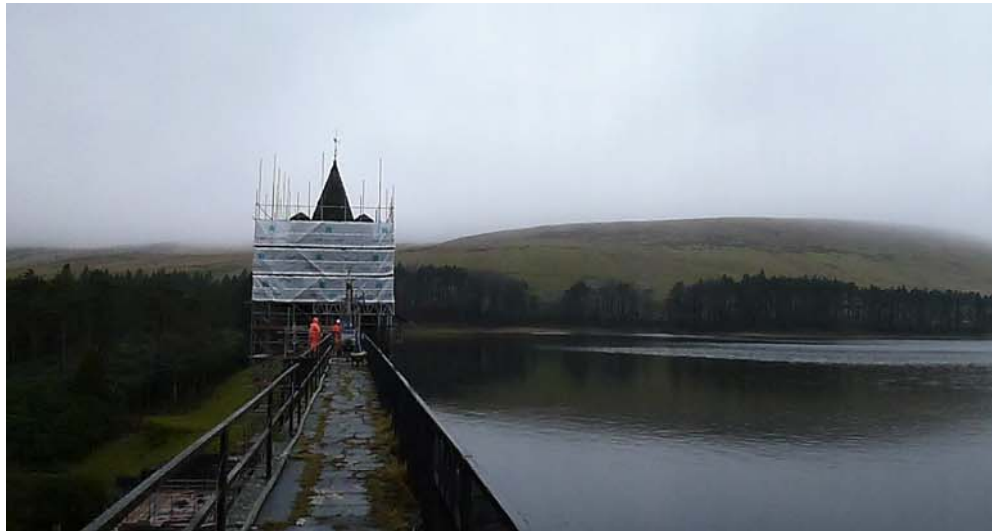
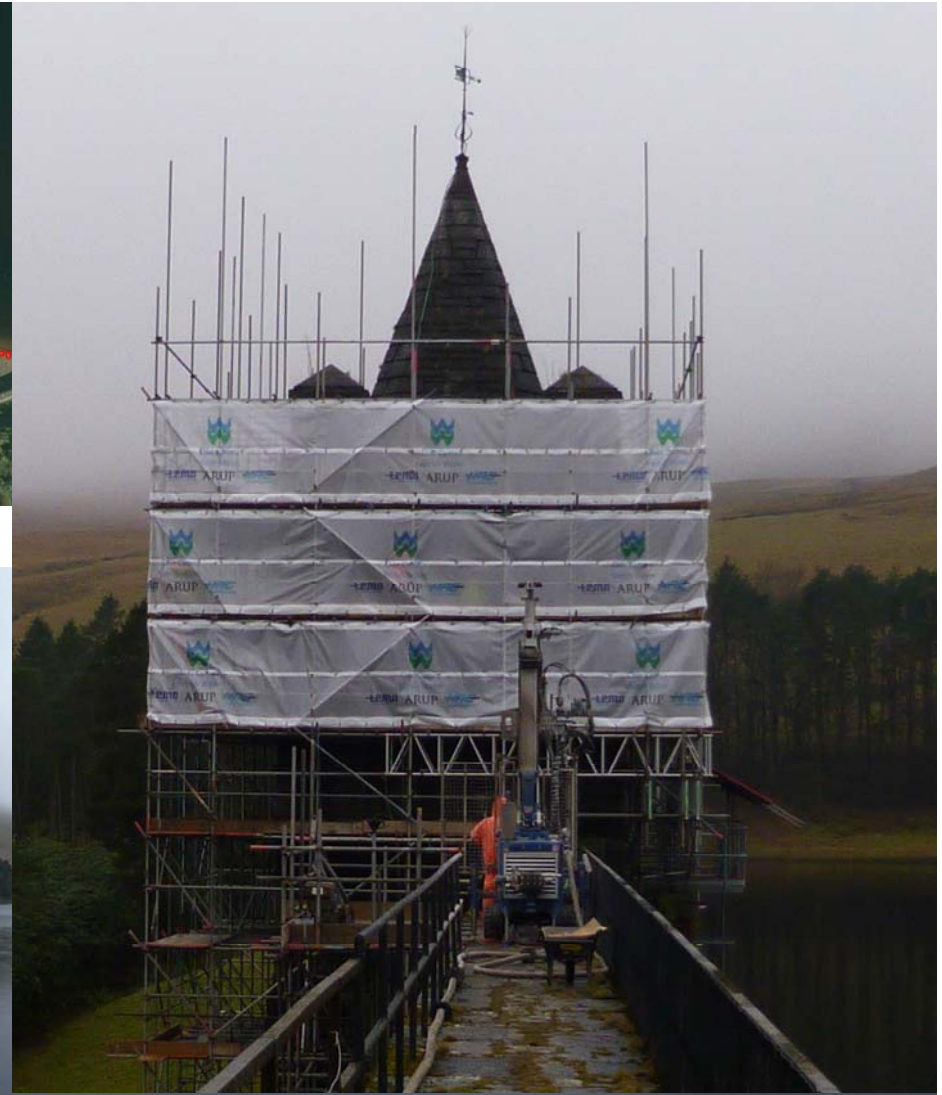
Ground investigation objectives

- Confirm geometry of the dam and construction details at interfaces
- Identify primary seepage routes
- Identify geotechnical properties
- Provide additional instrumentation

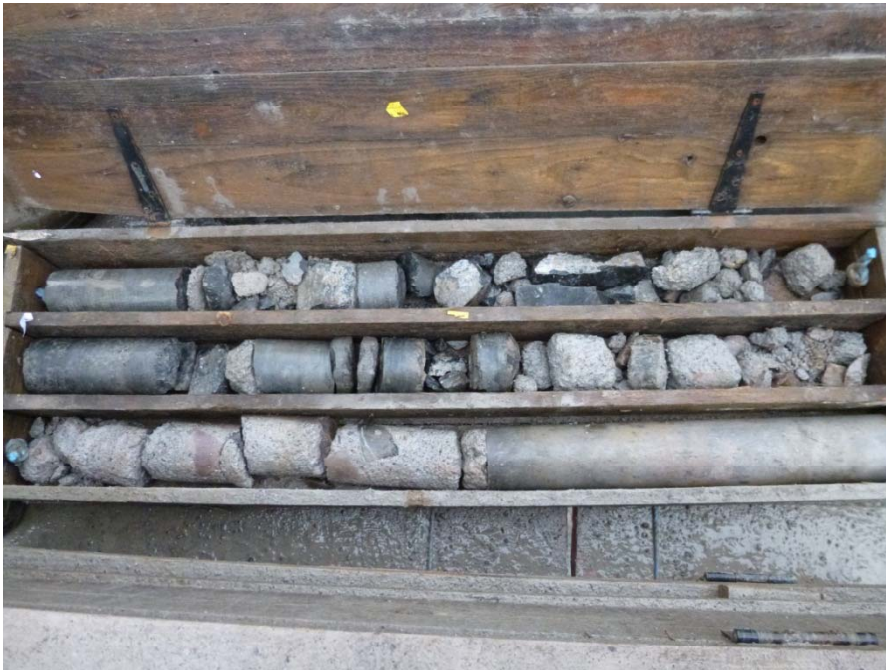
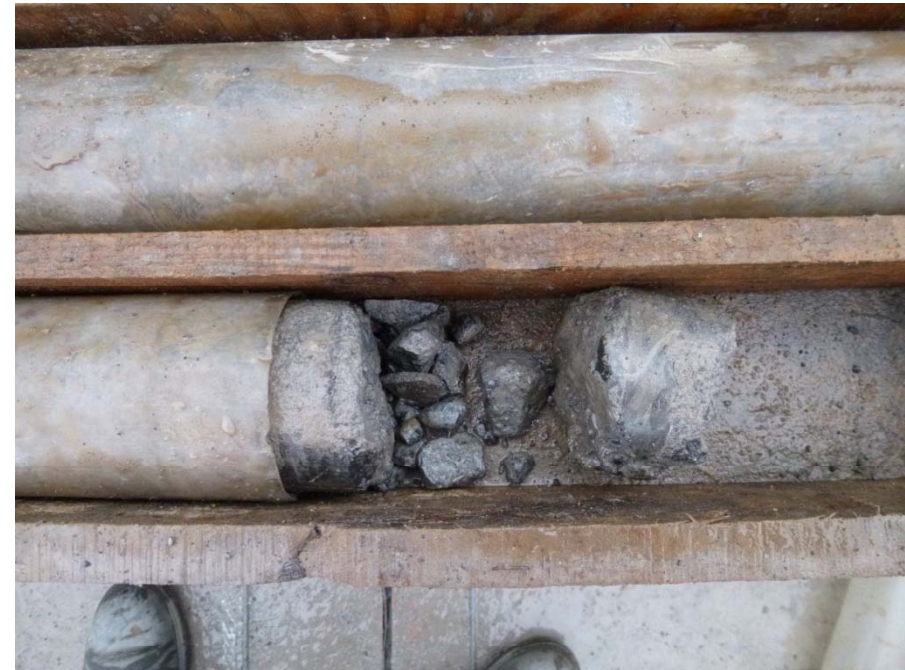
Key findings – dam construction

- Dam founded on competent bedrock
- Concrete cut off proven
- Geometry as per 1890s drawings
- Fractured concrete encountered throughout the dam
- Concrete eroded by flow of water

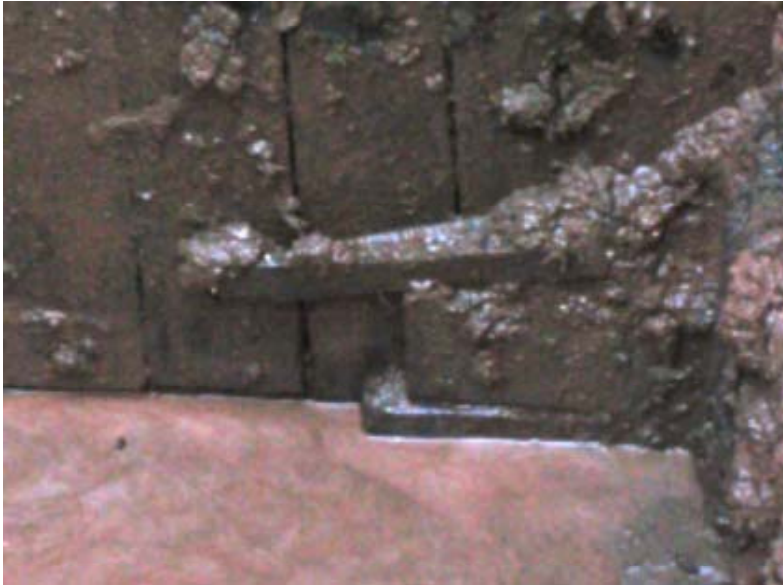
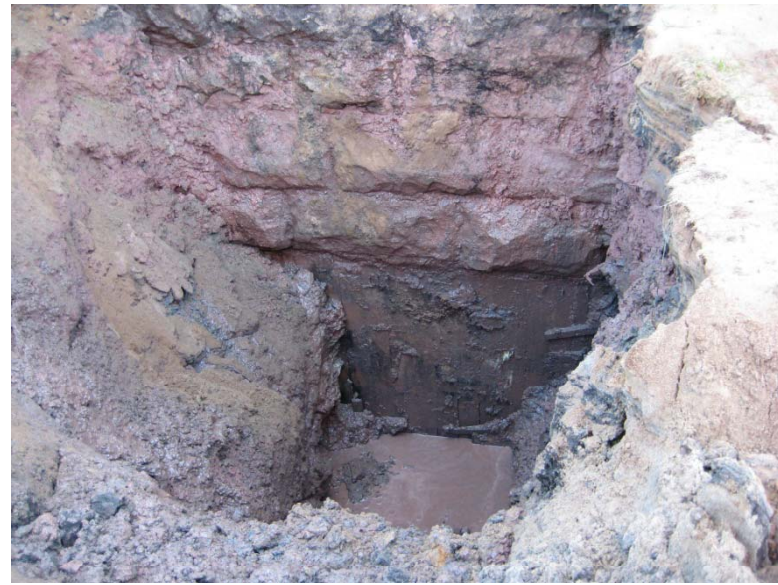
Key findings – concrete cut-off

- Temporary timber shoring remains in place around cut-off
- Timber on the downstream, passive side has rotted
- Layout of timber shoring is typically as per 1890s temporary works drawings

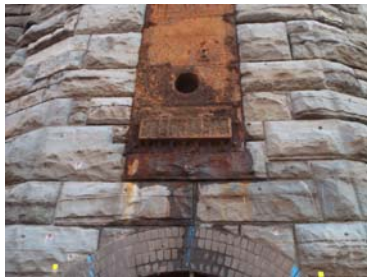
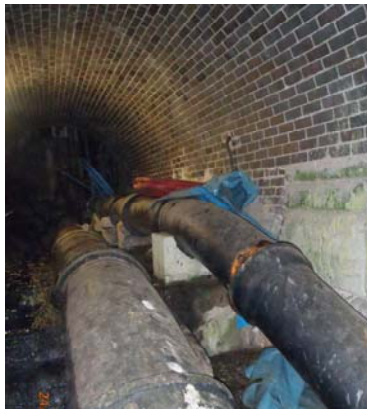
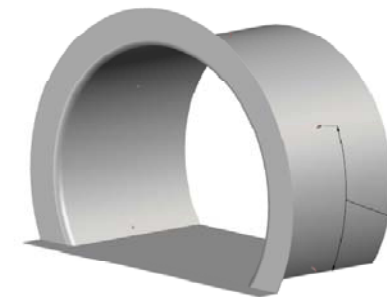
Detailed design – negative pressures

- Concern over negative pressures at tunnel entrance and existing steps
- Concern over the ability of the existing masonry lining to resist suction pressures
- Mitigated through provision of new 150mm thick reinforced concrete liner
- Concrete liner designed to act integrally with a new stainless steel insert at tunnel entrance to overlap existing bands of masonry

Stainless steel insert and concrete lining

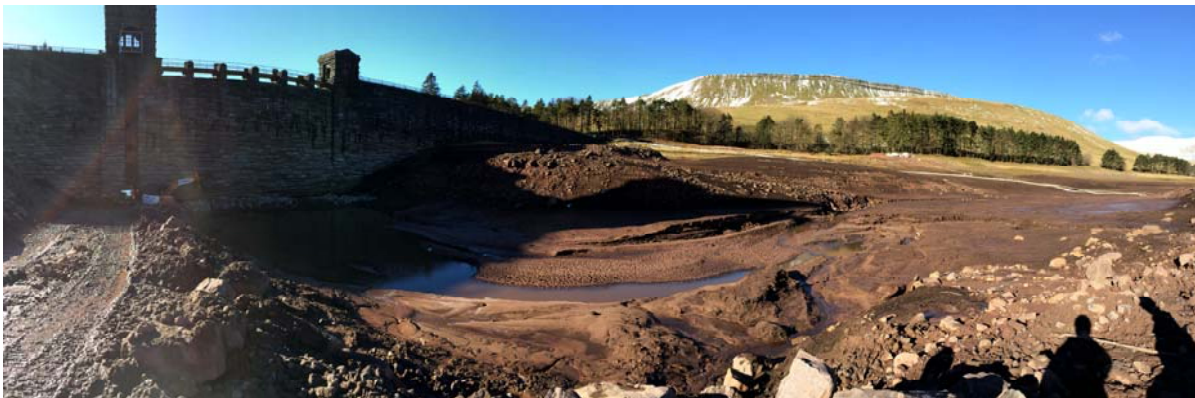
- Principal Contractor – Skanska; Main works package awarded to Joseph Gallagher Ltd (JGL)
- Main construction considerations:
 - Construction of concrete lining – compaction
 - Removal of existing masonry plug
 - Management of flows to complete works on upstream face of dam - drawdown
 - Unknown quantity of silt against upstream face of dam and suitable formation for inlet screen

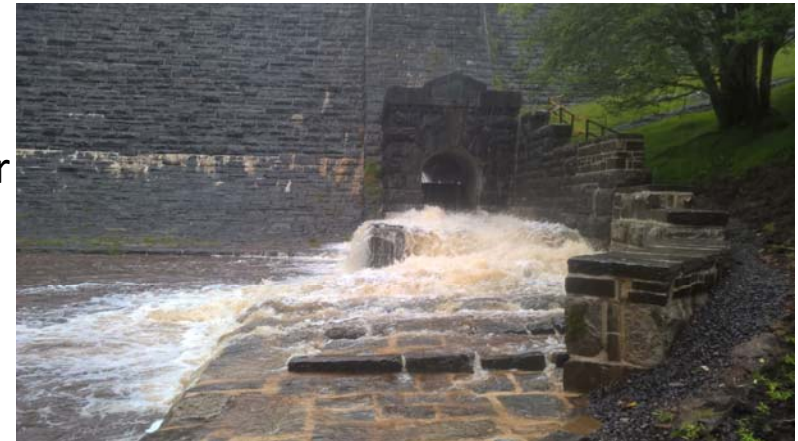
Outlet culvert in operation

- Upper Neuadd previously supplied water to the Neuadd water treatment works in Pontsticill.
- More recently used in cascade with Lower Neuadd and Pontsticill reservoirs to supply Pontsticill water treatment works.
- Full reinstatement to original top water level was not progressed following review of the catchment yield, present and future demands and costs.
- Recent work undertaken to meet the requirements of the last statutory inspection, which required the dam to be safe under PMF loading.
- Calculations based on site investigations proved that the dam is safe under resultant water levels in a PMF event.
- Supervision of the reservoir is continued under the Act until a long-term solution is implemented.
