## **Comments on failures of small dams in the Czech Republic during historical flood events**

J. RIHA, Brno University of Technology, Zizkova 17, 66237 Brno, CZ.

**SYNOPSIS.** During the catastrophic floods, namely those in July 1997 and August 2002 and also during local flood events, which occur almost every year in the Czech Republic, more than 100 failures of small dams were identified during last decade. After careful analysis of typical small dam failures, the reasons for dam collapses were found and assessed. During the flood events the most frequent failure of small dams was by breaching due to dam overtopping. The majority of small dam spillways suffer from insufficient capacity, inconvenient structure and arrangement. At some places spillways were blocked by broken gates, clogged jammed racks or floating debris. Moreover, in some cases the bottom outlets were not maintained and out of order. In the paper, several examples of unsuitable spillways and other dam appurtenances are shown.

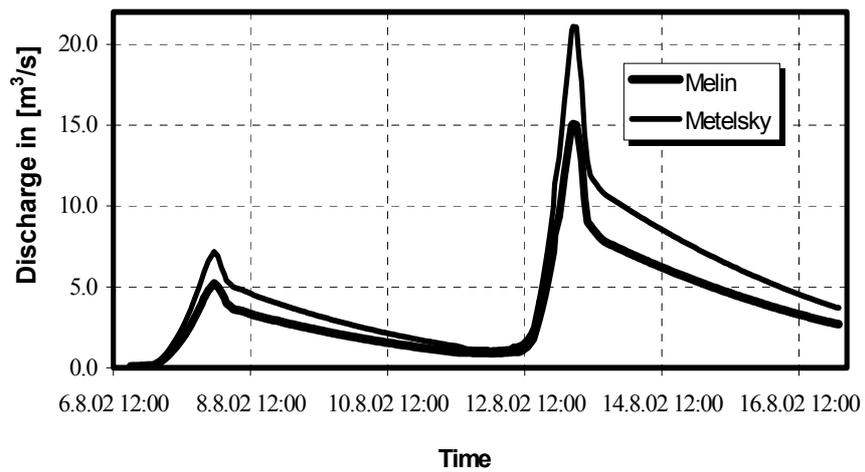
The flood hydrograph corresponding to the “natural” August 2002 flood at the dam profiles was derived using a rainfall – runoff model (Figure 6). The results of the modelling were compared with results obtained from the calibrated hydrodynamic model. The flood routing model calibration was based on the traces of the flood at the site. The flood routing in the area downstream of both ponds was considerably influenced by their collapse.

Figure 6: Derived flood hydrograph in August 2002 at the dam sites

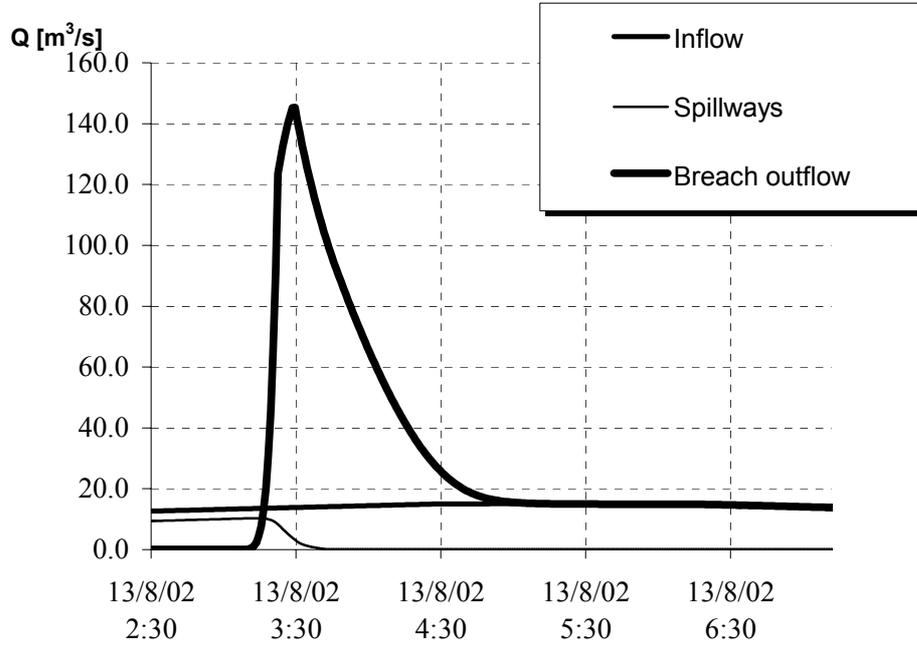
The results of hydrological and runoff modelling indicated a rapid increase in the inflow discharge to the pond on the evening of 12 August 2002 with the peak discharge approximately  $15 \text{ m}^3/\text{s}$  (Fig. 7), which corresponds with 50 year flood (Table 2). The flood routing through Melin reservoir showed a transformed flood peak discharge  $13.5 \text{ m}^3/\text{s}$  and shift of the peak by 2.5 hours. At the same time, the spillway capacity was about  $10 \text{ m}^3/\text{s}$  at the water level at the dam crest.

Figure 7: Melin reservoir - inflow and outflow

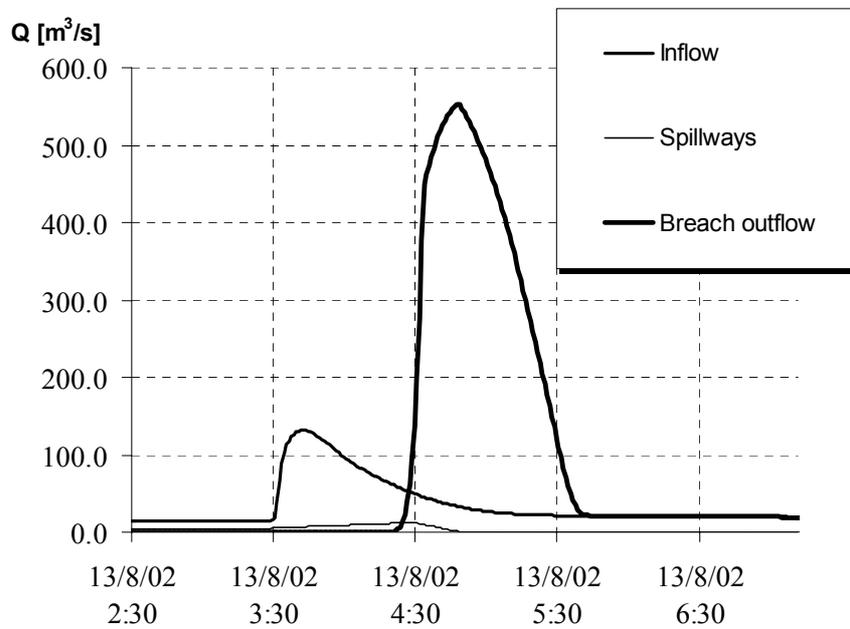
The detailed modelling of the event showed that the water level during the flood event was about 0.6 m above the spillway crest. At that time the Melin dam break wave entered the Metelsky pond and caused dam overtopping in two places. The resulting peak discharge was about  $550 \text{ m}^3/\text{s}$ , and the total volume of the flood wave was estimated to be 2.3 million  $\text{m}^3$ . The widths of two breach openings were 35 m and 27 m, the breach depth was about

7.7 m. Final dam break flood hydrographs compared with the hydrological flood are shown in Figures 7 and 8.

Figure 8: Metelsky reservoir - inflow and outflow
