The failure of the Mostiště embankment dam

JAROMÍR ŘÍHA, Brno University of Technology, Czech Republic

JIŘÍ ŠVANCARA, AQUATIS a.s., Consulting engineers, Czech Republic

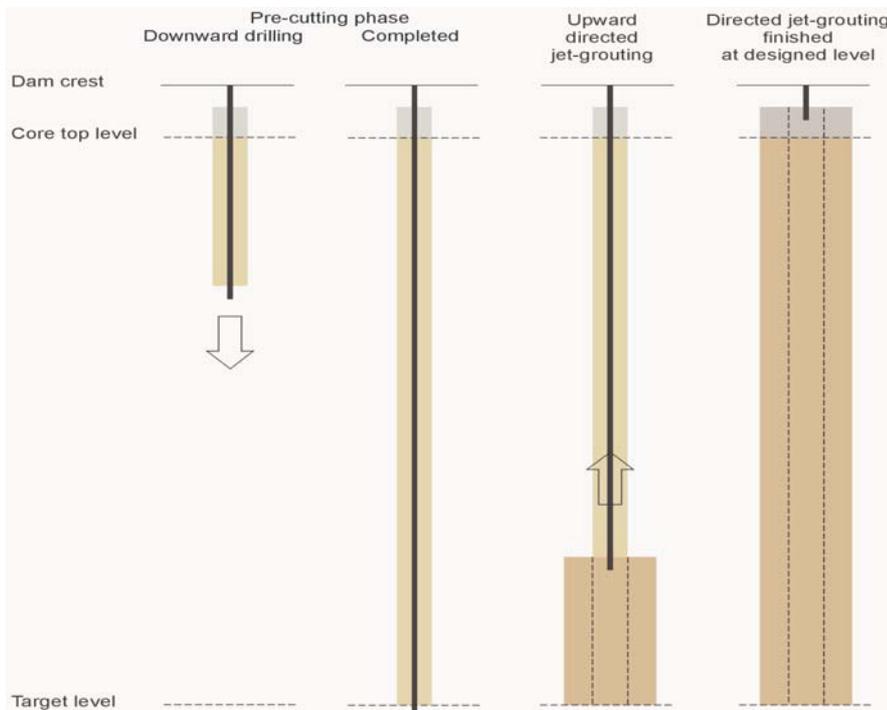
Figure 7: The scheme of jet grouting

Furthermore, the technology had to avoid damaging the impervious core, so the grouting boreholes were inclined by 16 degrees in the direction of the inclined core so as to be sufficiently far from its faces. The procedure was based on the modified single jet method proposed by Soletanche.

Jet grouting technology was applied in five sequences with reference to the restricting requirements based on the results of stability calculations (Fig. 6).
