Session 3

GEOTECHNICAL ASPECTS OF DAMS

An investigation and assessment of embankment stability at Daer Reservoir - R Morrin and M Sullivan

An investigation and assessment of embankment stability at Daer Reservoir

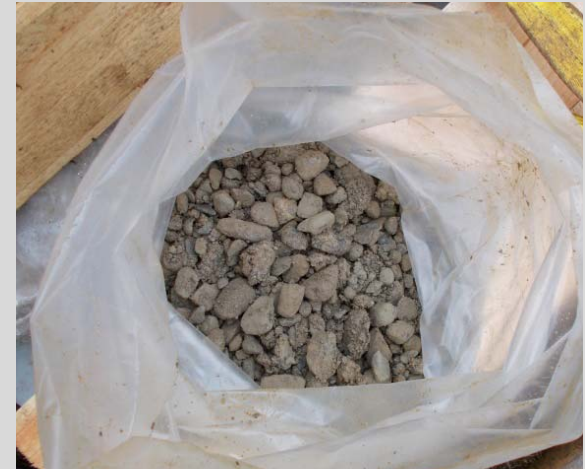
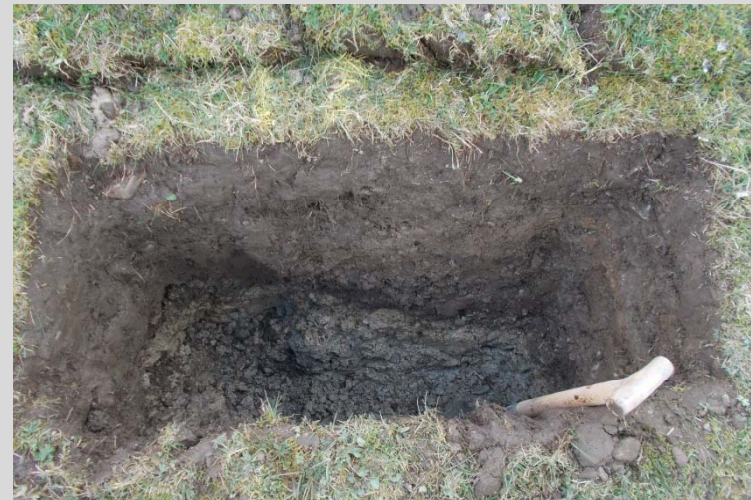
- Leakage of water through core wall
- Limitations of drainage system
- Embankment (area of slip):
 - thick topsoil layer;
 - near surface saturated zone;
 - re-worked granular glacial fill.
- Groundwater:
 - generally low phreatic level;
 - shallow, perched groundwater
- Shear strength properties
- Postulated leakage pathway

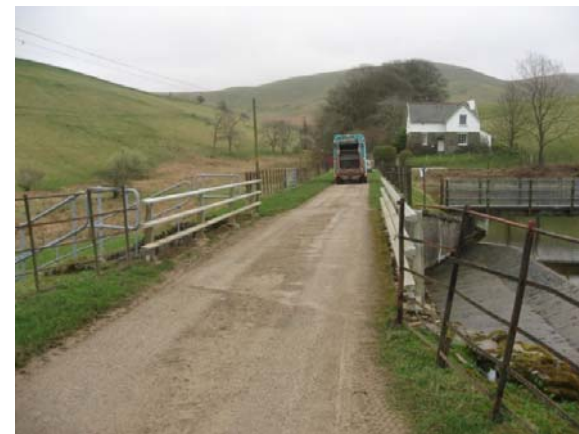
Restricted access across embankment. Pinch-point on spillway bridge 4.5m.

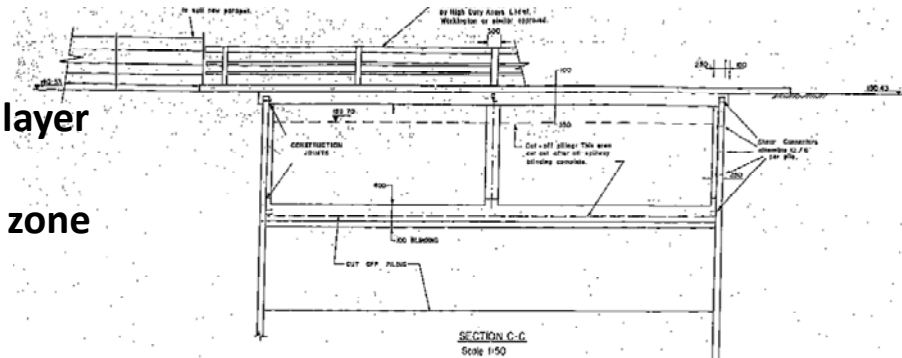
- FP18 Poorly compacted or high permeability layer around conduit through the embankment
- FP20 Poorly Compacted or high permeability zone associated with a spillway abutment wall
- FP21 Crack/gap adjacent to spillway

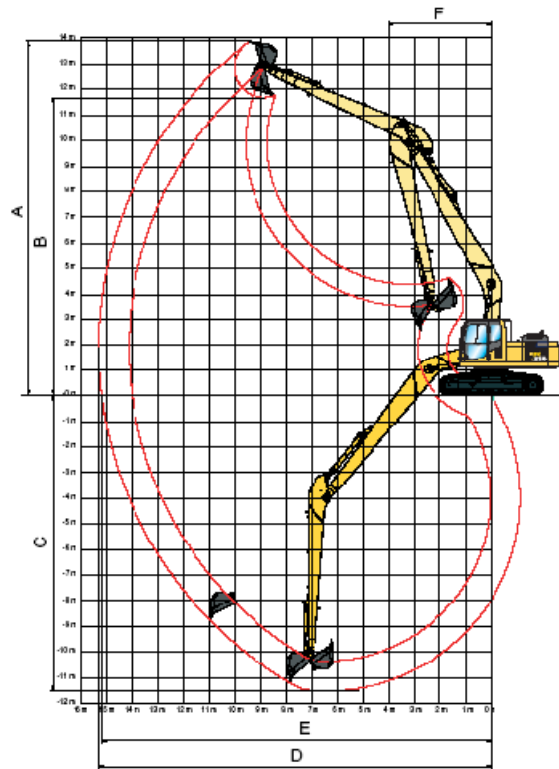
Constructability: depth of trench determined by size of excavator that could be used on the crest and maximum reach

FP 15: Suffusion in soil foundation (suffusion process by which finer soil particles are moved through constrictions between larger soil particles by seepage forces)

FP 14: Poorly compacted or high permeability layer in the embankment

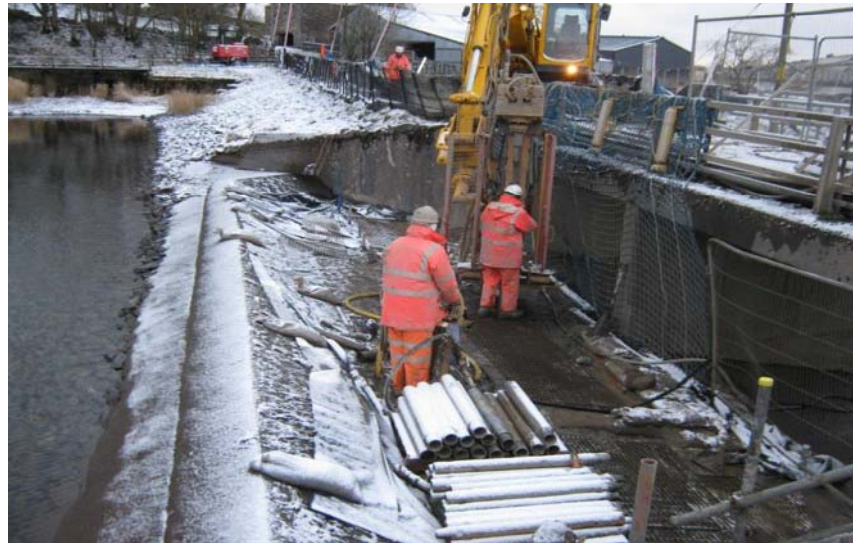
Monitoring of embankment during construction Works

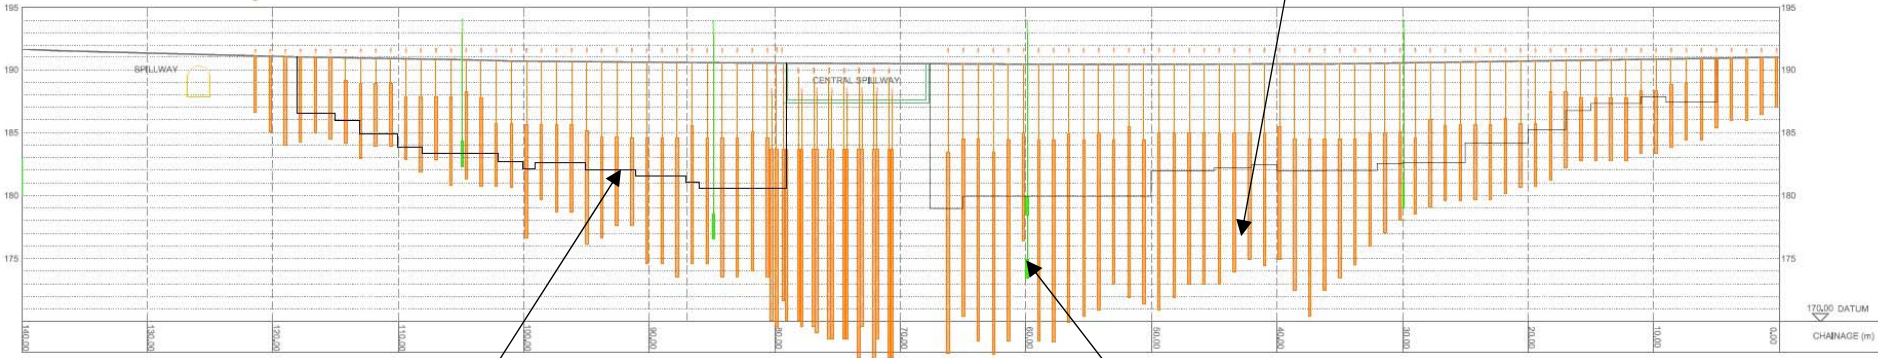
TaM injection holes showing extent of injection points

Profile line showing extents of slurry trench wall

Validation holes for in-situ permeability testing

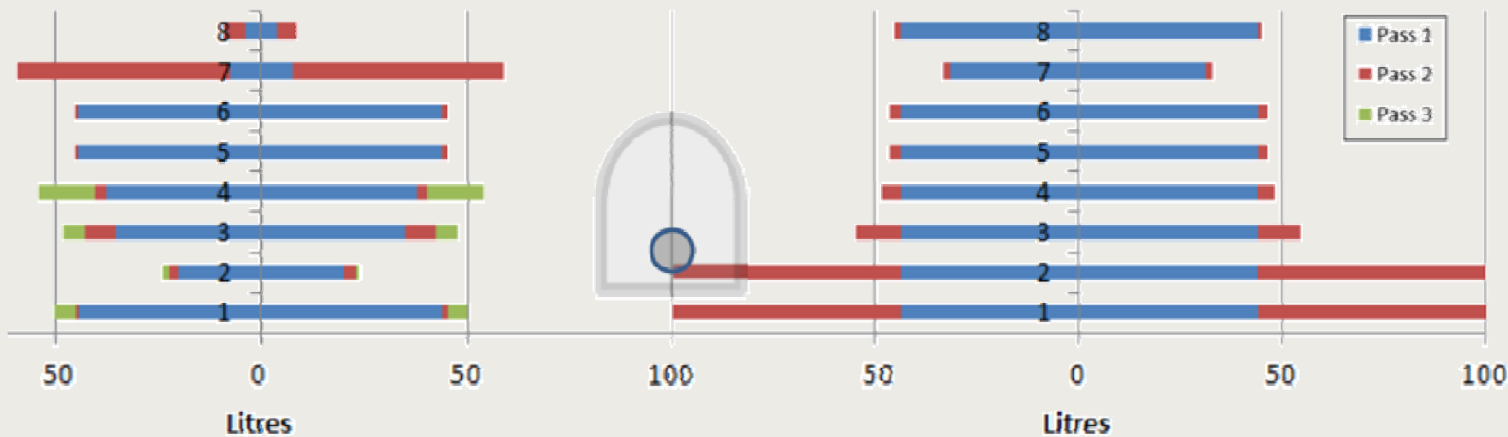
Blackstone Edge

- Permeation Grouting
 - Rotary open hole drilling
 - Grid of boreholes to form a 'collar' around the pipe
 - Falling head permeability tests
 - Tube-à-Manchette grouting
- Challenges
 - Grout loss into tunnel
 - Inability to 'thicken' the grout mix
