Dams: Benefits and Disbenefits; Assets or Liabilities?

Proceedings of the 19th Biennial
Conference of the British Dam Society
held at Lancaster University from
7–10 September 2016

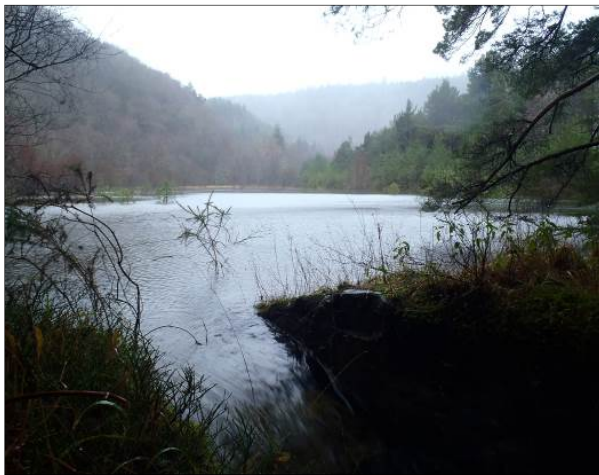
Figure 2. View during impoundment Dec 2015

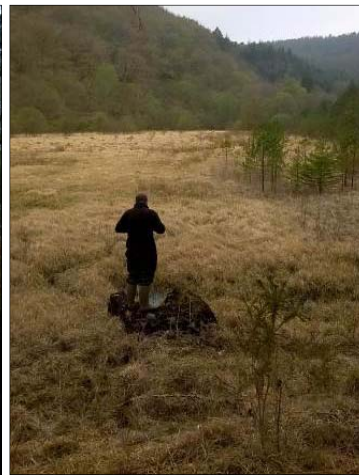
Figure 3. View of basin and SE standing on bottom outlet

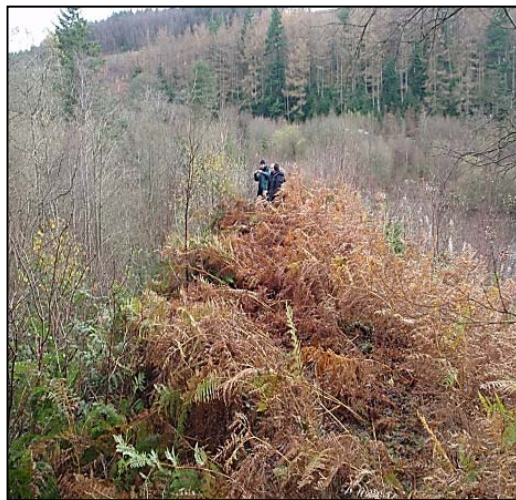
Figure 6. View of crest as found

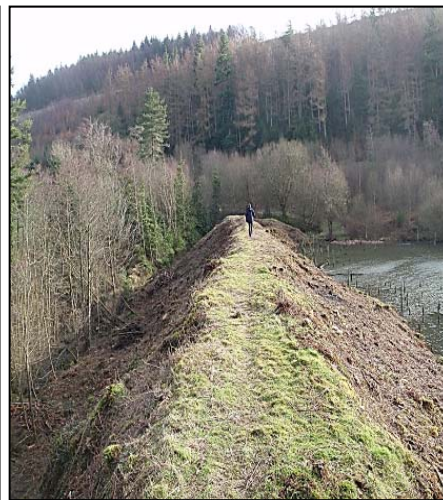
Figure 7. View of crest following vegetation clearance

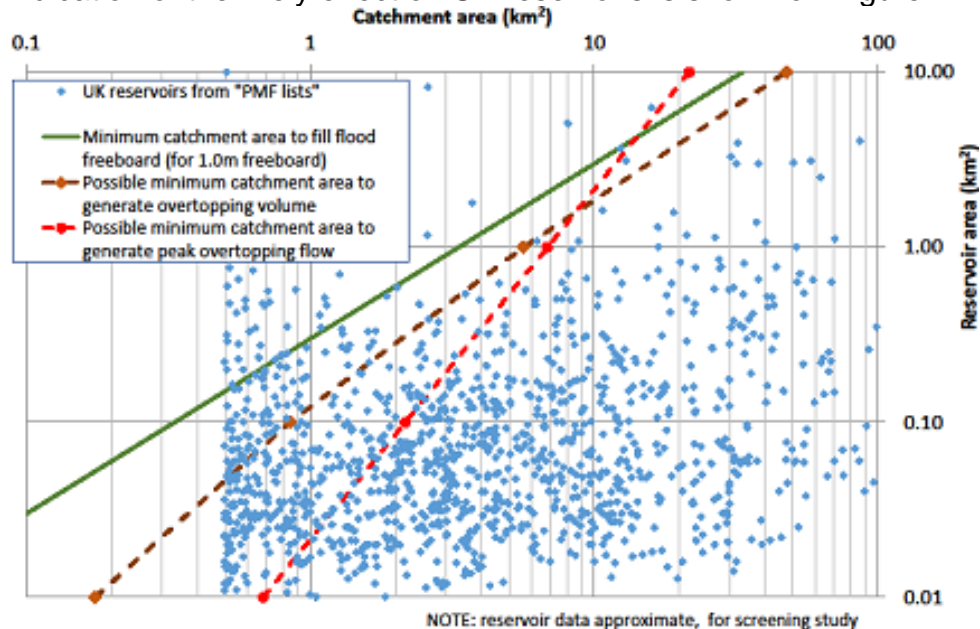
Figure 2. Indicative distribution of catchment and reservoir areas, and conditions when 0.3m overtopping may apply

the minimum credible catchment area for 0.3m overtopping and the catchment area necessary to fill the reservoir to dam crest. An indication of the likely effect on UK reservoirs is shown on Figure 2.

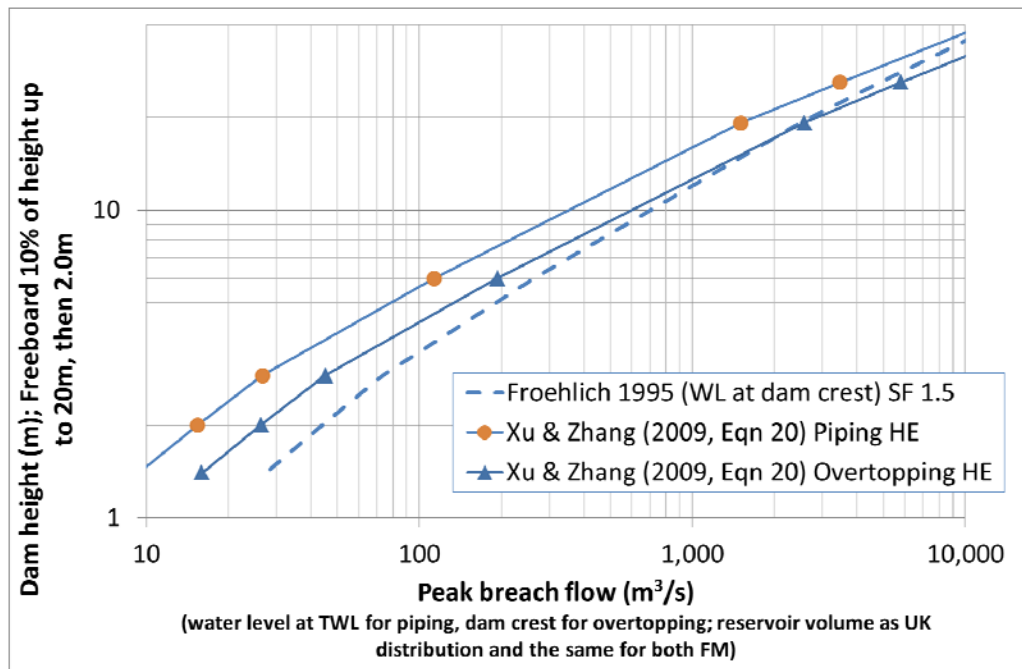
Figure 3. Comparison of breach discharge from 2009 specification with updated methodology

The updated specification will therefore use peak flow from Xu and Zhang (2009) and time to peak flow based on Froehlich (2008). Because of the lack of geotechnical data on the materials forming most UK dams the High erodibility equations in Xu and Zhang will be used; anticipating that in the medium to long term the science and data available may progress sufficiently to take erodibility into account. A comparison of peak outflow for the average distribution of each of dam height and reservoir capacity is given in Figure 3.

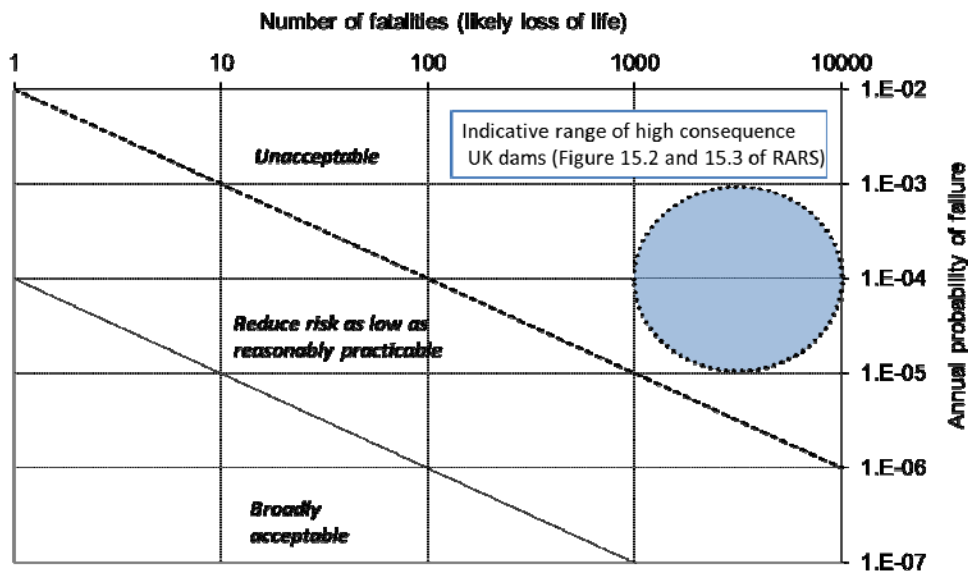
Figure 1 Typical risk zone for UK very high consequence dams

In terms of QRA, high risk dams are those in the Unacceptable zone of an FN chart, as shown on Figure 1. Figures 15.2 and 15.3 of the “Guide to risk assessment for reservoir safety” (RARS) (Environment Agency, 2013) suggest that around 15% of UK dams may have very high consequences of failure which include an average social life loss (ASLL) of in excess of 1000 deaths, whilst the overall probability of failure of most UK dams is between 1 in 1,000 and 1 in 100,000. Potentially, this places a significant number of very high consequence dams within the Unacceptable zone, where the risk cannot be justified except in extraordinary circumstances (HSE, 2001). The challenge to the dam engineering profession is identifying practicable means to manage the risk of these very high consequence dams.

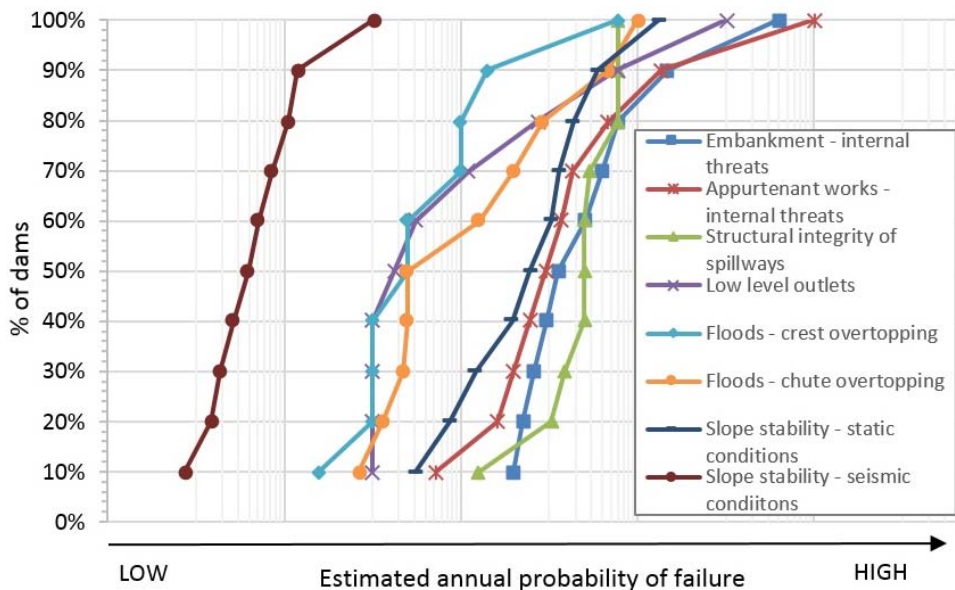
Figure 2. Comparison of different threats to embankments across the portfolio

One of the measures of these refinements is to compare the distribution of likelihood of failure for different threats across the portfolio, as shown in Figure 2. This shows that the greatest threat to the safety of embankment dams is masonry spillways, followed by internal threats in embankments; buried structures; then chute overtopping. This appears a reasonable conclusion. The generally low threat from crest overtopping is noted and reflects the significant investment in spillways over the last few decades.

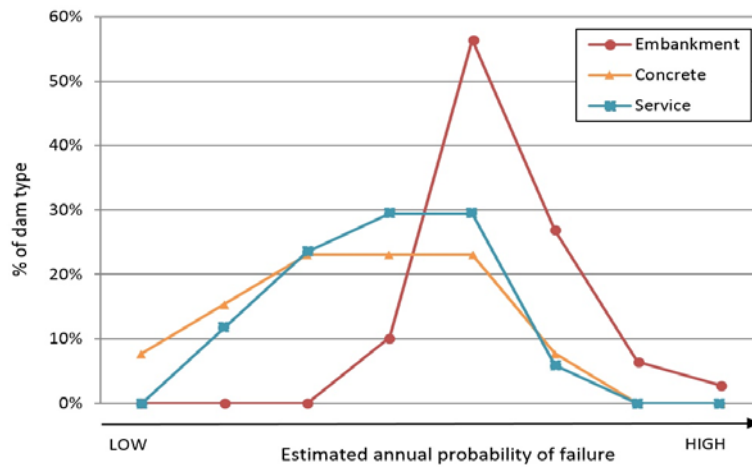
Figure 3. Comparison of likelihood of failure of embankment dams with concrete gravity dams and service reservoirs

A separate measure of the reasonableness of the output is how the tools provided in RARS rank concrete gravity dams and service reservoirs compared to embankment dams, with the distributions shown in Figure 3. Again the output is considered reasonable, with service reservoirs typically an order of magnitude safer than embankment dams, and concrete dams even more so.

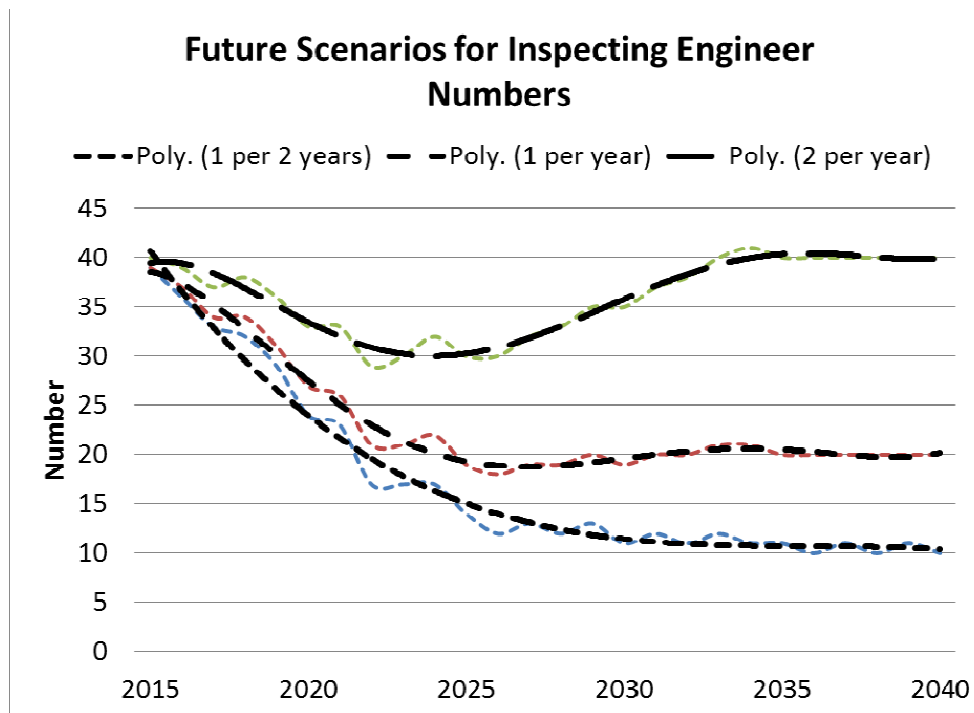
Figure 1. Future Scenarios for Inspecting Engineer Numbers

The chart below summarises the running of those three scenarios combined with the retirement profile derived from the survey undertaken at the Forum. An average term as an Inspecting Engineer of 20 years has also been assumed for the new appointments (i.e. appointment on average in late 40s).

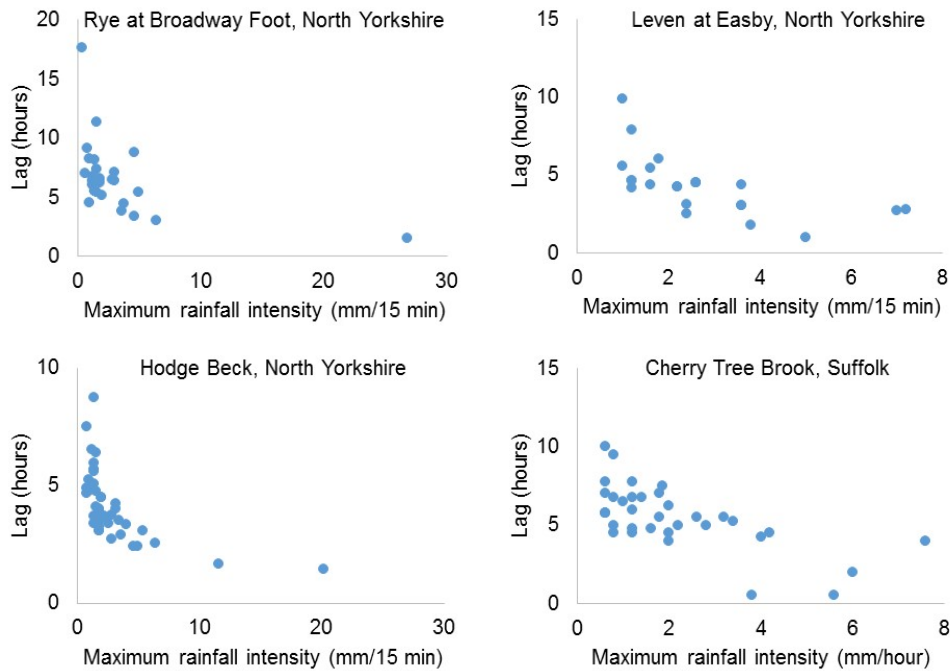
Figure 1. Lag time as a function of maximum rainfall intensity for four catchments. Each symbol represents a different flood event.

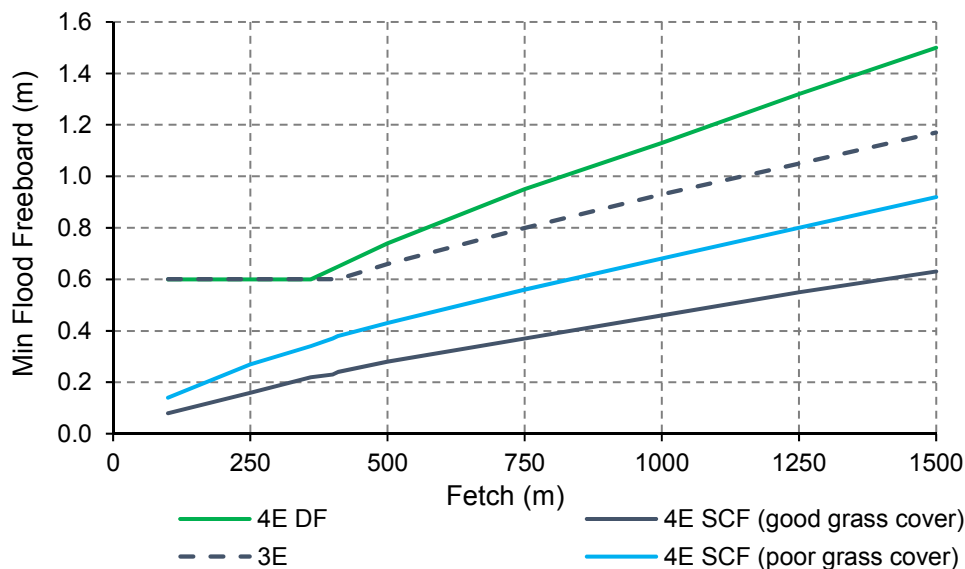
Figure 1 Sloping Upstream Face – No Wave Wall

The two approaches have been applied to an embankment with a 1V:3H upstream slope (no wave wall) and a smooth upstream slope. The results are shown in Figure 1 below.

Figure 1 suggests that the 4th Edition estimate of flood freeboard for the DF, all parameters being equal, is always greater than the

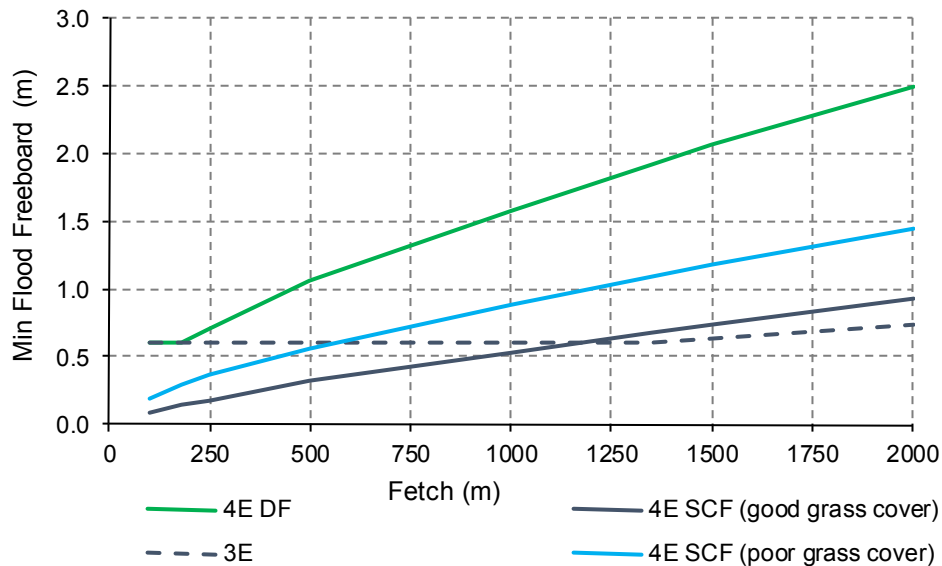
Figure 3 Vertical Face in Deep Water

The Figure shows that the 4th Edition freeboard estimates are significantly higher than those that would be obtained from the 3rd Edition. The freeboard also increases relatively rapidly with increasing fetch. A vertical face in deep water is typical of concrete dams, generally which can tolerate significant overflow. Figure 3 has been prepared using the criteria for embankment dams and therefore is not applicable directly to concrete dams.

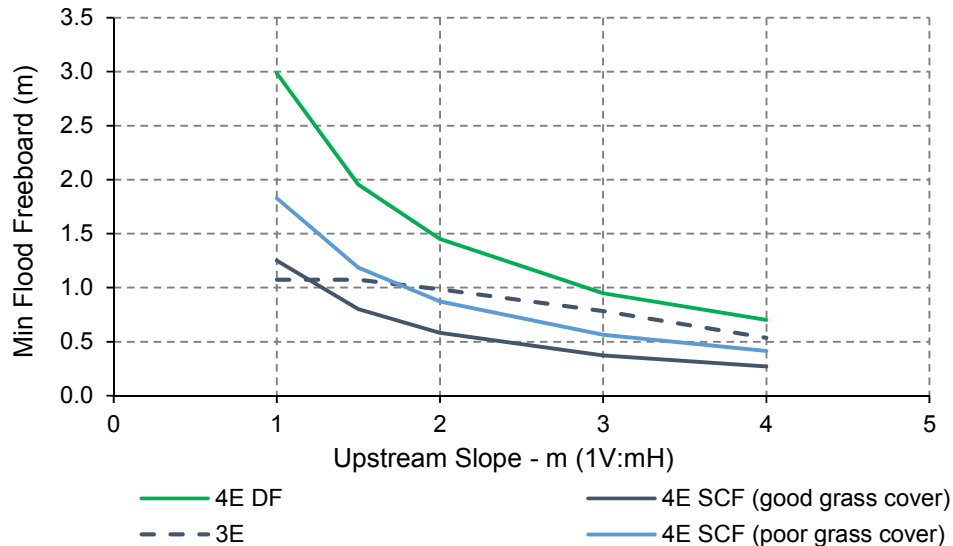
Figure 4. Influence of Slope Inclination Freeboard Estimates (smooth slope)

The influence of the upstream slope inclination has also been investigated for a smooth slope. The results are shown in Figure 4 below.

Figure 4 shows that the rate of increase of the estimates from the 4th Edition increases rapidly for slopes steeper than 1V:2H. While embankment dams with upstream slopes steeper than 1V:2H might be rare in the UK, the result suggests that increasing freeboard by crest raising and localised steepening of the upstream slope could be counterproductive. In such cases it could be better to select a vertical wave wall or focus efforts on strengthening the downstream face to resist erosion damage.

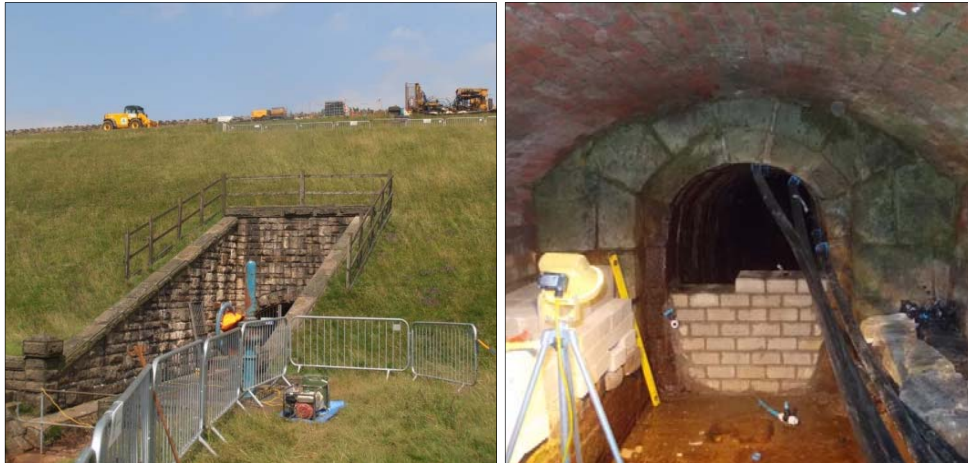
(a) Permeation grouting from crest (b) Tunnel infilling operations

Figure 2: Remedial works at Blackstone Edge reservoir

- A grid of four boreholes at 1m spacing (two either side of the anticipated pipe location) was drilled from the embankment crest to a depth of 14m using rotary open hole drilling techniques.
- Falling head permeability tests were undertaken in the first borehole over the specified grout zone.
- Tube-à-Manchette (TaM) grout tubes were installed within the boreholes.

- A cement, Bentonite, Ground Granulated Blast-furnace Slag (GGBS) and plasticiser grout mix (12.5kg; 3.6kg; 25kg; 0.41litres respectively) was injected through an inflatable packer installed within each TaM port.

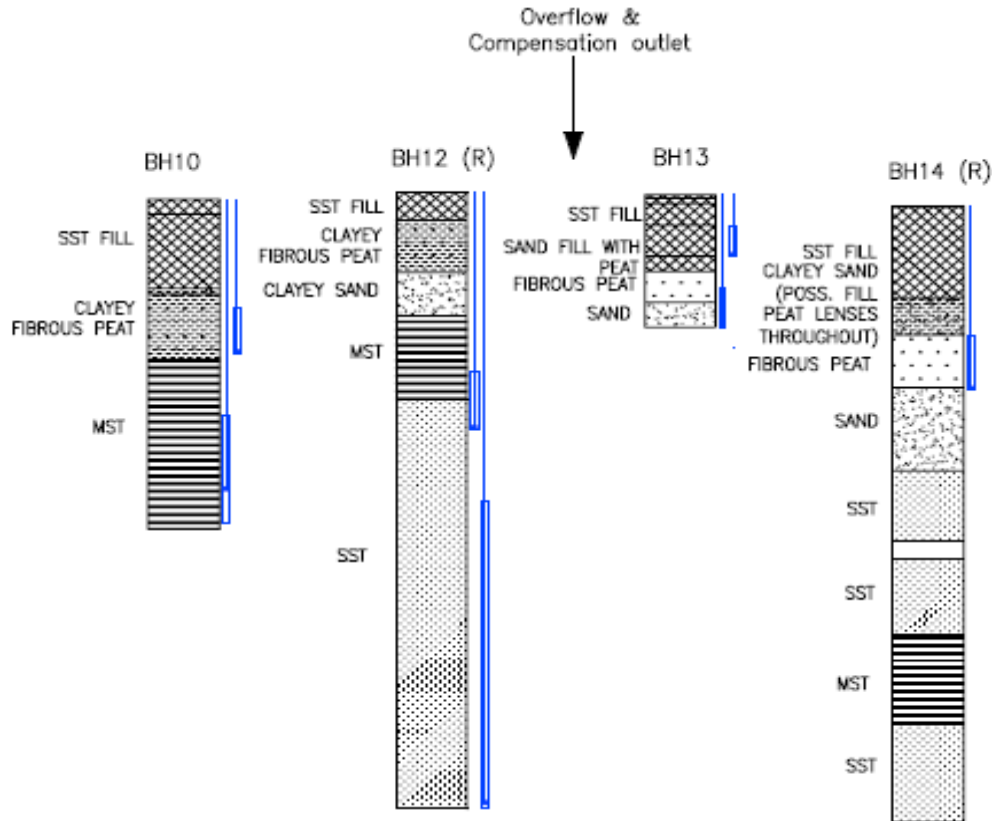
Figure 4: Historical boreholes surrounding Whiteholme outlet tunnel

deposits of weathered sandstone and peat, overlying natural peat and Glacial Till. These deposits overlie Kinderscout Grit.

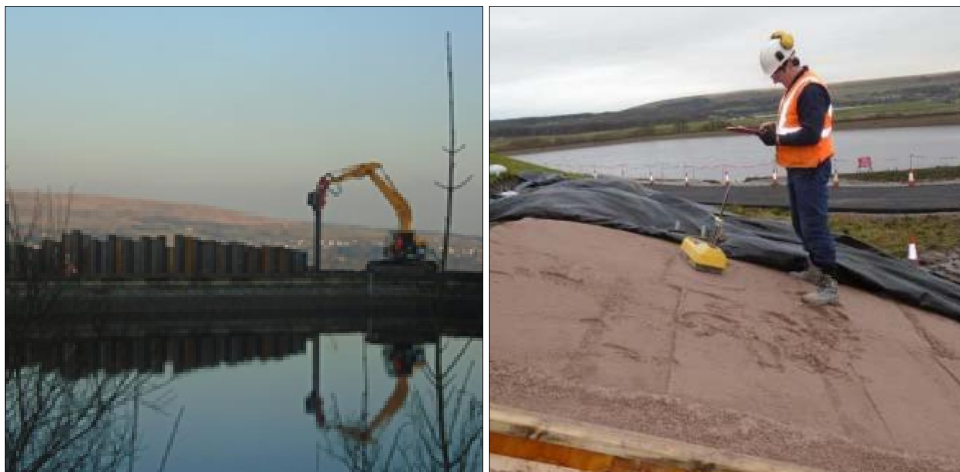
(a) Movax sheet pile installation

(b) Nuclear density testing of filter

At Springs IR an embankment face filter blanket has been combined with partial sheet pile cut off walls at both the crest and toe. These will act as a crack resistant, physical barrier to prevent the passing of fines through the embankment and along the conduit. In combination with slip-lining and tunnel infilling works, the probability of failure will be reduced to within the 'ALARP' range. Challenges on site relating to the drivability of the piles to the design depth have been overcome with the use of a Doosan air hammer following initial installation with a Movax vibrating hammer attachment.

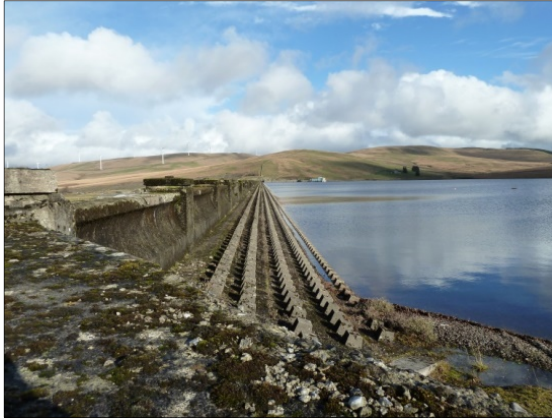
Figure 1. Daer reservoir

The reservoir has a capacity of 25,460,000m³ and is retained by an embankment dam with a height of 42m and a crest length of 793m. The upstream slope varies between 1 in 3.25 and 1 in 2.5. The downstream slope varies between 1 in 2.5 and 1 in 2.25 with a berm just below the mid-point. The embankment is formed of Glacial Till with an articulated concrete core wall keyed a minimum of 0.90m into the underlying rock and a single line grout curtain. There is a rockfill drain at the base of the core wall with foundation finger drains

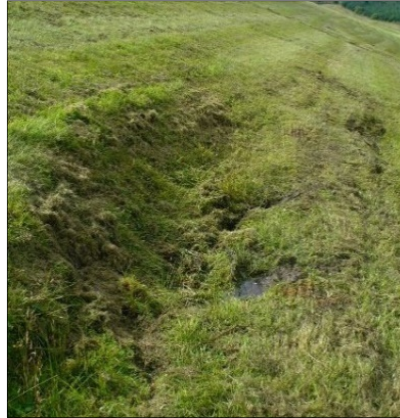
Figure 2. Wet patch on face

An inspection under Section 10 of the Reservoirs Act 1975 (HMSO, 1975) was undertaken on 23rd August 2013 by Dr A K Hughes. The report noted that the embankment was generally dry with few signs of distress or instability. However concerns were expressed regarding the volume of water passing into the main seepage monitoring chamber from fissures in the rock in excavations that were open at that time. Measures in the interests of safety were included for this; for the re-establishment of seepage monitoring points on the embankment; and for installation of drainage in a wet patch first noted in 2008 towards the right hand end of the downstream face (Figure 2).

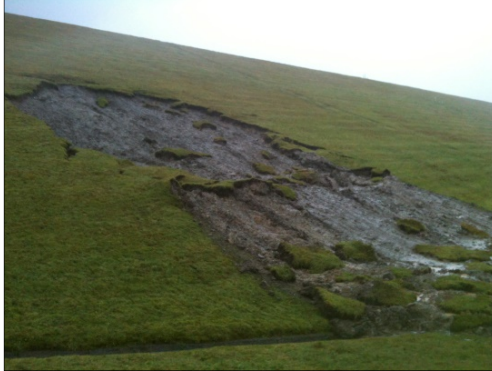
Figure 3. Slip area

The slip measured around 20m x 25m in area (Figure 3), and appeared to be around 0.5-1.0m deep. The depth was difficult to assess because the movement had left a very uneven surface. The slip was located immediately above the berm, towards the right hand

end of the dam and near to the wet patch identified in the inspection report. The displaced material had flowed across the berm, and engulfed the concrete mitre drainage channel.

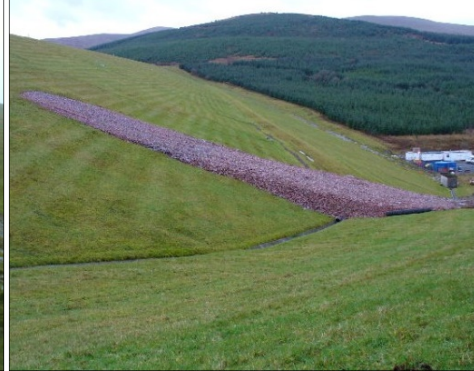
Figure 4. Rockfill berm

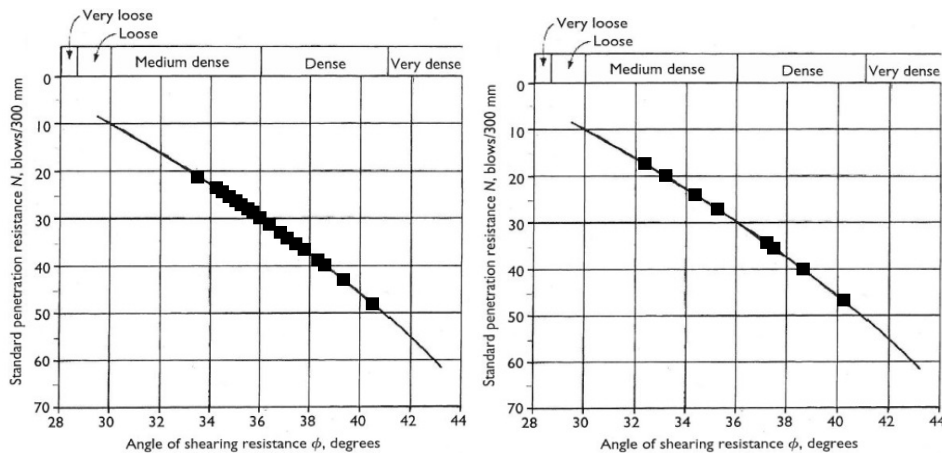
Figures 7 and 8. Relationship between SPT N value and ϕ'

SPTs typically recorded N-values ranging between 6 and 48 with only three recording N-values less than 20. The results of SPTs indicate the embankment fill to be typically medium dense to dense. Twenty six SPTs recorded N-values greater than 50, suggesting a very dense material or the presence of obstructions. The results were used to derive shear strength properties, using the relationship between N-value and ϕ' (Peck *et al*, 1967). Figure 7 and Figure 8 present the range of values for ϕ' for the fill beneath the crest and the face of the embankment respectively.

Based on the correlations it was considered reasonable to adopt $\phi'=34^{\circ}$ as a fairly conservative parameter to input into slope stability models. The lowest value adopted for sensitivity testing was $\phi'=32^{\circ}$. Given the granular nature of the embankment fill, the effective cohesion (c') was assumed to be zero.

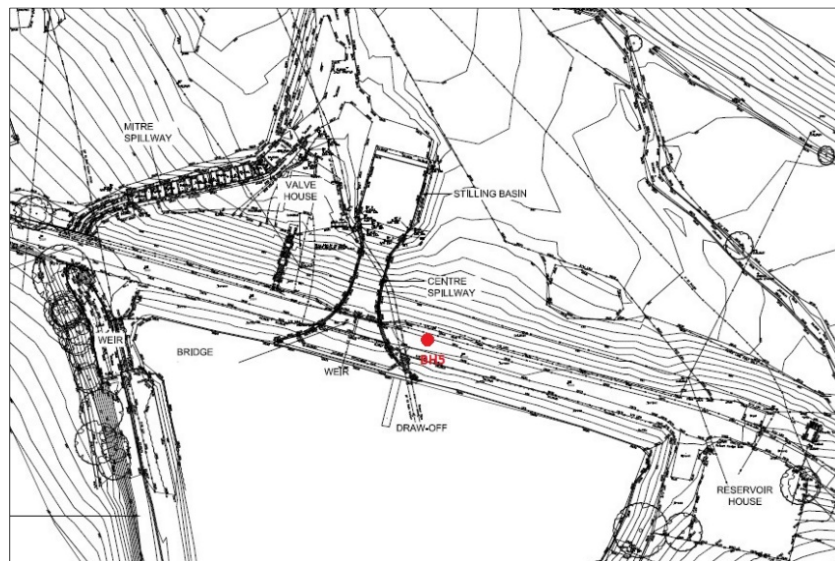
Figure 1. Chapel House Embankment Layout

The general arrangement of the embankment is shown in Figure 1. The reservoir has a drawoff shaft which is connected by an iron bridge to the crest of the dam, Figure 1. The shaft joins a 275mm cast iron supply main through the body of the dam and a 610mm diameter scour pipe controlled by a valve on the upstream end on the valve shaft and another at the toe. Anecdotally it was suggested that the pipes were housed within a concrete lined tunnel through the embankment but there is little evidence to support this theory.

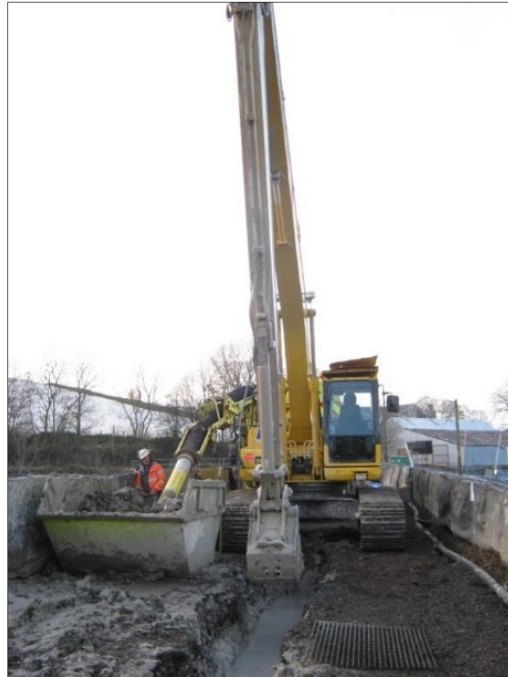
Figure 3. Installation of slurry trench cut-off wall with vacuum excavator removing arisings from skip

The general sequence of work was to carry out the EoC holes along the downstream side of the crest prior to installing the 119m length slurry trench cut-off wall either side of the central spillway. The slurry wall was constructed using a long reach 360° excavator. Slurry was continually supplied to the trench to maintain a slurry level 500mm below ground level during excavation to prevent trench collapse. To ensure no cold joints if there was an unavoidable pause in construction the excavation was taken back into the previously formed slurry.

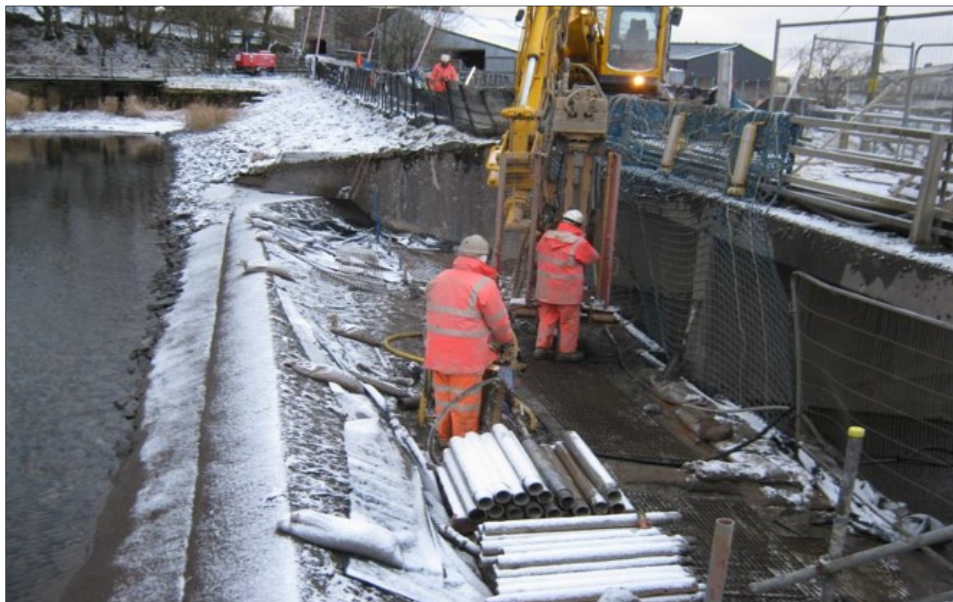
Figure 4. Installation of TaM holes over central spillway showing reservoir water level maintained during the works

The spillway TaM grouting installation was achieved using an excavator fitted with a front mounted rotary percussive drill mast. It was a requirement that no load be imposed on the spillway bridge and the rig was therefore sited on the crest road and only the mast placed on the spillway as shown in Figure 4.

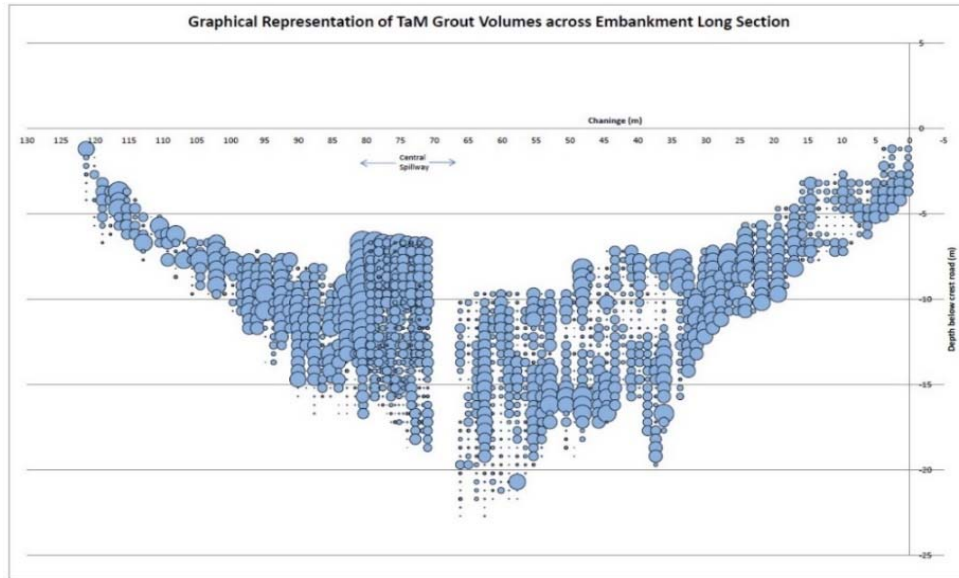
Figure 5. Graphical Representation of TaM Grout Volumes across the Embankment Long Section (note: between chainage 65 – 70 EoC grouting used to fill area around pipework through the embankment)

The successful validation of the works was reliant on a combination of records, testing and monitoring which all formed part of the Construction Quality Assurance Validation report. To ensure the quality and integrity of the grout mix, specific gravity (mud balance), viscosity (marsh funnel) and bleed testing was conducted daily. In addition five in-situ permeability tests were carried within the permeation grouting areas and indicated a successful average in-situ permeability of 3.09×10^{-7} m/s. Validation of the slurry trench cut-off wall was achieved by 90 day triaxial permeability laboratory testing which showed that the target permeability of $>1.0 \times 10^{-8}$ m/s was achieved with an average permeability of 2.71×10^{-10} m/s. Grout takes of the EoC and TaM holes were recorded and presented graphically, Figure 5.

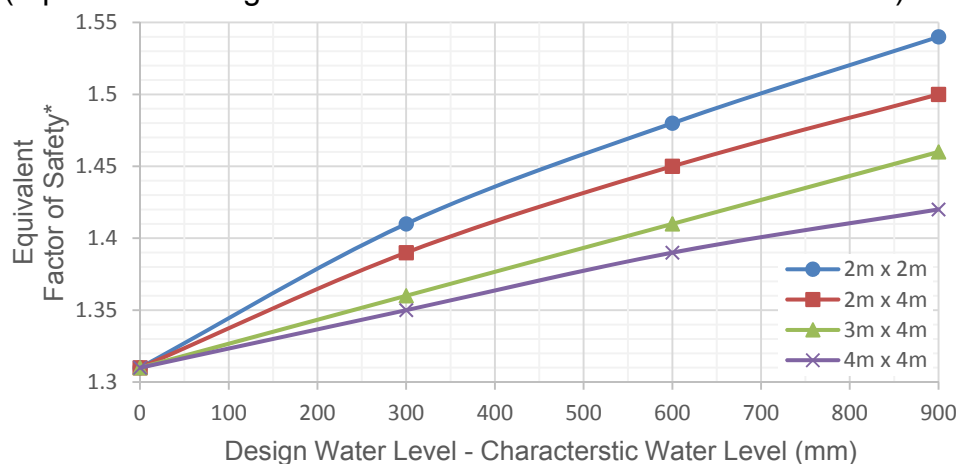
Figure 4. Variation in Unfactored FoS with Fixed Design Water Level

* Reported for design including partial factor multiplier of 1.05

The homogeneous steady state model was used with the landside slope set at 1V:3H. Three embankment heights were checked (up to 4m). The crest width was fixed at 4m (the 2m high embankment was also tested with a 2m wide crest).

Unfactored factors of safety were calculated as the characteristic water level was varied to represent various freeboard allowances (reported as design water level minus characteristic water level).

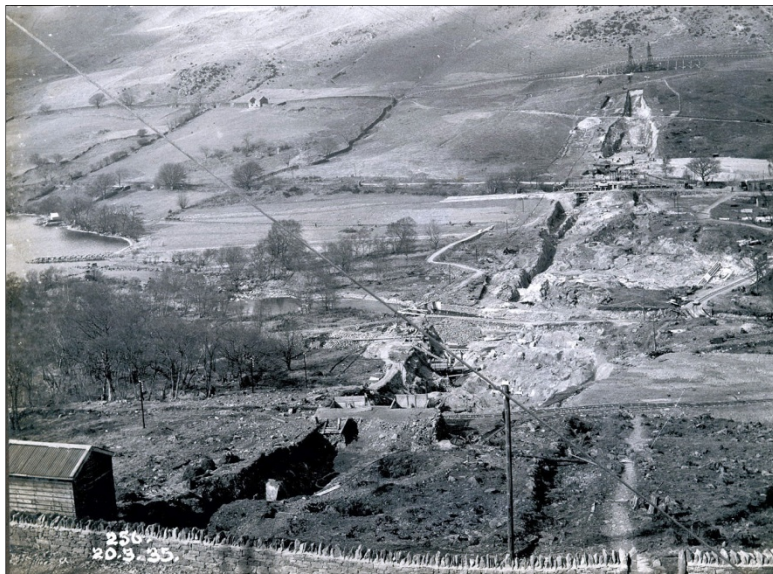
Figure 2: Initial excavations for foundations underway (1935)

Construction of the dam commenced in 1929 despite the ongoing public outcry. Due to the high ground pressures created by this form of construction the foundations were required to extend to strong rock. Rock at the site was proved at depths of between 16ft to approximately 35ft below existing ground level and comprised the Birker Fell Andesite formation, a volcanic extrusive rock (Figure 2). Grouting was required at the base of the cutoff trench in order to improve the nature of the rock which was locally fractured due to faulting in the area.

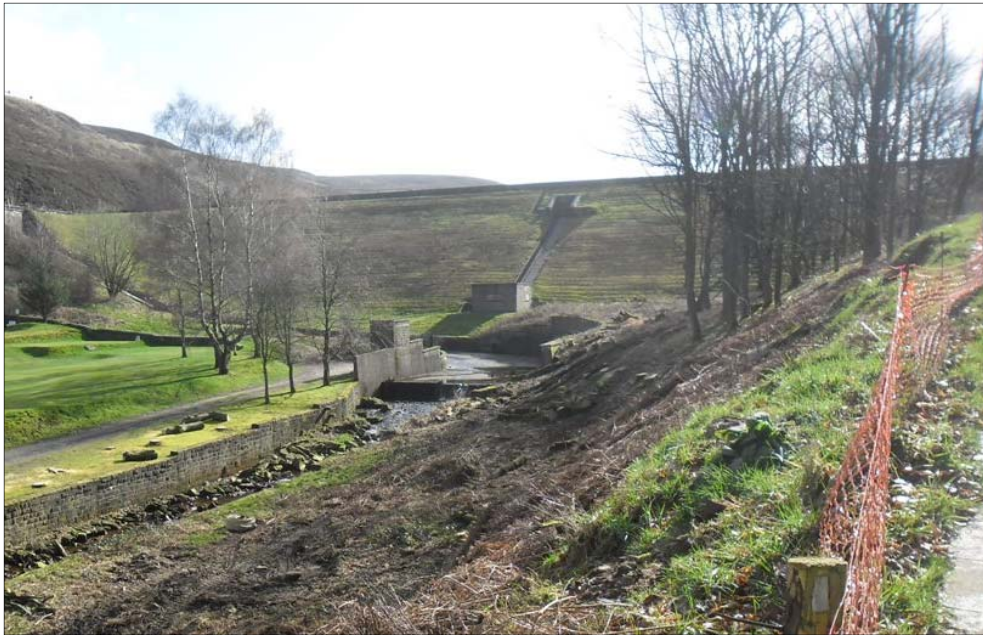
Figure 4. Hurst Reservoir embankment before discontinuance.

Investigations were undertaken on the crest and downstream face of the embankment (Figure 4) in 1999 by Strata Surveys Ltd. Piezometers were installed in each hole and these were monitored along with the embankment toe drain on a regular basis for several months. In 2006 the panel engineer recommended that the reservoir level be held down by 3m, while a leak adjacent to the siphon chamber was investigated. Monitoring of the piezometers was

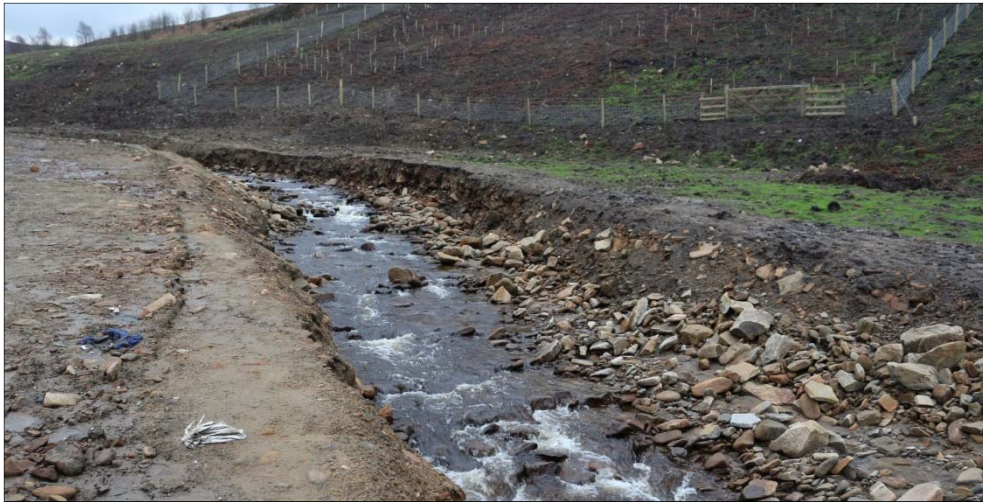
Figure 7: Deposition (right foreground) and erosion (right bank distant) in the recreated Hurst Brook channel.

There have been some minor concerns that the course of the brook was not as intended as there has been marked erosion in some areas of the landscaped stream bed and deposition in others (Figure 7). This erosion also revealed that the contractor had used geotextile in some areas to contain reservoir sediment in the landscaping, which has subsequently been removed where exposed.

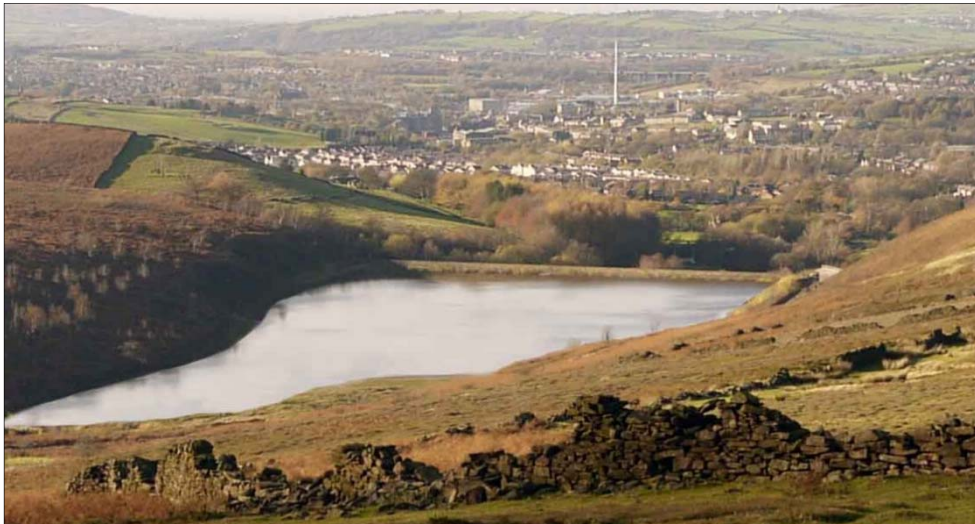
Figure 8: View of Hurst Reservoir before Discontinuance.

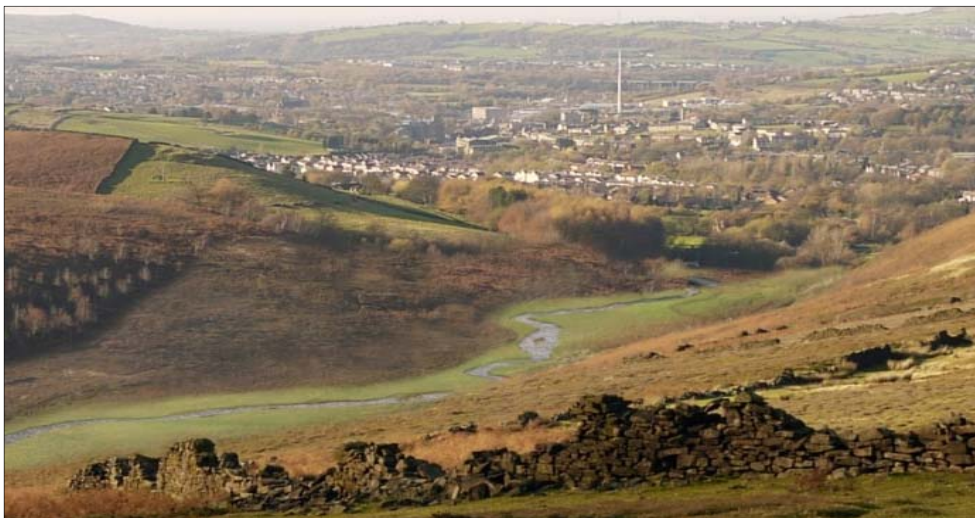
Figure 9: Composite view of Hurst Brook valley post Discontinuance.

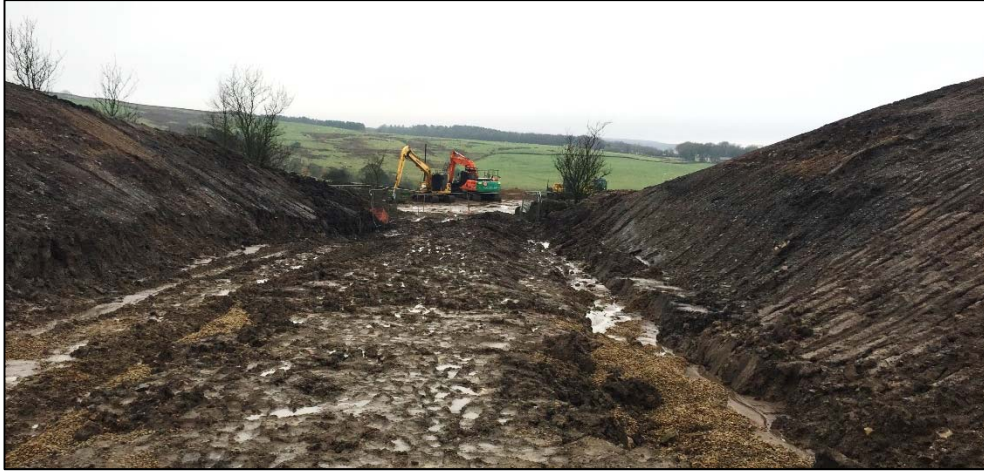
Figure 1. Cutting the notch at Sunnyhurst Hey Reservoir

The discontinuance works at Sunnyhurst Hey Reservoir comprised the creation of a notch (Figure 1) in the western arm of the embankment in order to reduce its capacity such that it would no longer fall within the Reservoirs Act 1975. A proportion of the embankment fill material was reused at Earnsdale Reservoir as general fill behind the reinforced earth berm. A new pipe was constructed between the two reservoirs to permit the transfer of flows from the former Sunnyhurst Hey Reservoir to Earnsdale Reservoir. Sunnyhurst Hey Reservoir Basin has been engineered to form a new wetland habitat which will develop over the coming decades. Hughes *et al* (2008) state "...that the discontinuance of dams is often

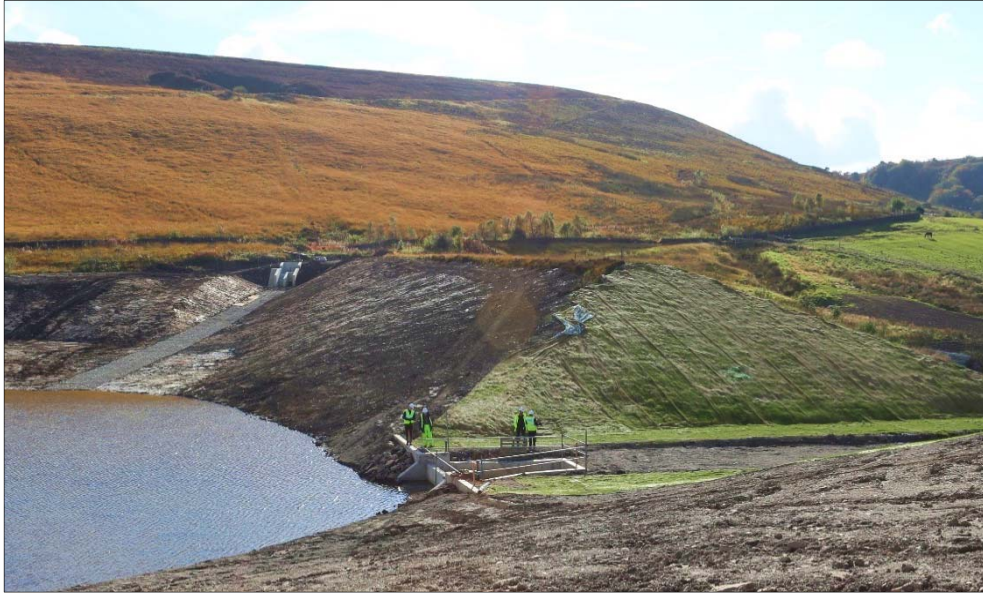
Figure 2. Completed notch cut through Sunnyhurst Hey embankment (centre right) with new concrete inlet screen structure (background, centre left) and new concrete outlet weir (centre bottom).

The excavation of the notch took place during the summer and autumn of 2014 and included the installation of the new pipeline and weir structure (Figure 2). Excavated soil was stockpiled for re-use at Earnsdale Reservoir as general backfill to the reinforced earth berm construction; the construction of the inlet structure and screen followed during 2015 with the Certificate of Discontinuance

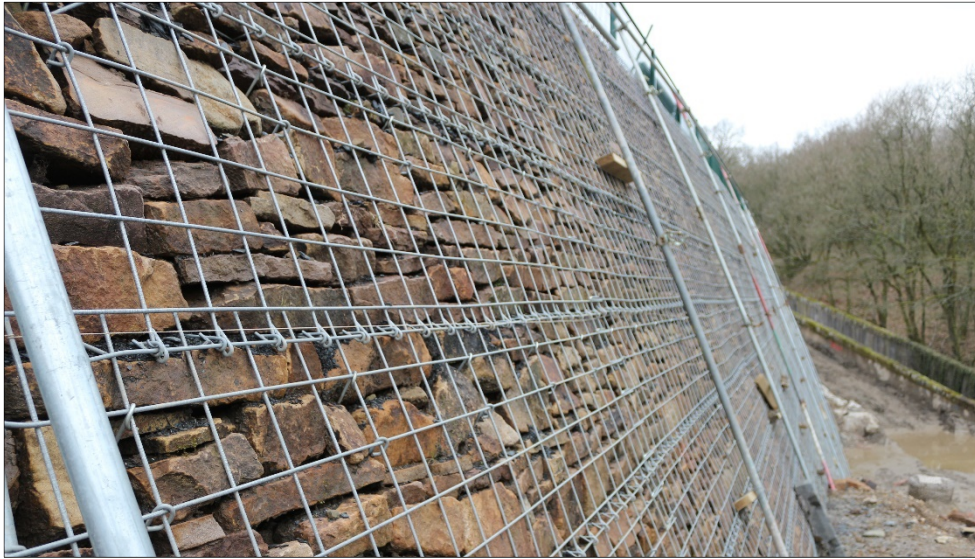
Figure 7 Eco wall nearing completion

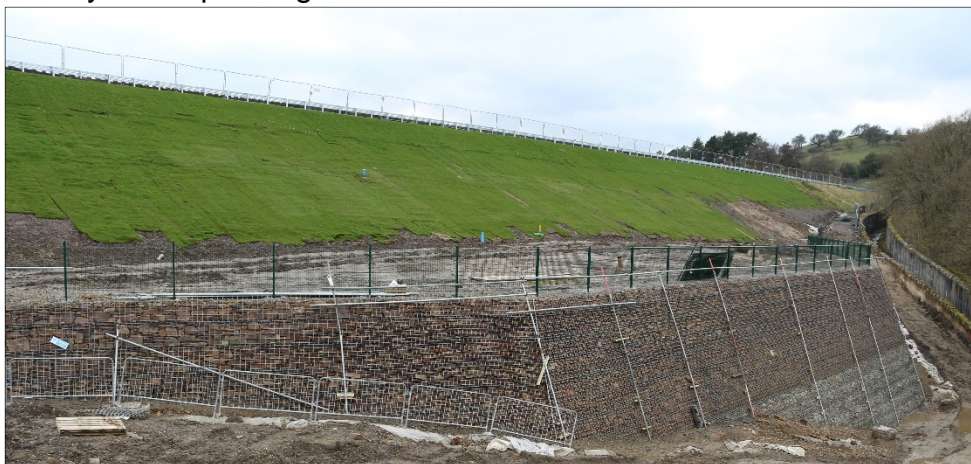
Figure 9. Eco Wall nearing completion

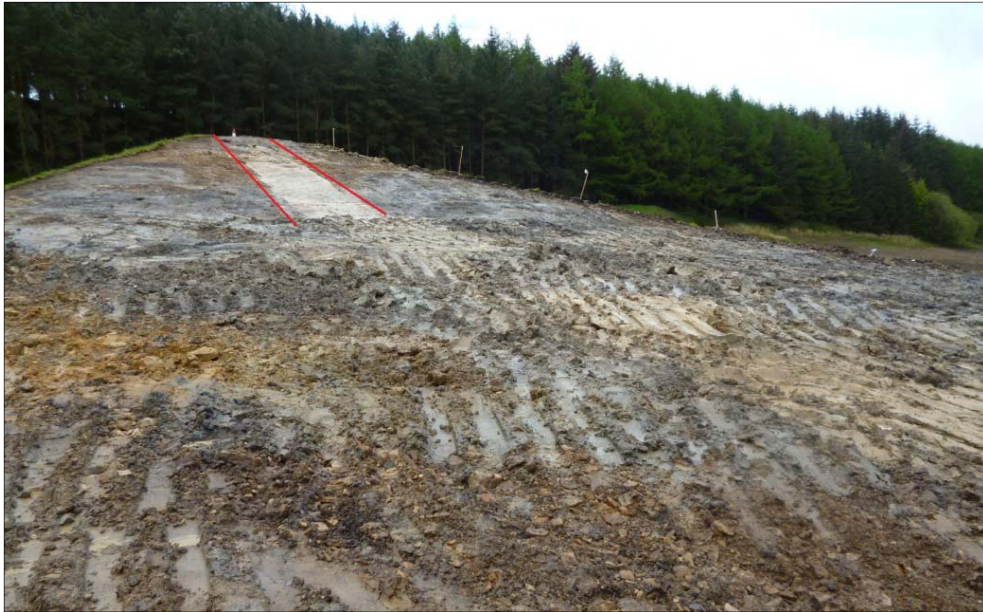
Figure 3. V-notch excavation through Beaver Dyke showing clay core

During the excavation works the clay core was exposed in the embankment. The boundary between the core and the embankment fill was clearly observed due to the distinctive change in colour and material type, as can be seen in Figure 3 below. The core was observed as linear and there was no evidence of lateral deformation caused by movement or settlement of the embankment.

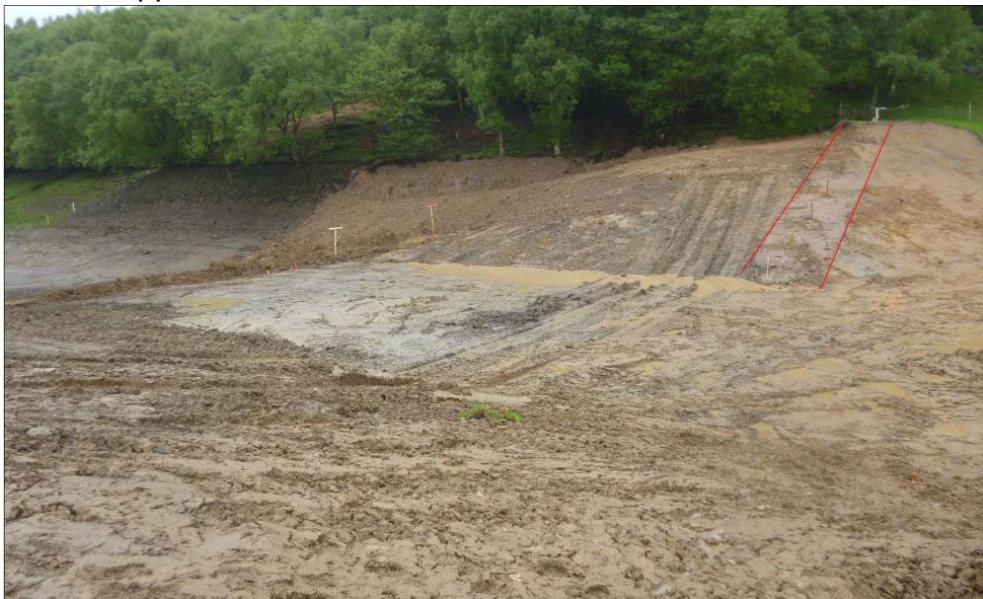
Figure 4. V-notch excavation through Oakdale showing clay core

The material exposed in the excavations of the dam at Oakdale generally comprised a sandy, gravelly clay and silt within the embankment shoulders with a central puddle clay core. The margin of the clay core was well defined (see Figure 4) and lateral deformations were not evident. The material of the shoulders appeared relatively homogenous while distinct zoning of materials was not apparent.
