Dams: Benefits and Disbenefits; Assets or Liabilities?

Proceedings of the 19th Biennial
Conference of the British Dam Society
held at Lancaster University from
7–10 September 2016

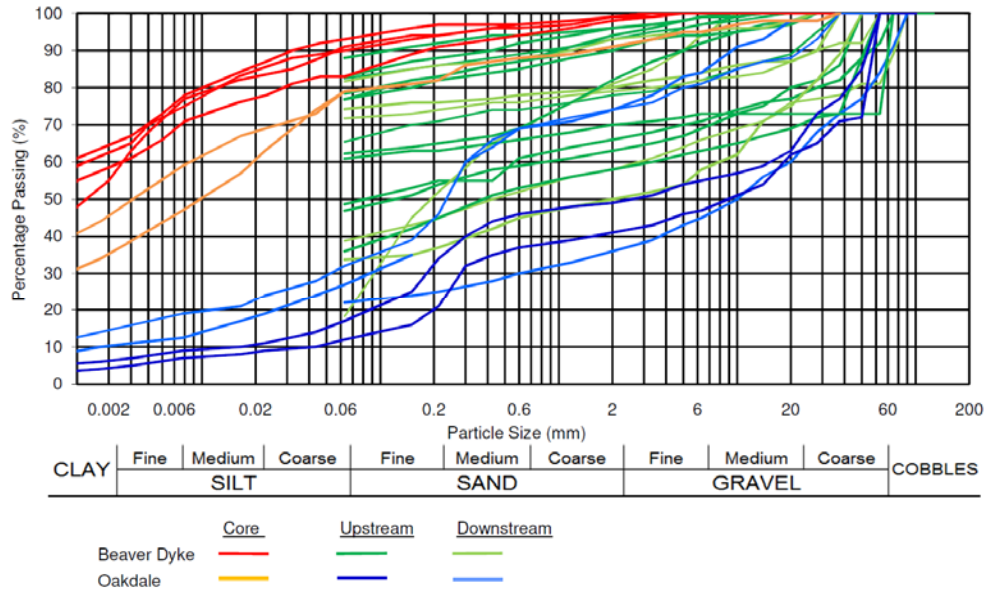
Figure 8. Grading of the embankment materials

There is no distinct pattern relating to the material and distance from the clay core, although the material appears to become coarser grained with depth. This may be a design feature but is more probably the order of materials dug from the borrow pit. At level 160mAOD the material is more variable in grading, but overall, the fill materials can be described as predominantly fine grained.

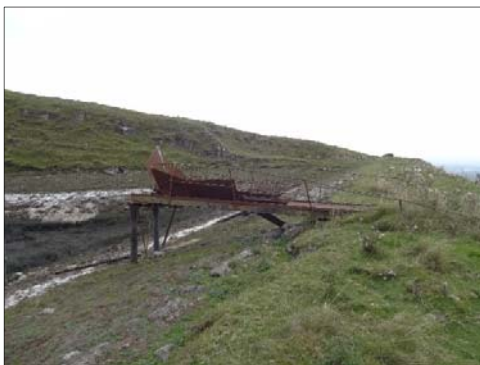
Figure 3: dam crest

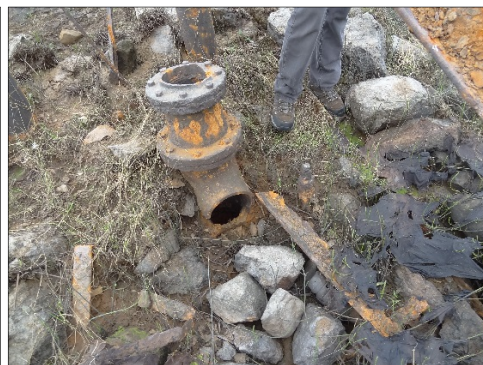
Figure 4: drawdown pipework

There is also no means of recording water levels at present and the recent introduction of weekly observations by the Reservoir Manager has indicated that the water level approached crest level on several occasions during 2015. The ground along the toe of the dam is particularly soft and damp and it appears that some of the old redundant pipework through the embankment may be leaking.

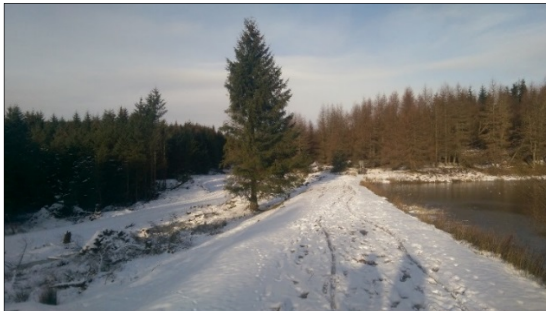
Figure 5: Greenlands No.1 dam crest

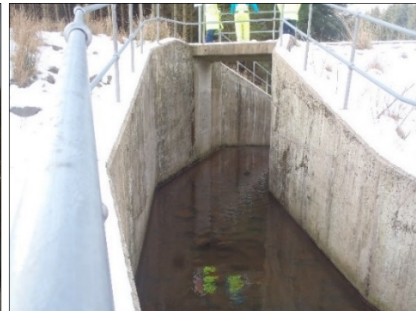
Figure 6: Greenlands No. 2 spillway

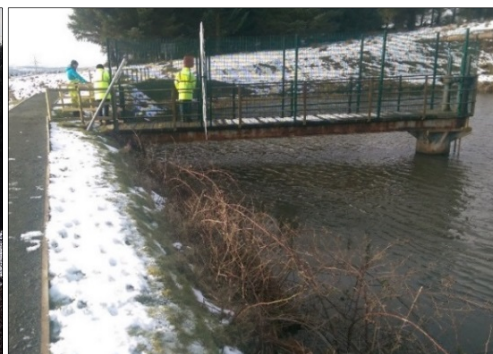
Figure 8: Greenlands No.3 crest

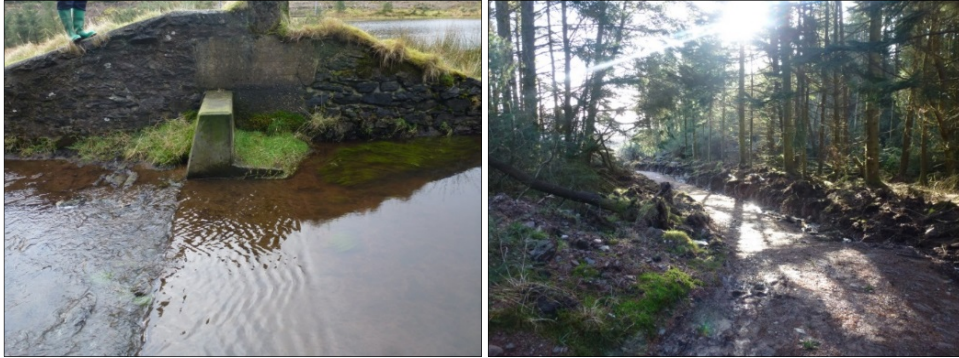
Figure 9: lowered spillway

Having discontinued the reservoir previously through lowering the spillway level (Figure 9), it was initially considered that further lowering of the spillway would be a relatively simple and quick process.

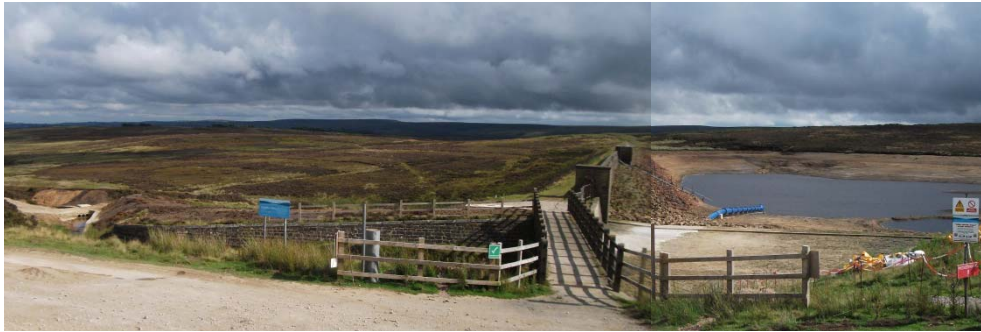
Figure 1: Overview of Keighley Moor reservoir and siphon.

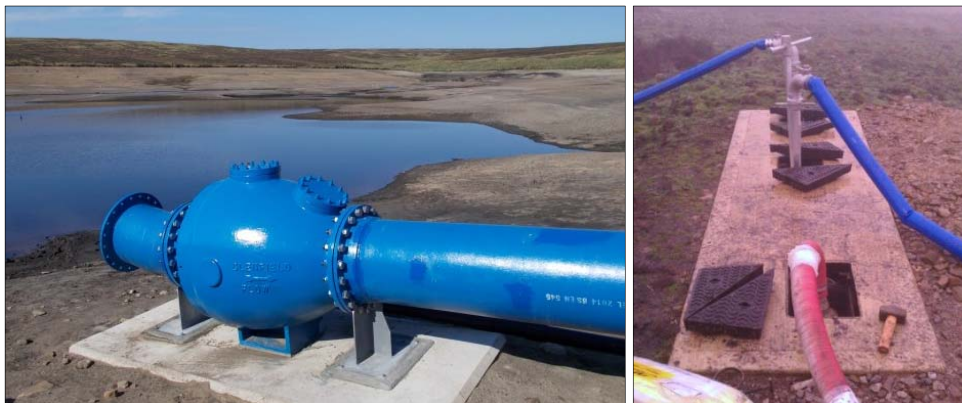
Due to the location and lack of a suitable power supply, a pumped priming system was selected. To allow for this pumped priming method, an upstream valve was required. A small mobile pump (kept off site) connects a permanent supply pipe and the filling hydrant to prime the siphon pipe, as shown in Figure 2. A second hydrant is included to allow air to escape from the siphon pipe during priming.

Figure 2: View of intake NRV (left), and the siphon crest priming arrangement (right).

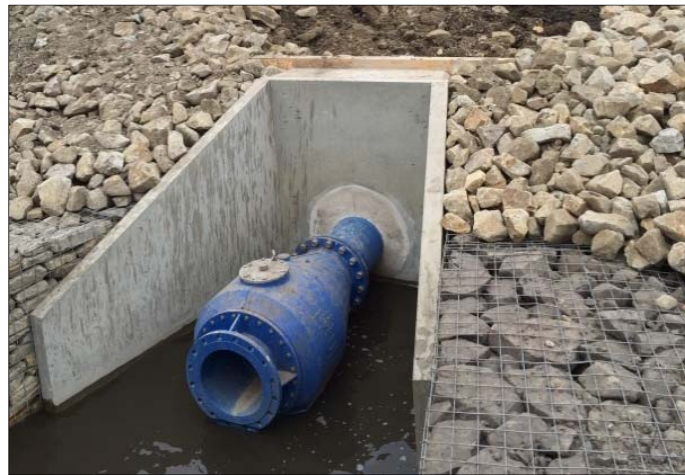
During detailed design optioneering it was identified by the client (MMB) that the provision of an artificial inlet sump could significantly decrease the length of pipework required. This reduction in length lowered the frictional losses sufficiently to enable the use of a smaller diameter pipe whilst still achieving the required discharge capacity and operational range. The siphon is buried for the entire length.

Figure 3: Wessenden Old IR Siphon inlet arrangement during construction

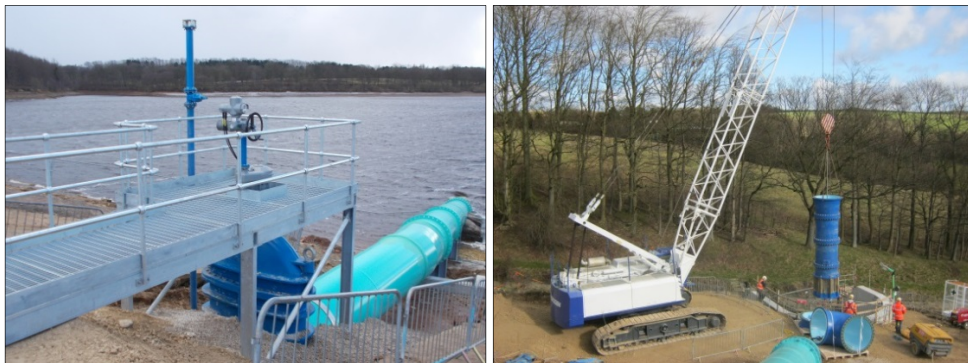
At the Client's request, a gate valve was included at the crest on the upstream side to enable isolation of the system. An air valve to allow the introduction of air into the siphon was also included at the crest to allow 'breaking' of siphon flow if the downstream valve could not be operated. The downstream valve is a submerged discharge valve (Figure 4) reducing from 1400mm to 1200mm diameter.

Figure 4: View of Eccup ESR siphon gate valve (left) and terminal submerged discharge valve (right) during construction.

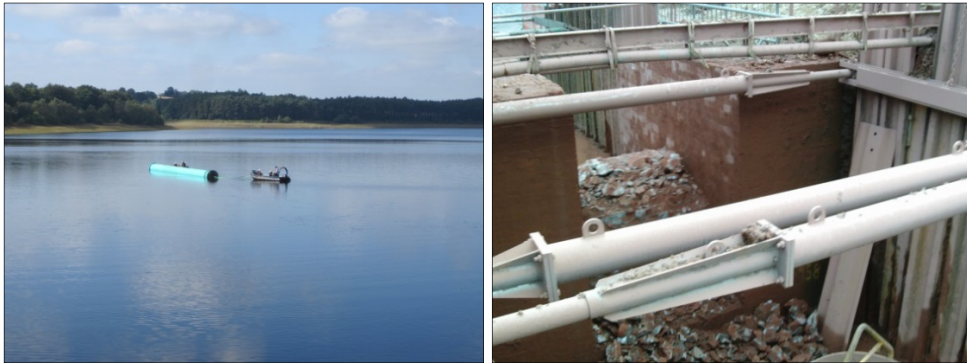
could not be drawn-down to below the siphon inlet level due to ongoing supply demands. Therefore, to construct the siphon intake the upstream section of pipe was floated onto the reservoir, manoeuvred into position and then sunk onto pipe saddles constructed by divers. This is shown in Figure 5 with a view of the works cutting through the existing brick buttress for the crest works.

Figure 5: View of the intake section of siphon pipework being floated across Eccup ESR (left) and cutting through the brick pillar for the siphon pipe (right).

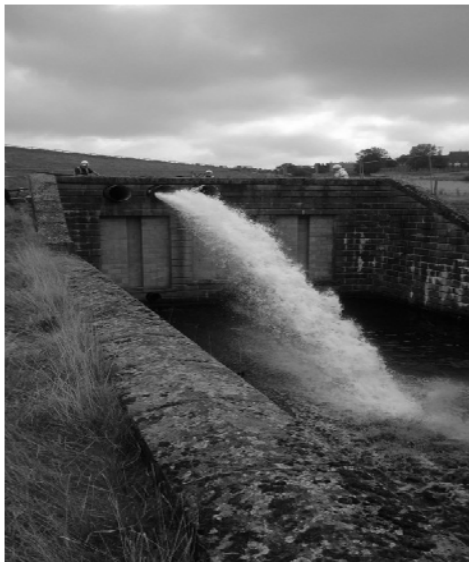
Figure 4: Valve test during commissioning at Pitsford

The siphon scheme was commissioned in September 2014 (Figure 4) and has increased the calculated initial rate of drawdown to 0.2m/day whilst the time to reduce the volume in the reservoir to 50% has been decreased from 29 days to 15 days with the average winter inflow. A simplified schematic of the drawdown facilities at Pitsford reservoir is shown in Figure 2 below.

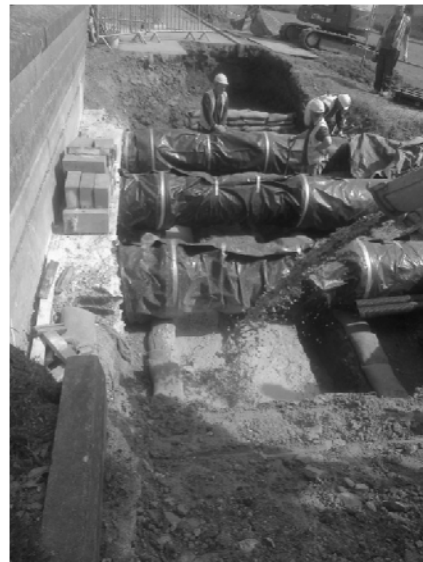
Figure 5: Concrete protection to core during construction of siphons at Pitsford

One important element of the design of the siphons was the detail for passing the pipes through the narrow core of the dam. The details of this had to be agreed with the All Reservoirs Panel Engineer beforehand and a delegated inspection of the core was necessary at the time of construction. The construction detail is shown in Figures 3 and 5. Design of siphon systems such as this takes specialist hydraulic knowledge to ensure that the siphons can be operated successfully at the capacities required without cavitation occurring.

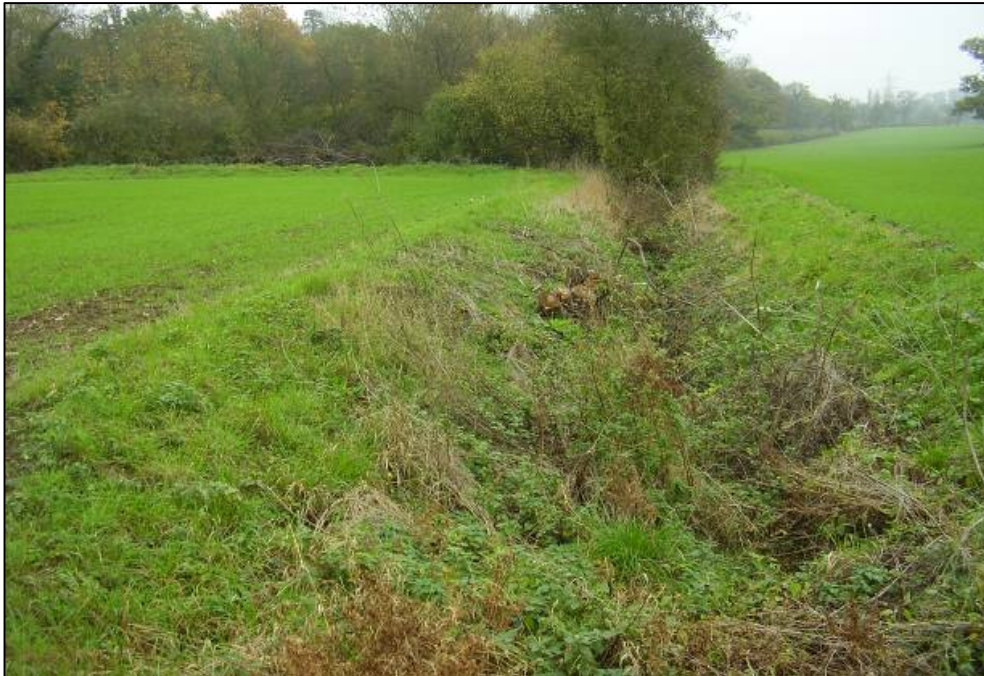
The receiving watercourse is a natural channel which runs alongside an agricultural field for 200m before flowing through a short culvert under a field access track (Figure 2). Over this stretch the channel consists of mud and grasses with a substrate of silt and vegetation. Beyond the field culvert, the brook flows for 4km to its confluence with a much larger river system.

Figure 2. View facing upstream from the field access culvert

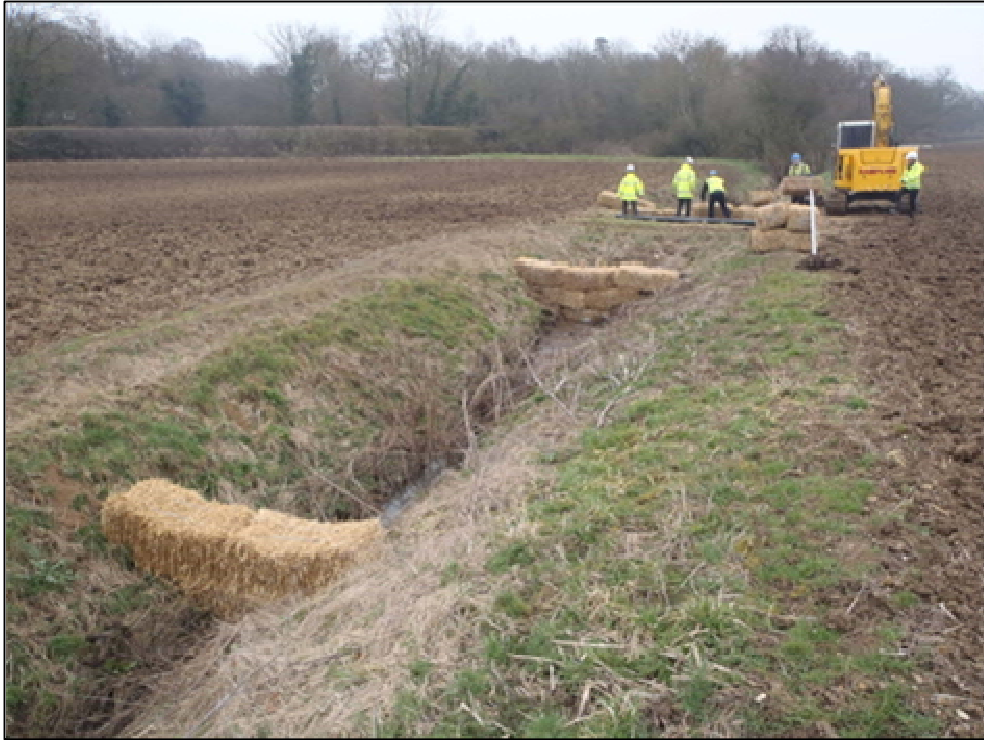
If at any point during the test the water flowing through the second wall of straw bales was observed to be sediment laden the scour valves were to be closed immediately.

Figure 3. Straw bales in place prior to the test

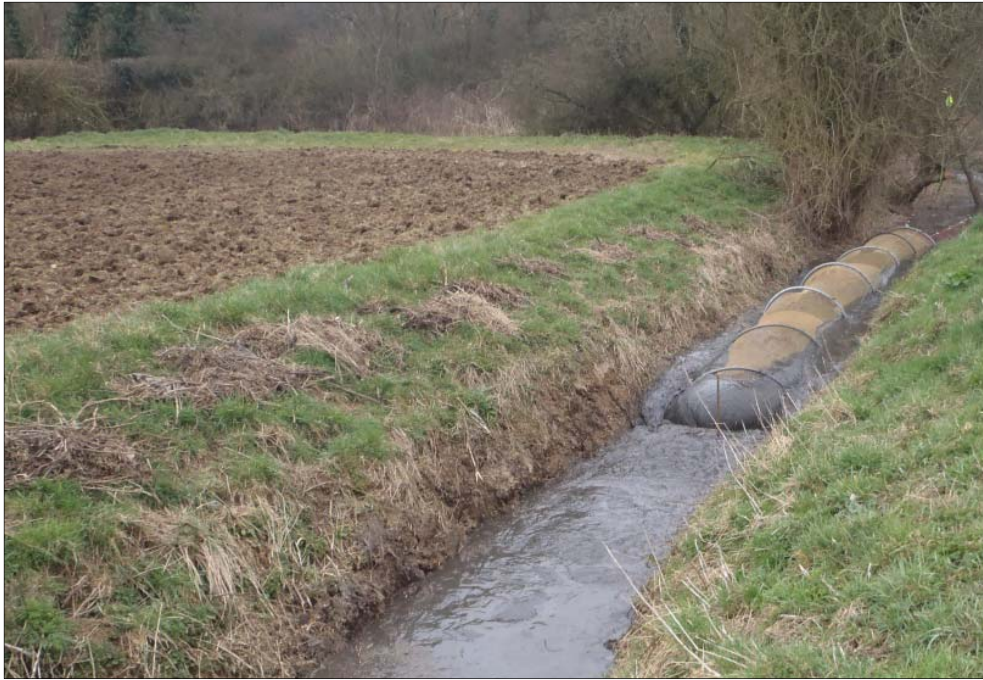
As expected with a reservoir scour release, the initial flow of water was seen to be sediment laden and carrying a small number of fish (see Figure 4).

Figure 4. Initial sediment laden flow

The water ran clear after 30 seconds. At this stage the total volume released was contained within the channel, impounded behind the straw bales. Had the test continued as planned, water would have been fully retained within the receiving watercourse.

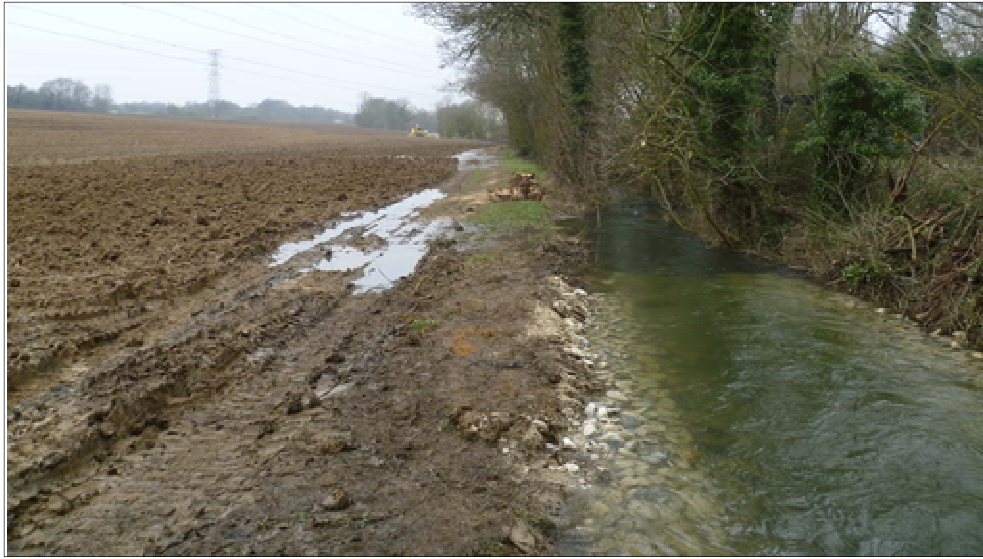
The actuated valve was closed 17 minutes after opening, leaving the scour valves partially open for nearly 15 minutes longer than expected. As a result of this excess flow, water spilled out of the brook in a number of locations (Figure 5).

Figure 5. Water spilling out of the watercourse

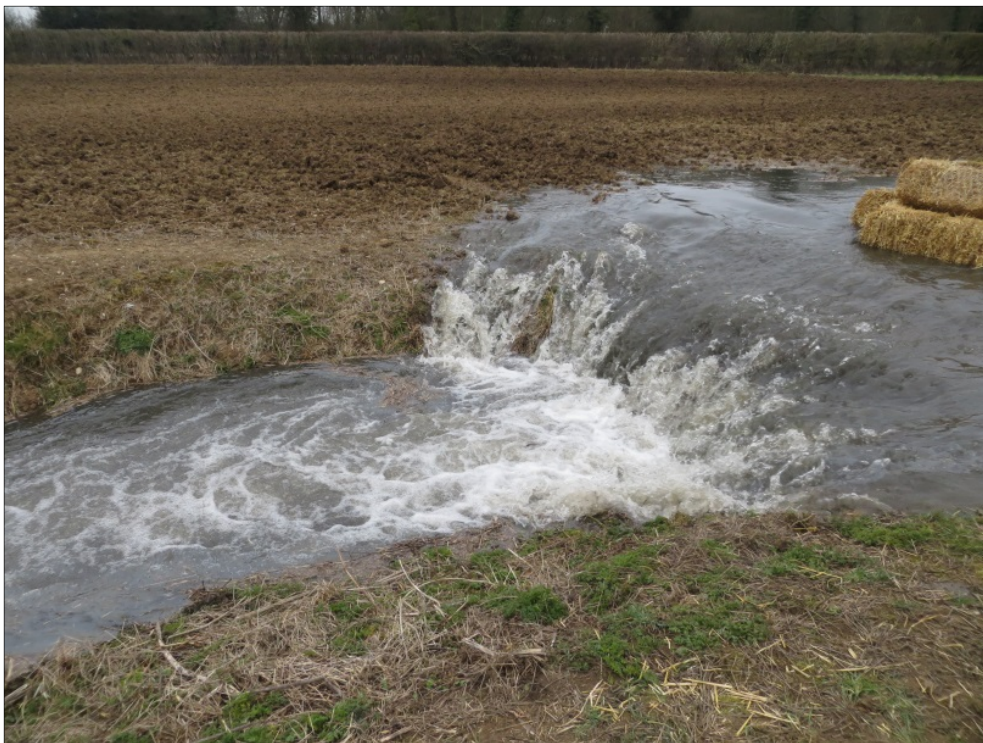
Ten minutes after the test began the access track behind the culvert was overtopped (Figure 6). One minute later the second and third lines of straw bales failed (Figure 7). The first line of straw bales (those blinding the culvert) was not destroyed, although the upper layer is thought to have lifted.

Figure 6. Overtopping of field access culvert

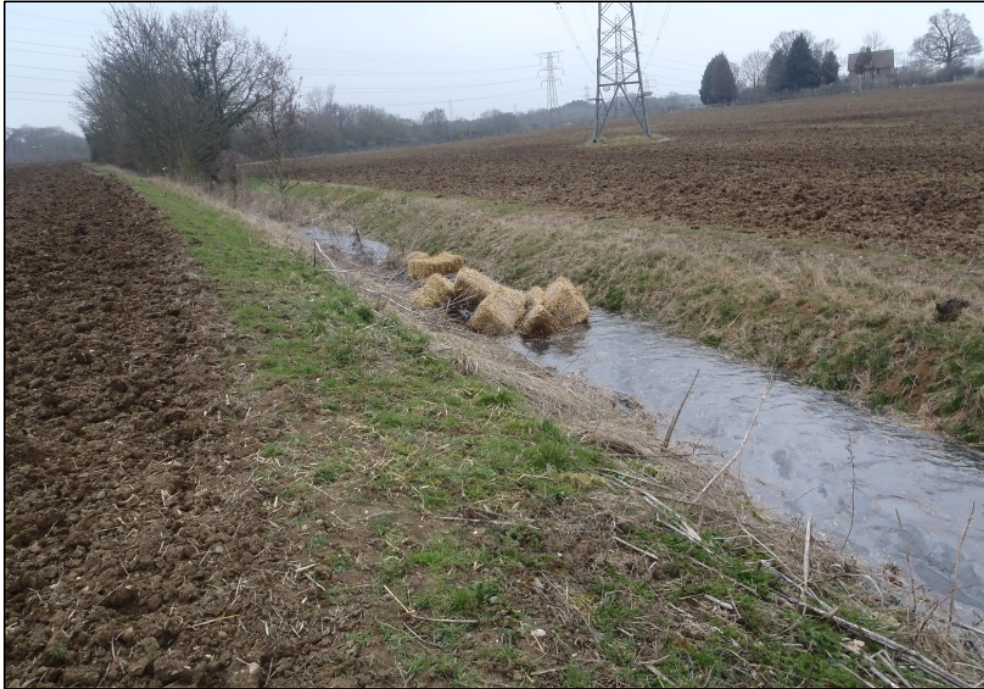
Figure 7. Collapse of second and third line of straw bales

After the water had drained through the bales, the sediment deposits were removed from the channel. A walkover downstream revealed the marks indicating raised water levels within the watercourse of less than 0.2m. There was also no evidence along the brook of either lateral migration or sediment deposition or erosion, nor any ecological concerns.

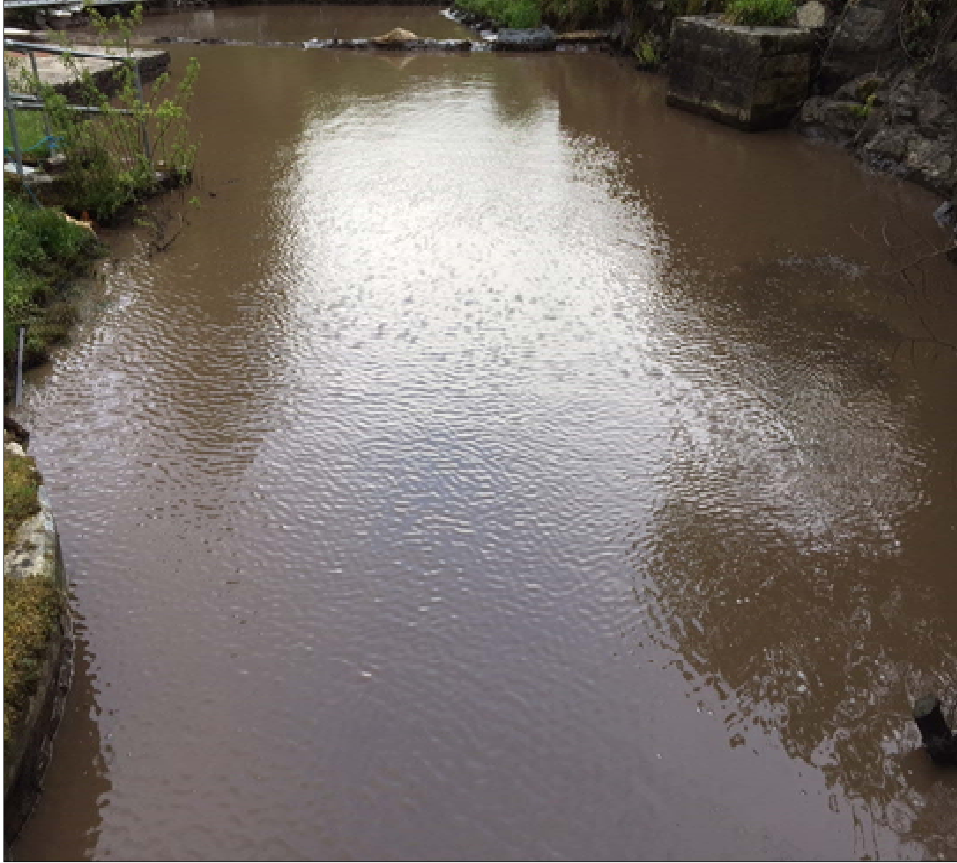
reservoir, causing a pollution incident in the downstream channel (Figures 1 and 2).

Figure 1. Sediment in downstream watercourse from reservoir drawdown.

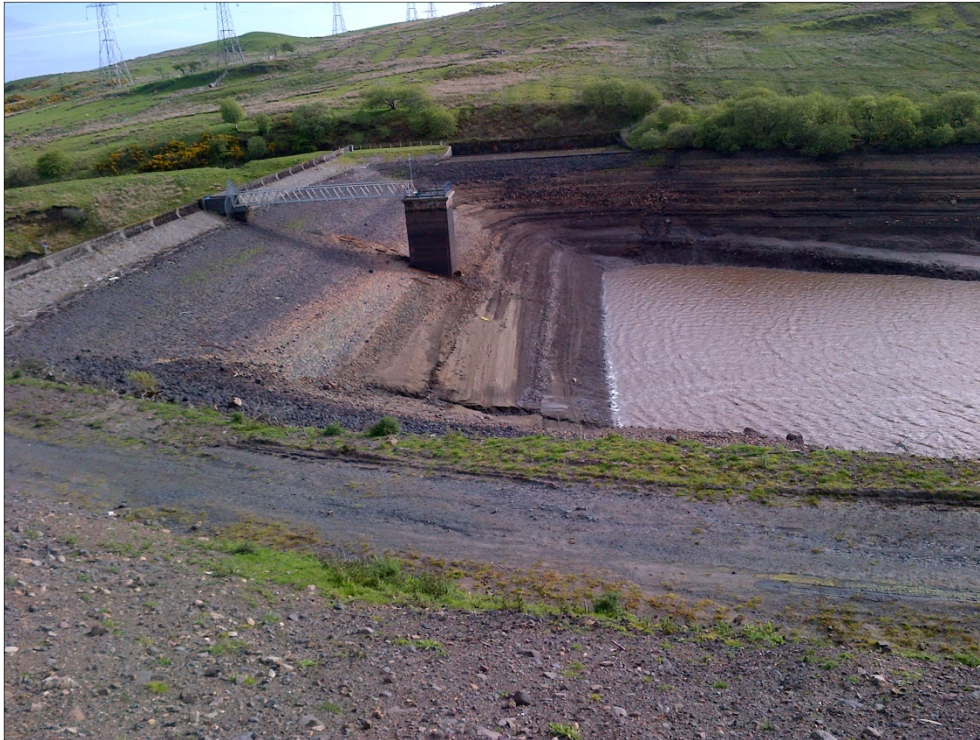
Figure 2. Suspended sediment in a drawn down reservoir from rainfall/runoff over exposed bed.

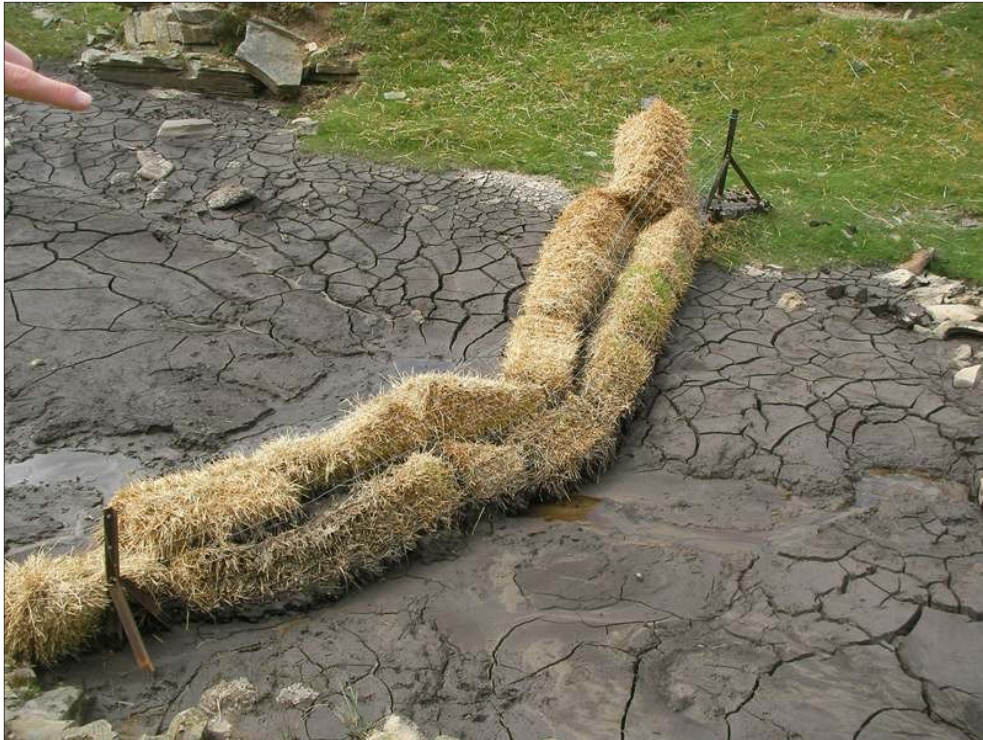
Recent EPI incidents have occurred due to a number of issues; lack of a bypass/bywash channel (inflow diversion and clean water dilution), monitoring frequency and records, impracticable water quality targets, inadequate means of silt capture/treatment (Figure 3), limited knowledge of the hazards (levels, nature and mobility of silt), and reliance on >100 year old infrastructure to manage flows. It is recognised that a greater understanding of the sites and the downstream receptors is essential for the successful management of a drawdown project. Starting a process to manage drawdown early in the life of a project will flag up the issues, enable appropriate mitigation and monitoring and reduce the risk of an EPI.

Figure 3. Inadequate means of treatment in place

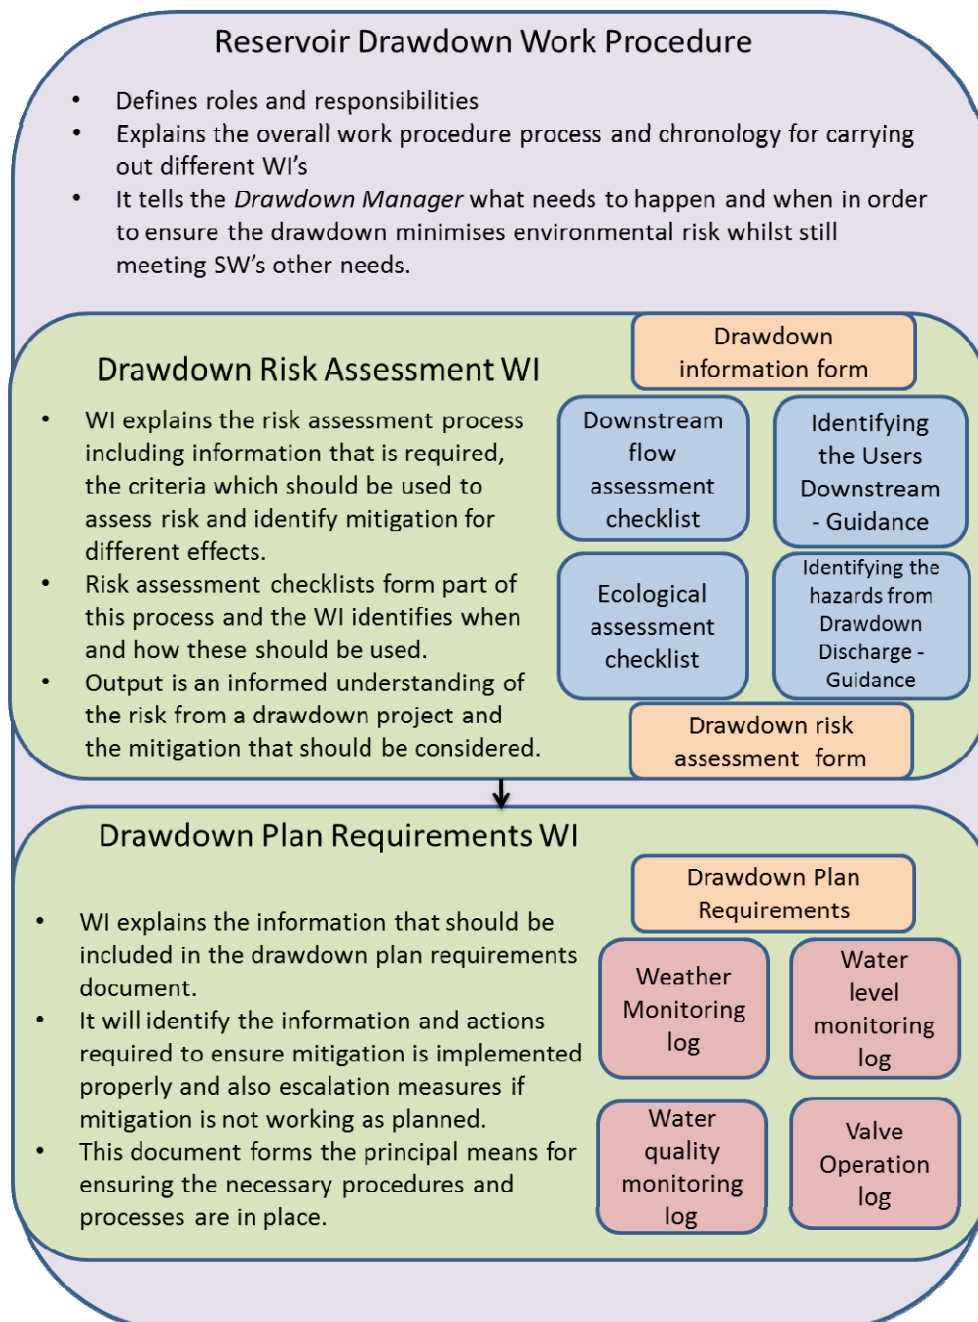
The first step in developing a consistent and practicable reservoir drawdown process was to establish procedural limits and key roles and responsibilities, understand the likely hazards and receptors, and finally prepare a Work Procedure (WP). The WP is the umbrella document that describes the tasks required through a series of Work Instruction (WI) documents and standardised forms and monitoring logs to plan and manage a drawdown with a clear understanding of the risks present. The tasks required by the WP are summarised in Figure 4. The key aims of the WP were to ensure that it is recognised as a mandatory process that must be followed for all drawdown projects, that it is not prescriptive and that the level of input is proportionate to the size and risk profile of the project.

Figure 4. Overview of the ROMS reservoir drawdown work procedure
 The WP can be broken down into a number of discrete exercises as follows;

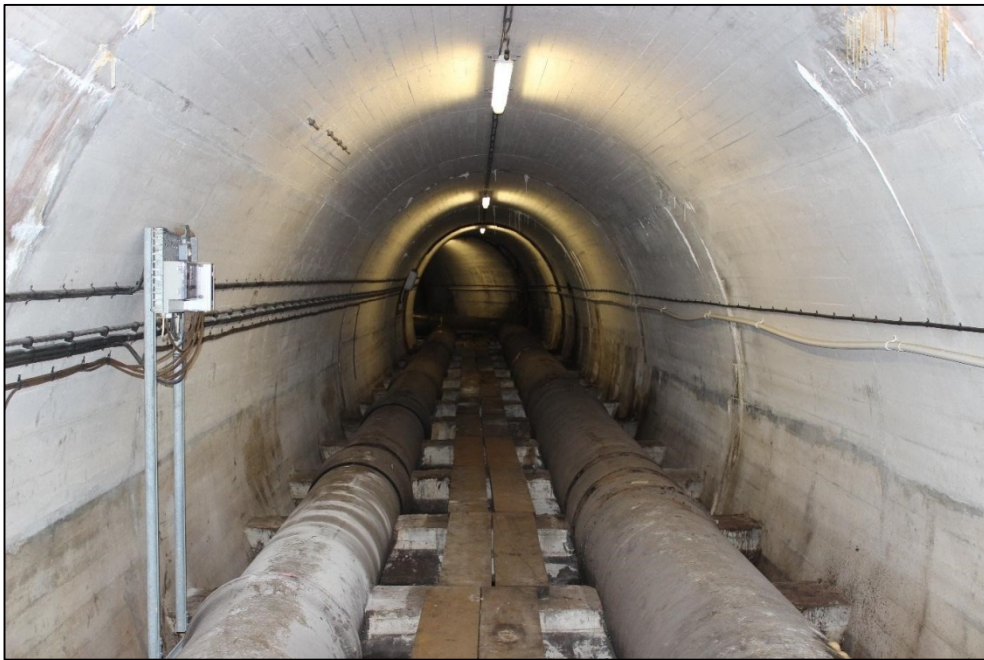
The supply and scour pipework are located in a concrete-lined tunnel that passes substantially below existing ground level beneath the dam. A valve tower is located over the tunnel upstream of the dam crest and the tunnel is plugged immediately upstream of the tower shaft. The 635mm diameter cast iron scour main is on the left side of the tunnel (looking upstream) and the 760mm diameter steel supply main is on the right as shown in Figure 1. The scour main section can be isolated by a single gate valve located immediately downstream of the tunnel's plug.

Figure 1. Talybont tunnel looking upstream, with the scour main on the left

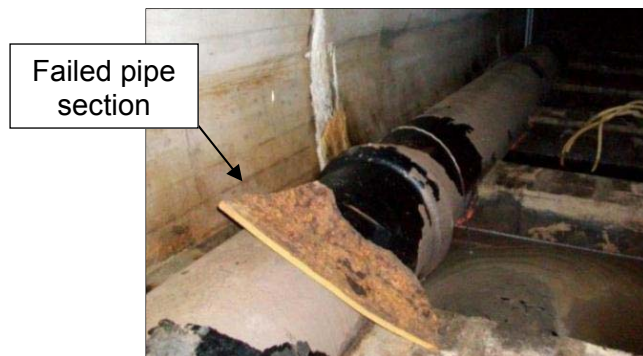
Figure 3. Section of the pipe that burst from the underside of the pipe

The following morning a Welsh Water operative received a call that the reservoir level had fallen by an unusual amount. On visiting the site the operative found that a significant amount of water was discharging from the tunnel. The first action was to close the scour valve and although it was not possible to close the valve completely, the flow from the tunnel significantly reduced. A detailed inspection found that a large section of the scour pipe had failed (burst out from the underside of the pipe) 21m from the tunnel portal. Part of the failed pipe section is shown in Figure 3.

Upon removal of the failed pipe section from the tunnel, a crack along the underside of the pipe was visible and corrosion was noted on the surface of the pipe section. A forensic exercise of this failed pipe section was undertaken in an attempt to gain a better understanding of the cause of the Talybont incident. A visual examination of the pipe showed evidence that the scour main had lifted off the pipe supports when the incident occurred causing minor

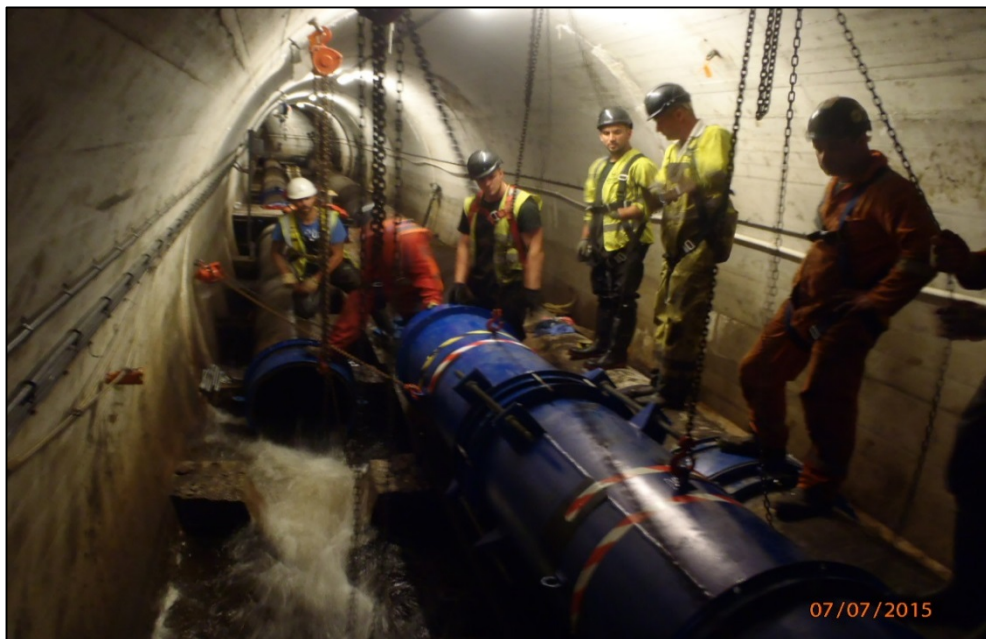
Figure 4. Flow discharging at the removed section of the scour main

The new steel pipe was rolled into the tunnel on timber boards in two sections to reduce the handling weight and then joined together within the tunnel using a tensile coupling. Then the failed pipe section was cut out and removed. Figure 4 shows the flow discharging from the cut section, whilst Figure 5 shows the contractors lifting the steel pipe into place using a lifting system that utilised a number of lifting points anchored into the tunnel roof lining and lugs on the pipes.

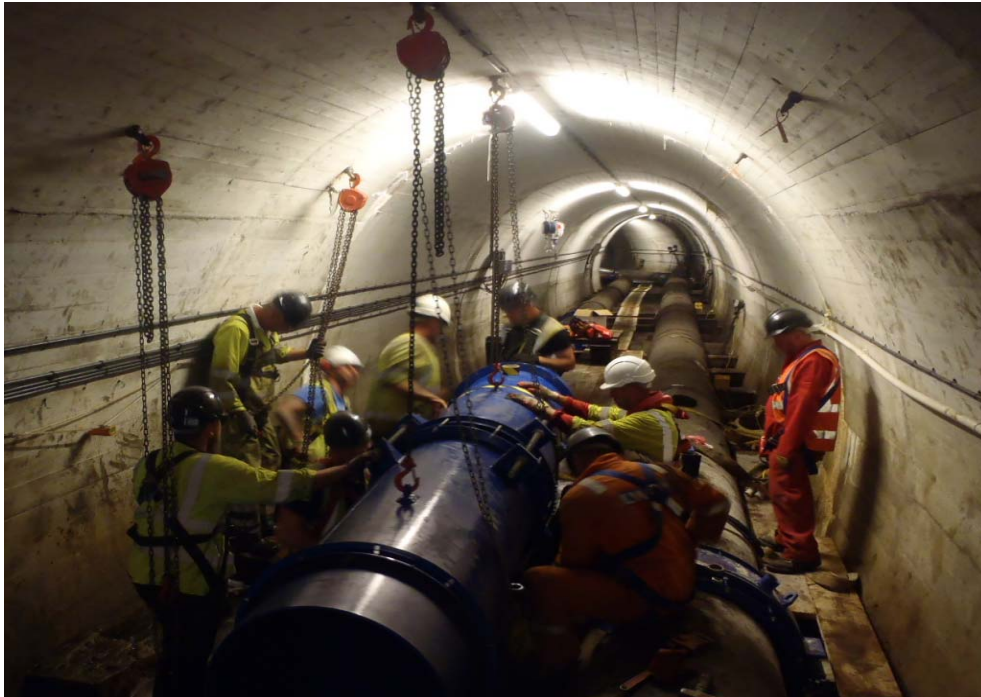
Figure 5. Lifting in the new section of pipe to replace the failed section

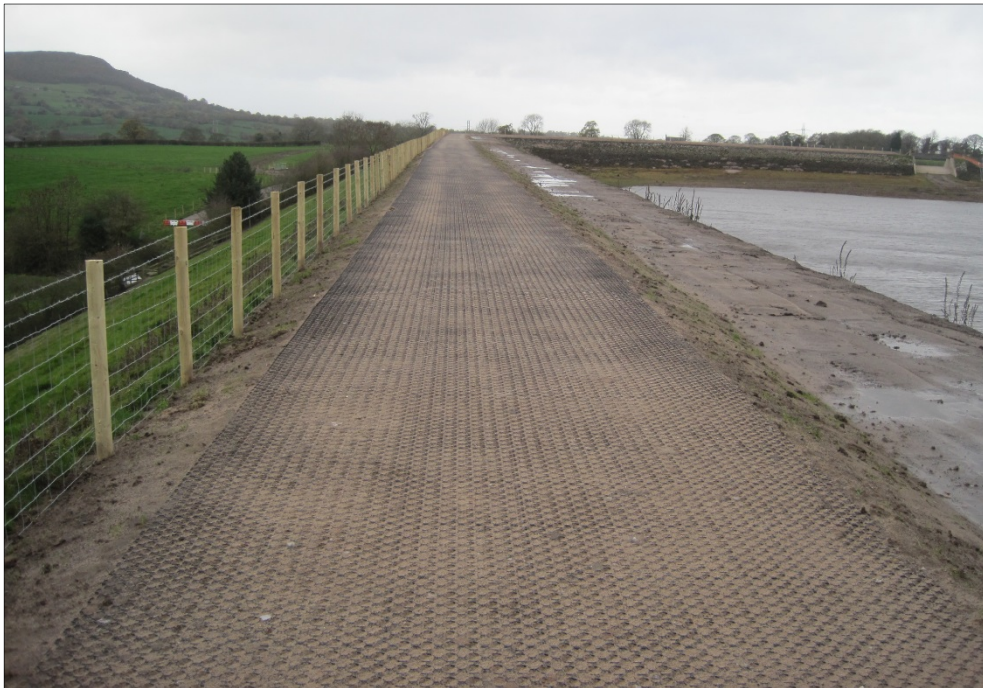
Figure 2. Crest raised

The main dam was raised during the works in 2015/16. The core was located by trial pits with a view to extending it upwards using puddle clay. The contractor proposed that it would be simpler to use piles to raise the watertight element. The core was exposed, a line of 1.4m long trench sheets was driven and then fill was placed around the piles to form the raised crest. An access track was built along the new crest using the 'BodPave' system to allow vehicles to reach the new siphons (Figure 2).

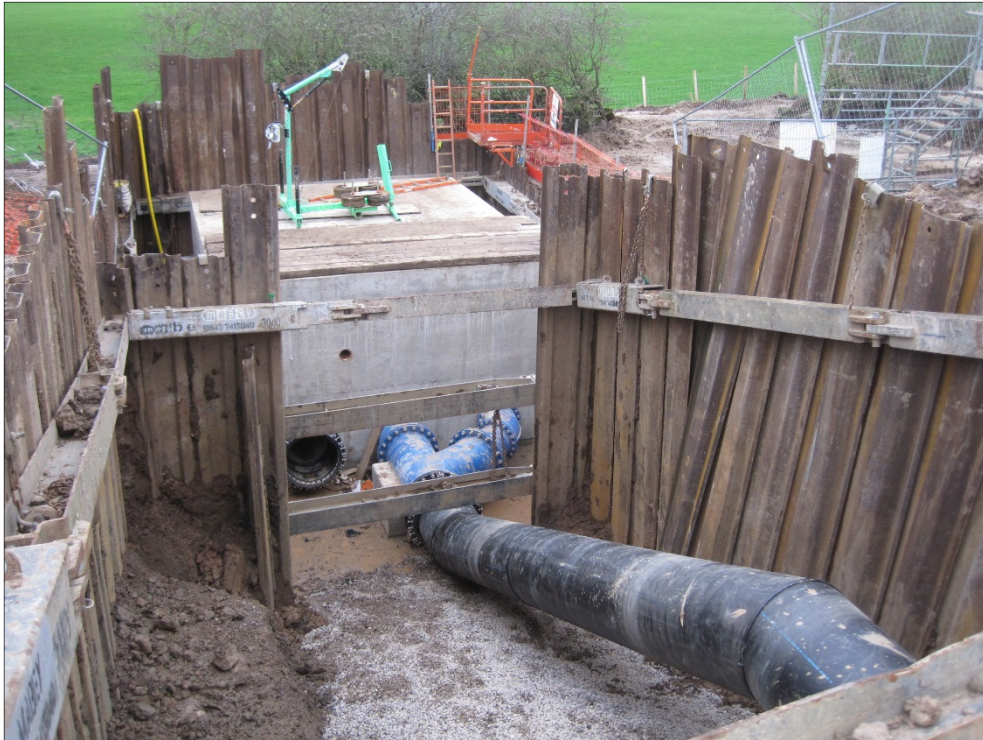
Figure 5. Pipework being laid under the downstream shoulder

Twin 625mm diameter HDPE pipes were chosen to reduce the stored volume by 50%, drawing the reservoir down by 3.0m in five days. The intakes are 6.1m below top water level and are protected by grilles. A priming chamber with guard valves is situated under the auxiliary spillway crest. The control valves are situated in a dry chamber at the downstream toe of the auxiliary spillway and discharge into a stilling chamber which remains full of water to ensure that air cannot enter the system at this point (Figure 5). The siphon discharge enters the existing system below the main spillway (Figure 6).

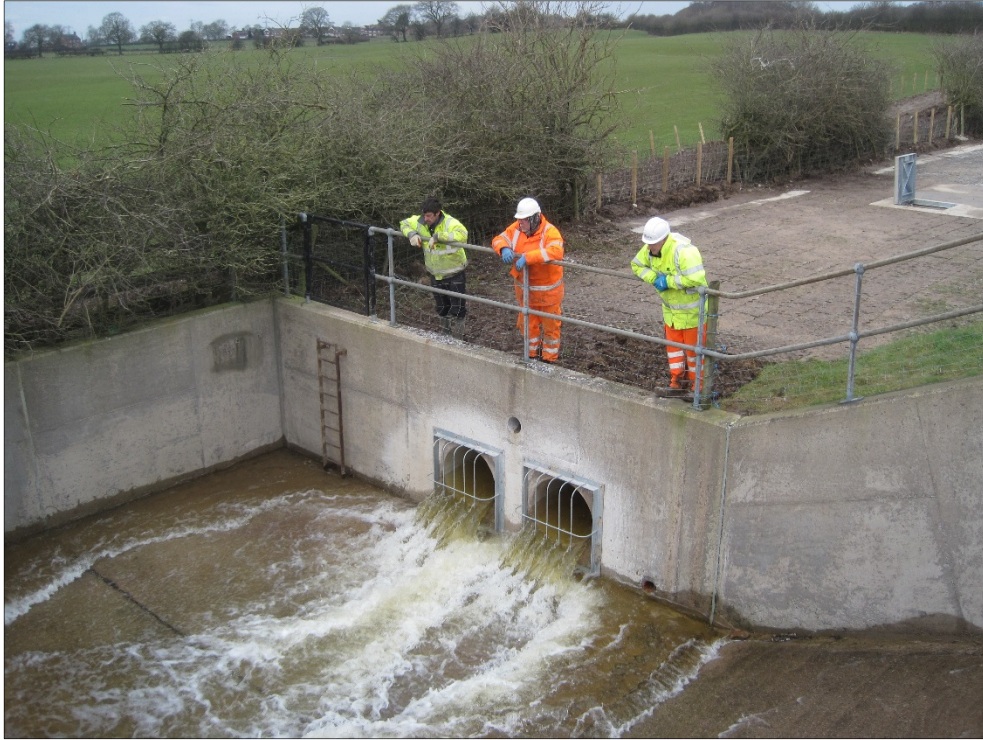
Figure 8. Siphon test, discharge into service spillway system

The siphons were successfully tested on 19 February 2016 to the satisfaction of the qualified civil engineer (Figure 8).

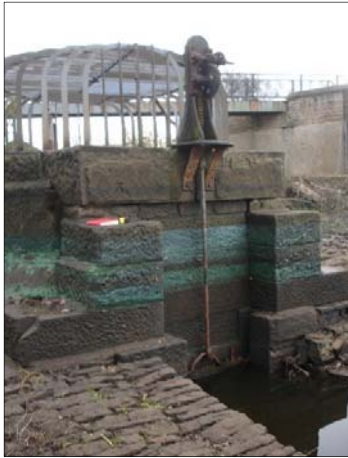
Figure 4. Existing Outlet Penstock.

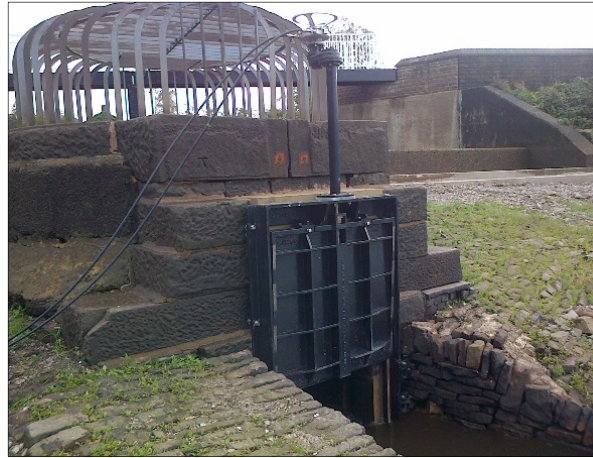
Figure 5. Replacement Penstock

All of the above options require a hose, cable or wire from the penstock structure to the preferred location on the footpath. To facilitate this a simple cable duct was installed from the headstock of the penstock to the bank and cables laid within it. In order to retain the ability to manually operate the penstock at the bellmouth (should the remote operating system fail) the headstock was designed such that it can be removed and a T key used to operate the penstock from above.

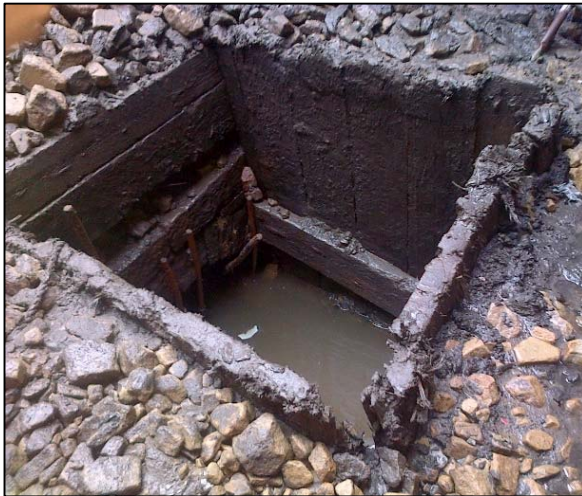
Figure 7. Wooden Hopper on Top of Drawoff Upstream Inlet

The installation of the cofferdam allowed the inlet to be exposed, but the resulting structure proved to be significantly different from the historical records. Underneath approximately 2.4m of silt there was a 1.5m high by 1.3m wide oval masonry tunnel, 40m long. There was a wooden hopper structure as per the diver sketch, but the 800mm vertical pipe identified by the divers was in fact the vertical flow path down through the silt with a subsequent horizontal route along the top of the tunnel (Figures 7 and 8).

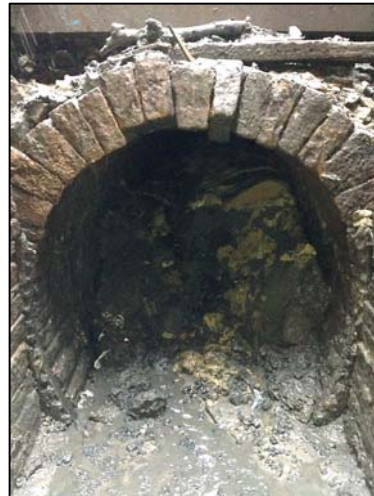
Figure 8. Drawoff Upstream Inlet Culvert Before Cleaning

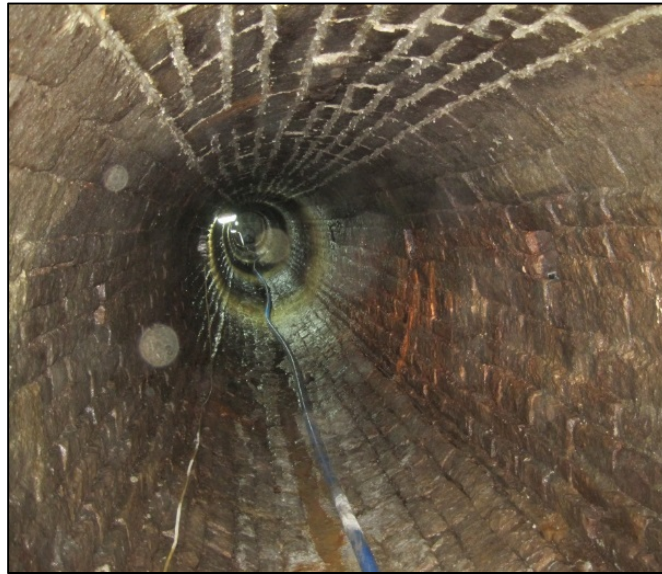
Figure 9. Drawoff Upstream Culvert After Cleaning

Once exposed the tunnel was cleaned, removing approximately 70m³ of silt, and upon inspection found to be in very good condition (Figure 9). A new entrance and grille was designed to allow vertical access by divers.

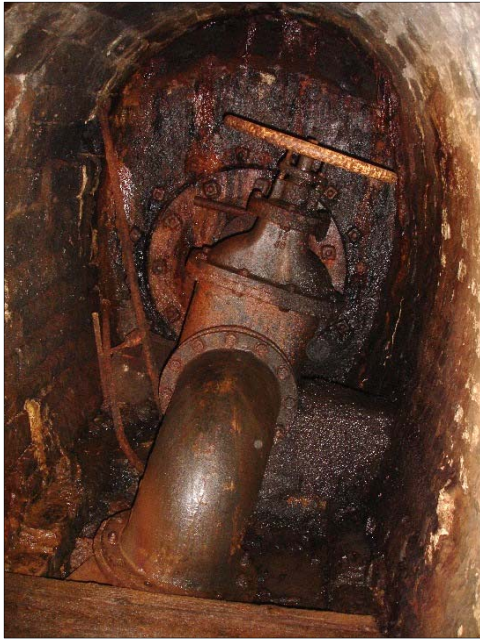
Figure 10. Existing Drawoff Valve in Downstream Tunnel

The bulkhead arrangement at the downstream tunnel was very unusual. It had two drawoff pipes cast into it, one a 9" blanked off pipe and the other a 12" pipe connected to the drawoff valve. The 9" pipe is believed to have been the supply to the railway line to operate the hydraulic turntable at Huddersfield station (Figures 10 and 11).

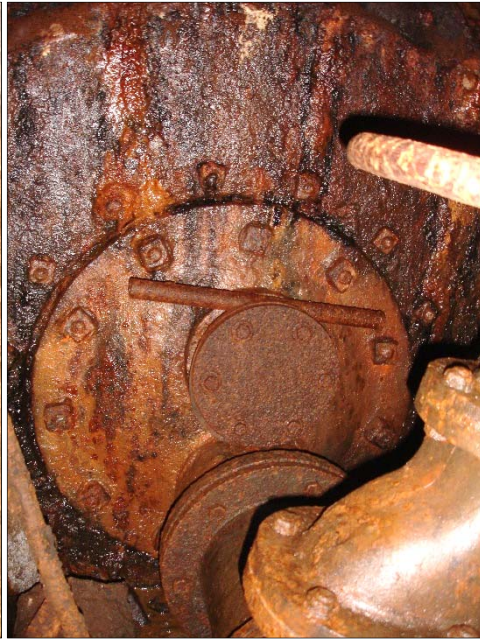
Figure 11. Bulkhead with Railway Pipe Blanked Off

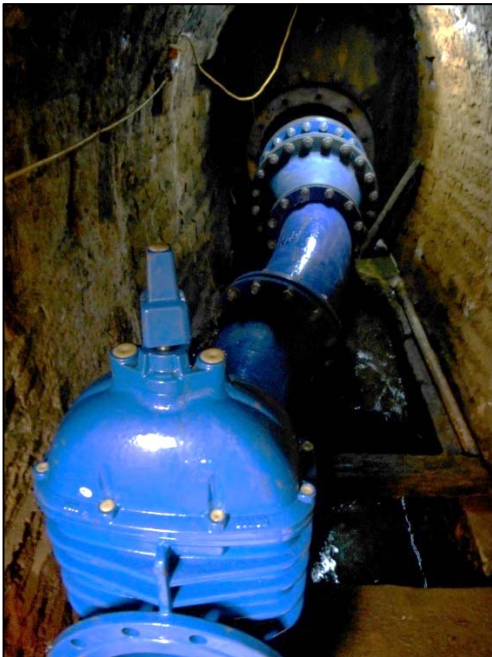
Figure 12. New Guard Valve at Bulkhead

The existing pipe work and bulkhead were removed. A new sleeve pipe from the upstream tunnel, blockwork wall and guard valve were installed (Figure 12). Pipework was also installed along the tunnel to the entrance where a scour valve was located (Figure 13). Immediately downstream of the valve, pipework directed water back into the outlet channel underneath the tunnel floor.

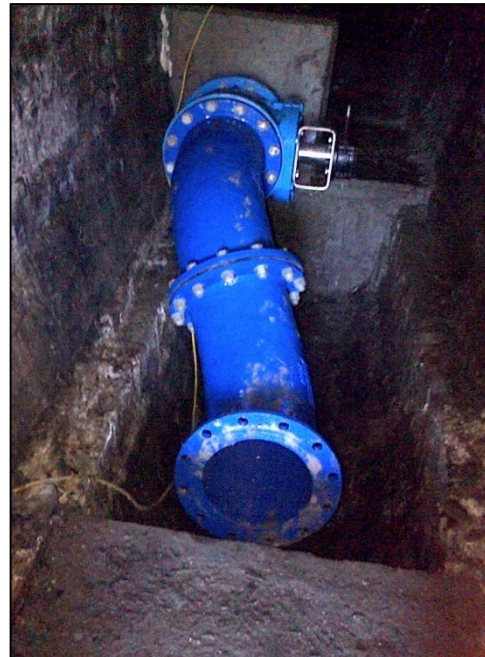
Figure 13. New Drawoff Valve At Downstream Tunnel Entrance

The new arrangement has dramatically improved the situation, with the guard valve able to be closed to allow the scour valve to be maintained and the scour valve located just inside the door of the tunnel entrance thus reducing the confined spaces risk and removing the need to traverse the tunnel (apart from when exercising the guard valve).
