Dams: Benefits and Disbenefits; Assets or Liabilities?

Proceedings of the 19th Biennial
Conference of the British Dam Society
held at Lancaster University from
7–10 September 2016

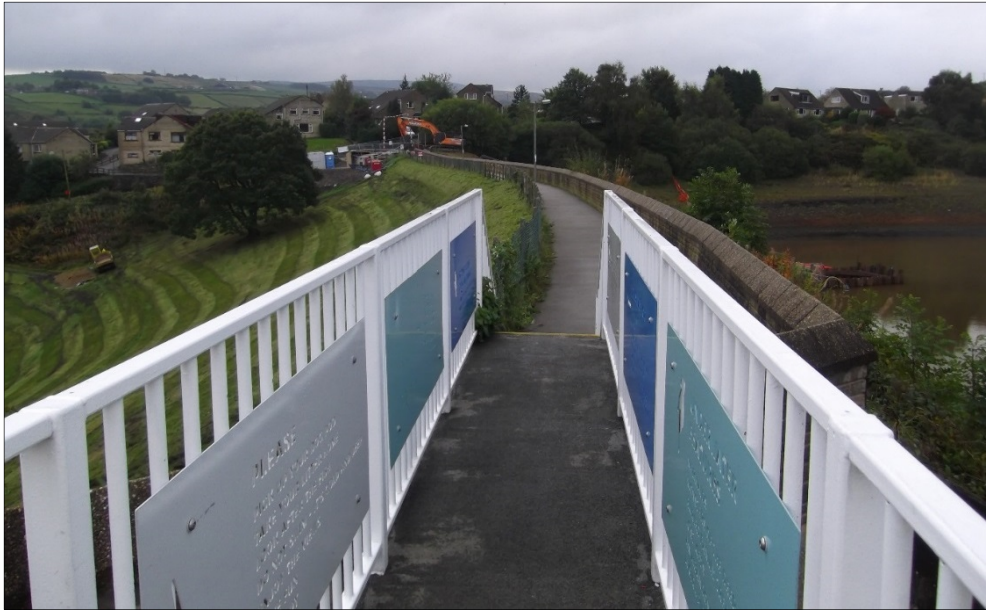
Figure 14. Refurbished Footbridge.

- Pressure grouting of the base slab culvert downstream of the second dropshaft and plunge pool,
- Refurbishment of the footbridge over the spillway; as part of this refurbishment a community initiative to develop interpretation panels to be hung on the bridge was undertaken involving the local community and primary school. These panels tell the story of the reservoir and canal history and its importance to the local community (Figure 14).
- Installation of a land drain on the eastern embankment, discharging via a V-notch into the scour outlet channel,
- Minor repairs to the spillway joint sealant and wave erosion protection.

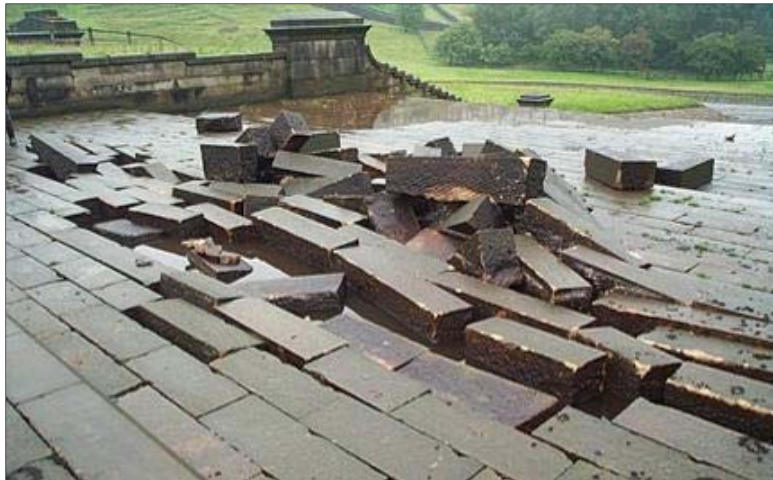
In July 2002 a flood event caused a number of masonry blocks in the spillway to be dislodged from the concrete backing between the two cascade sections in the channel (Figure 2).

Figure 2 - Damage caused to spillway invert in 2002

- At the cascades of steps it was found that flows separated from the base and leapt the whole of each flight of steps causing the water to severely impact onto the channel downstream. This could lead to impact damage of the spillway structure and negative pressures causing masonry blocks to be plucked out of the spillway, as per the damage caused in 2002.

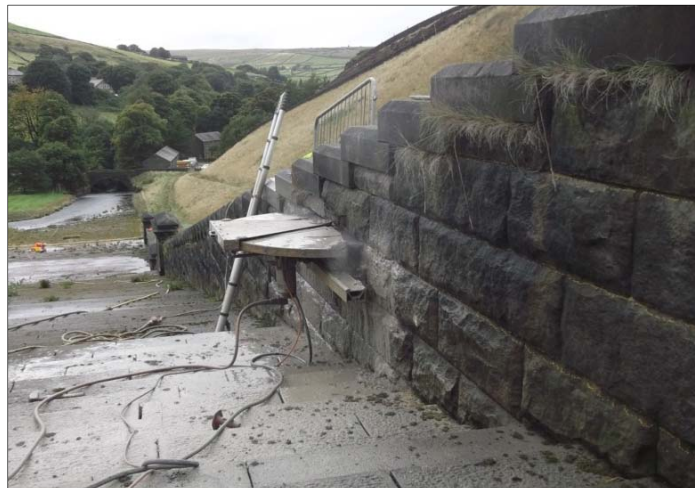
All interested parties were in agreement that work to the spillway was necessary but retention of the existing structure's key features had to be maximised. Permission was granted by the LPA to carry out additional investigation work in an attempt to retain as much of the existing structure as possible. Multiple cores of both the spillway walls and the spillway invert were carried out along with trial pits around the spillway to verify its condition. A section of the right hand side spillway wall was also taken down to allow a condition assessment of the concrete backing to be completed.

Figure 4 - Photograph of RHS spillway wall dismantling

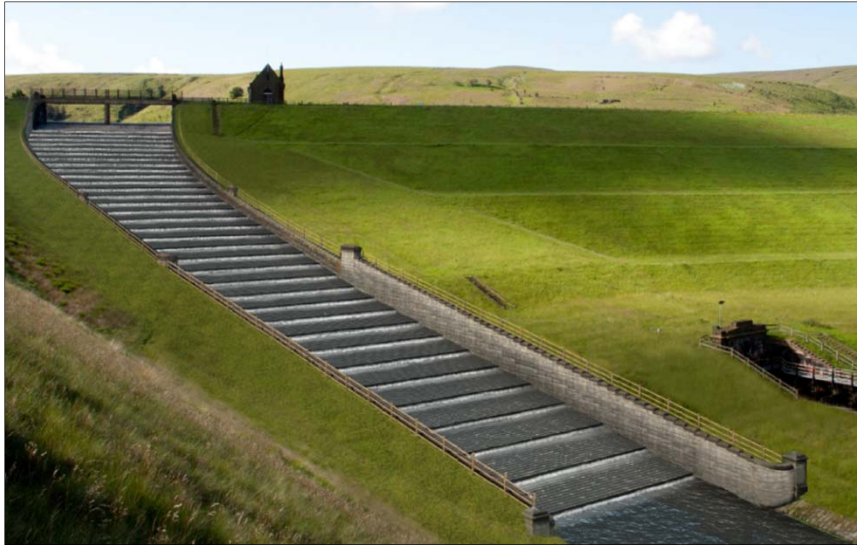
Figure 7 - Visualisation of the Final Solution

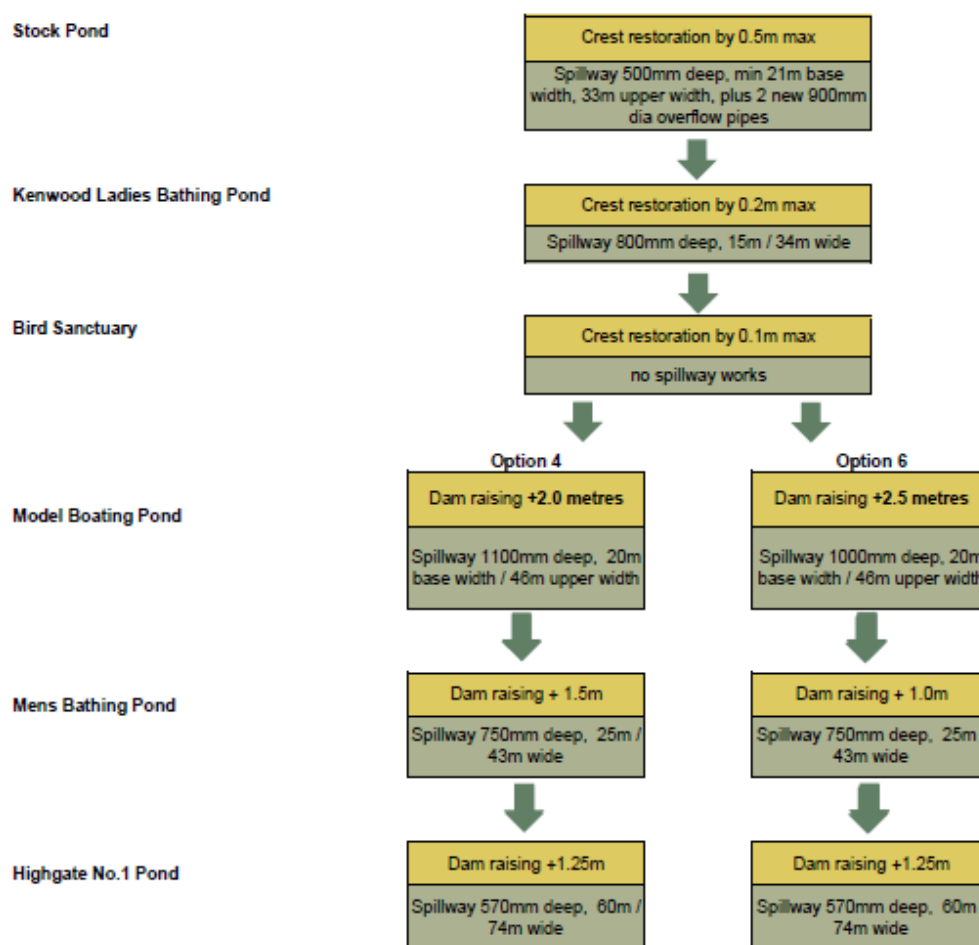
On the Highgate chain, this meant varying the height of the raising of the dam at Model Boating Pond, between 1 and 3 metres. This would be done by adding fill to the upstream face of the existing dam. The results were shown in the form of a flow chart which reduced in size at each stage as the options were reduced from 6 to 2 preferred combinations.

Figure 4: Preferred options on the Highgate chain

The option of raising Model Boating Pond by 3 metres would have reduced the required raise of the downstream dams to 0.5 metre, but this was discounted by the client and the stakeholders. There was a desire to limit the number of lorry movements in the earthworks to win fill on site and dispose of the silt within the borrow pits.

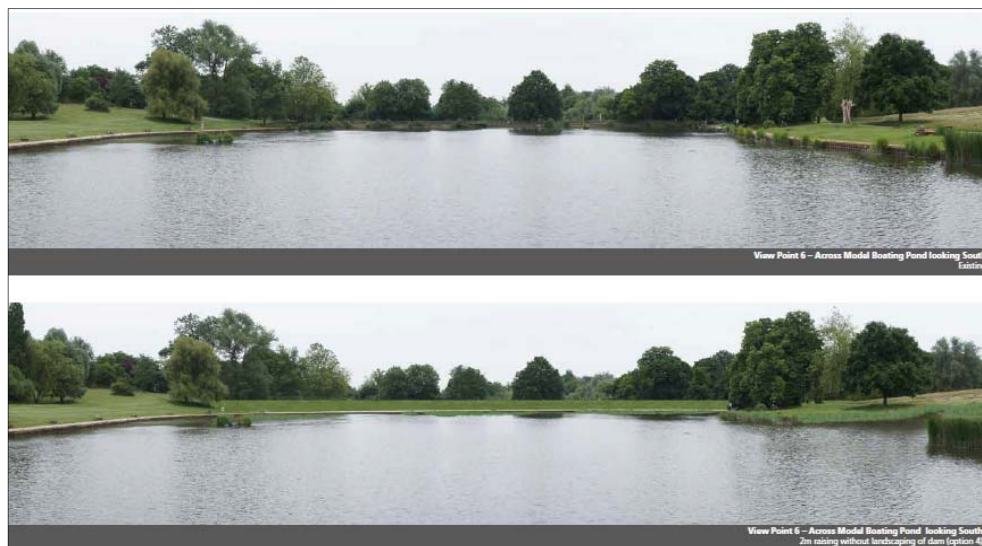
The proposed works at Model Boating Pond also included excavating the natural ground slope above the west side of the pond, to widen the surface area of the water and remove the sheet piles on that side to create a softened edge. This excavation was intended to provide material for the dam and so could be shaped to avoid trees, by leaving an island around the group of lime trees half way along the west bank. The upper slope of the west bank would be cut from the existing slope of around 1:10 to 1:5.

Figure 5: Visualisations of the altered view downstream across Model Boating Pond, with an island formed on the right (west) bank

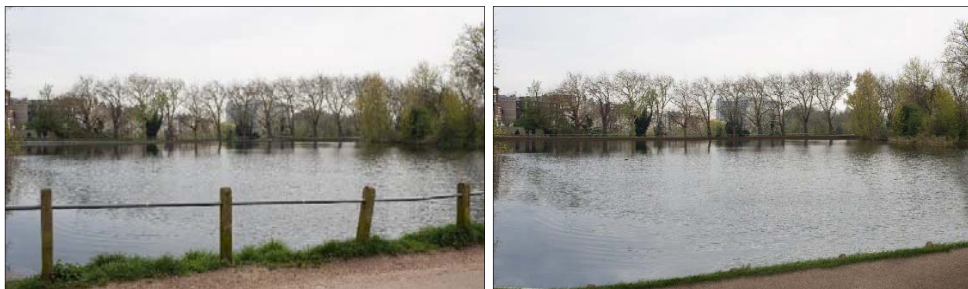
The focus of the options evaluation on this chain was an avenue of highly valuable London Plane trees on the crest of the dam at Hampstead No.2 Pond. To minimise the loss of these trees to two, a drop shaft was proposed to increase the driving head and therefore the discharge through a new concrete box culvert overflow. This was combined with fine tuning of the pipe through the catchpit dam and the introduction of a labyrinth weir spillway on the last dam (at Hampstead No.1 Pond) in order to balance the tree loss with the other objective of maintaining the standard of protection to the area downstream of the ponds.

Figure 7: Visualisations of the effect of removing two London Plane trees at Hampstead No.2 Pond (before on left, after on right)

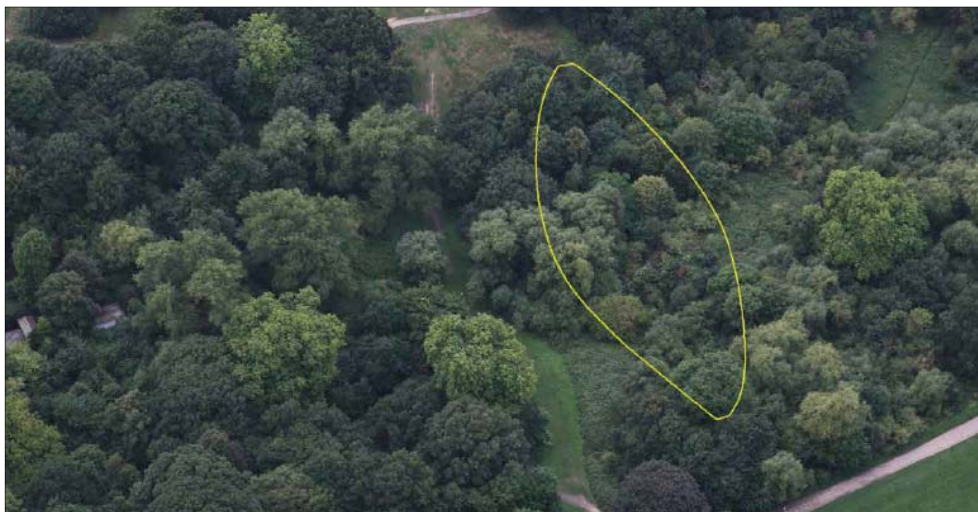
Two possible positions were considered for the dam. The first position was straight across the valley along the existing clearing / path. This seemed obvious to begin with, but an arboriculturist survey highlighted the high value of the trees bordering the clearing, compared to lower quality trees further upstream.

Figure 9: Location of preferred dam position upstream of the clearing (stream flows to Mixed Bathing Pond on left of photo)

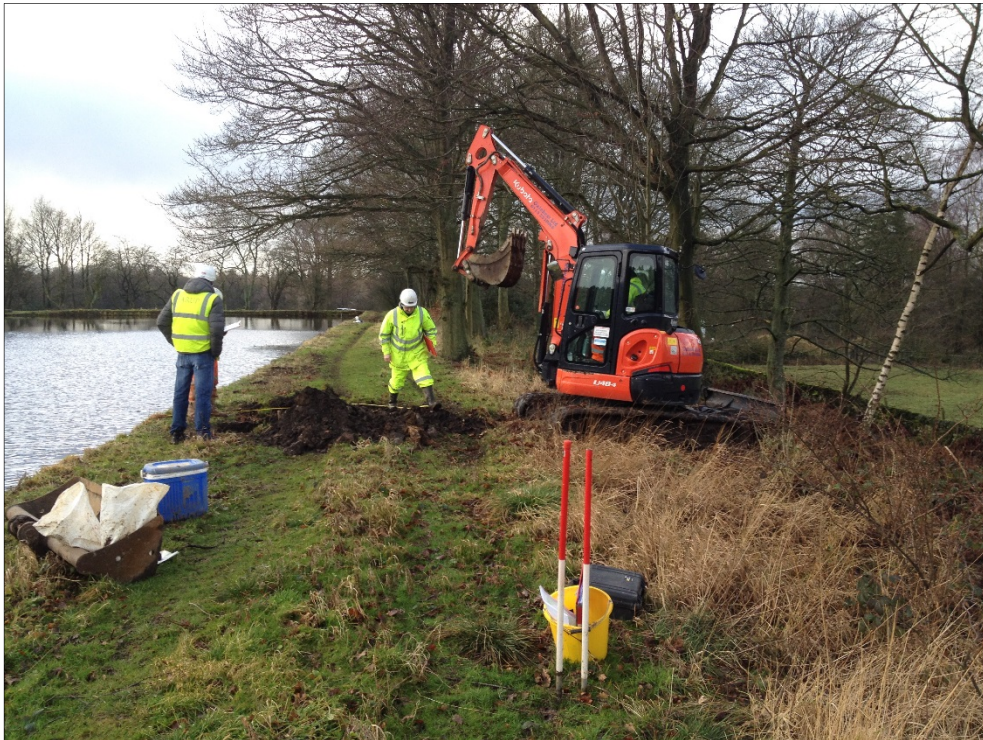
Limited information was available from the dam's construction, some 170 to 300 years ago. Hence the pre-design investigations were to establish basic design data rather than confirmation of existing knowledge. The ground investigation revealed that the topsoil was not removed before Swiss Lake construction commenced in 1710. The potential slope stability failure mode of a soft layer at the base of the dam was reviewed using the increased loading from the crest raising.

Figure 3 – Site Investigation trial hole at Swiss Lake

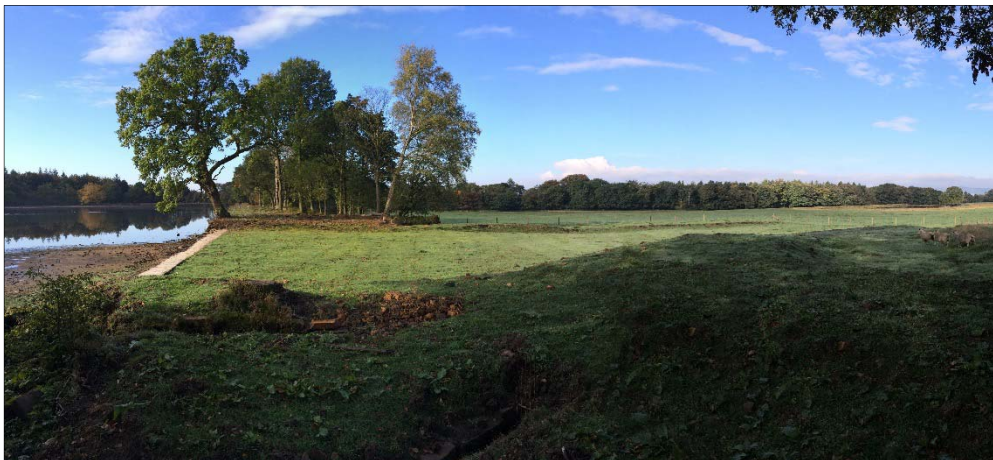
The new auxiliary weir was located on the north east abutment to utilise the existing topography. This ensured major earthworks were avoided through the open sections of fields, which contains historic ridge and furrow patterns, between Swiss Lake and Mud Pond. The location contained a number of mature trees that were removed, including their stumps and large roots to reduce the likelihood of future leakage paths.

Figure 4 – Swiss Lake auxiliary spillway looking to Mud Pond

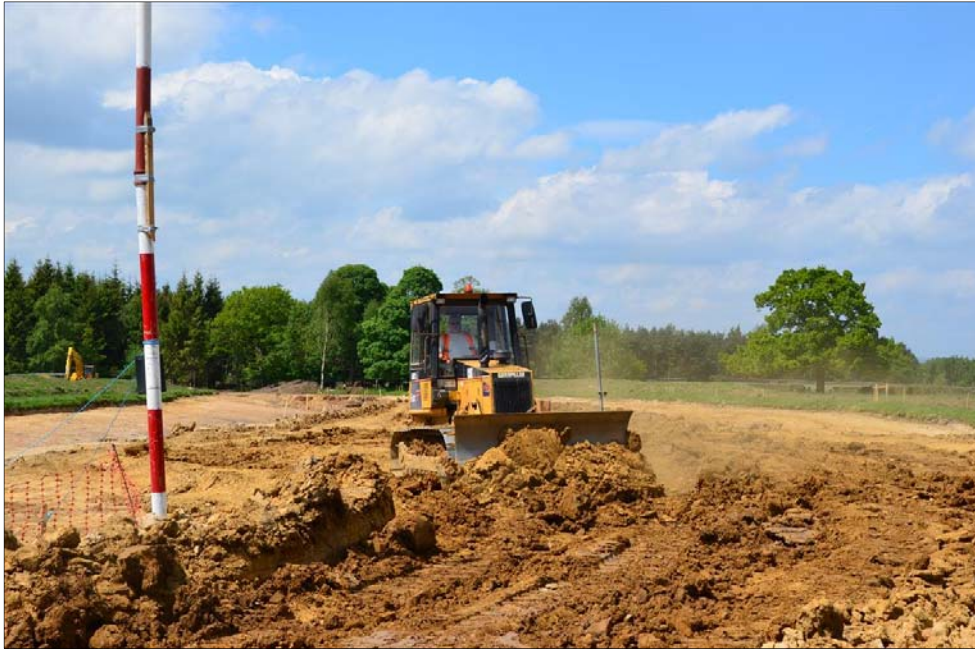
The excavation for Emperor Lake spillway was one of the first activities so that the material won could be used in embankment raising around Swiss and Emperor Lakes. No material was imported and the excess generated from the spillway excavation was used to sympathetically landscape an area to the west of the spillway.

Figure 7 – Emperor Lake spillway © The Devonshire collection, Chatsworth.

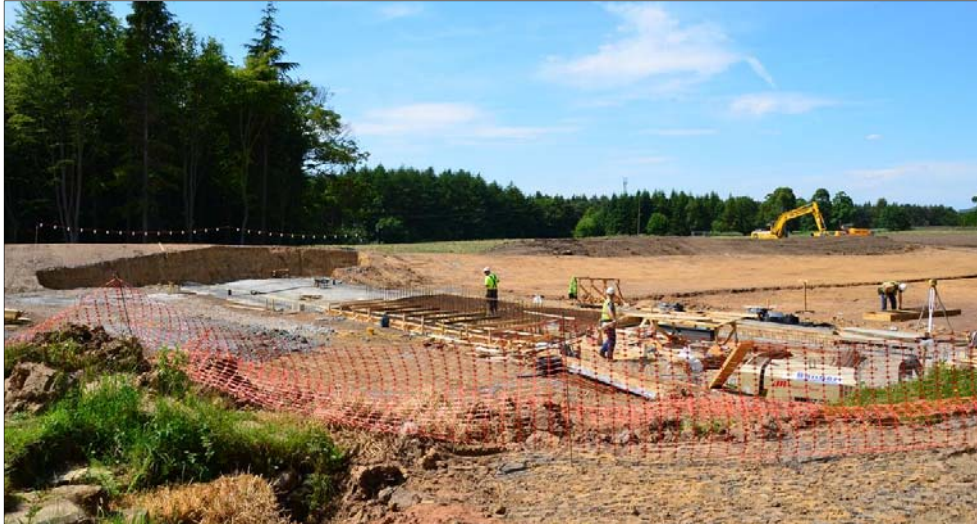
The second phase involved connecting the new weir to Emperor Lake by breaching the existing embankment and installing a new culvert and causeway structure. This phase could only begin once the initial phase had been inspected and approved by the QCE.

Particular challenges included the sequencing of the work to ensure that the upstream and downstream cut-off trenches beneath the weir were dug and cast against virgin ground with the minimum of time exposure. Concrete deliveries had to be carefully planned and managed, with it taking about 30 minutes to navigate through the multiple field gates on the construction access route off the A619.

Figure 8 Emperor Lake Weir construction © The Devonshire collection, Chatsworth.

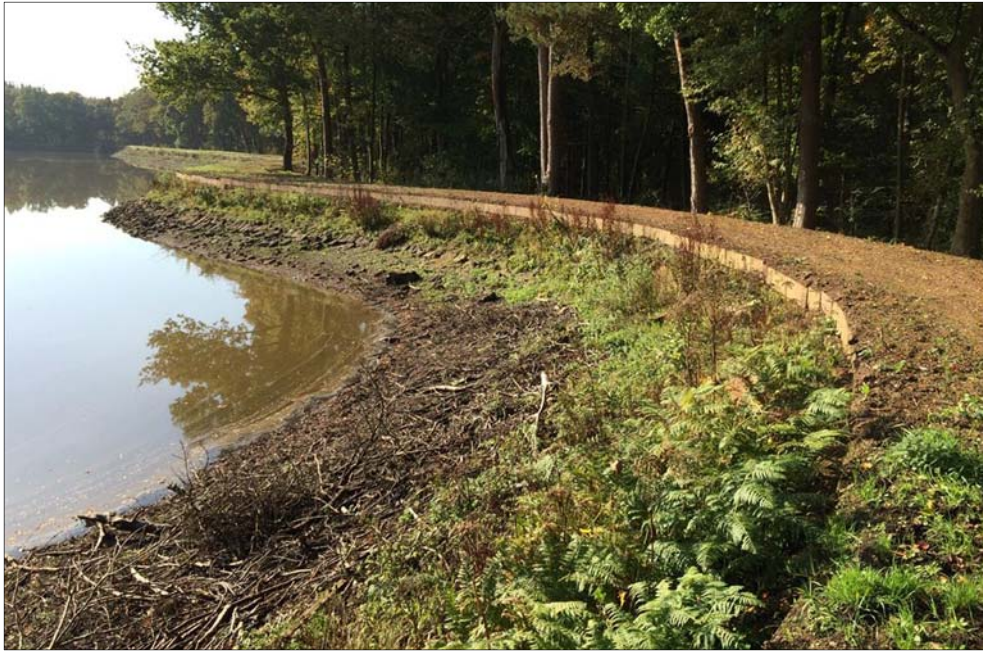
Figure 9 – Emperor Lake embankment raising works completed

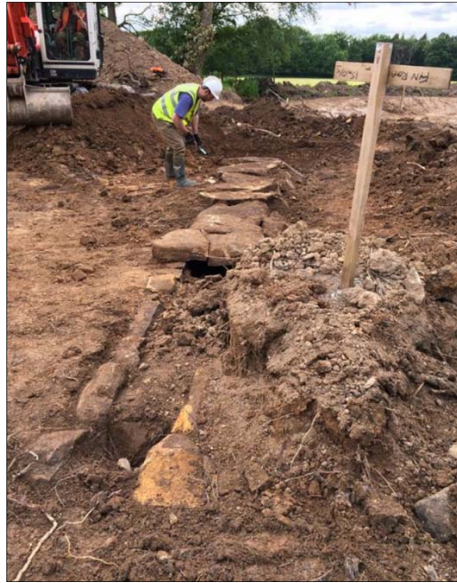
Figure 10 – Archaeological record of drainage sough at Swiss Lake

A drainage sough was discovered under the northern auxiliary spillway, which was archaeologically recorded and removed to prevent a future spillway weakness. During construction of the southern spillway, a leak was discovered. A scour hole had

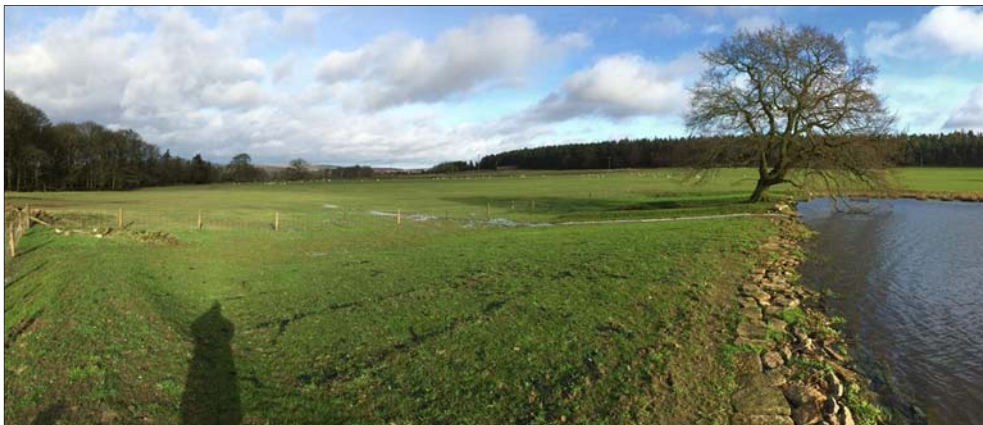
An iconic mature oak tree was retained, with two grass reinforced spillways, one on either side. The level was locally raised around the tree and a previous weak spot in the embankment reinforced. The original intent for a concrete cut-off in front of the tree was not possible due to the number and size of roots. Instead the cut-off extended as far as possible beyond the spillways with the remaining section being hand dug around the roots, then backfilled with bentonite pellets.

Figure 11 – Completed Spillway at Mud Pond

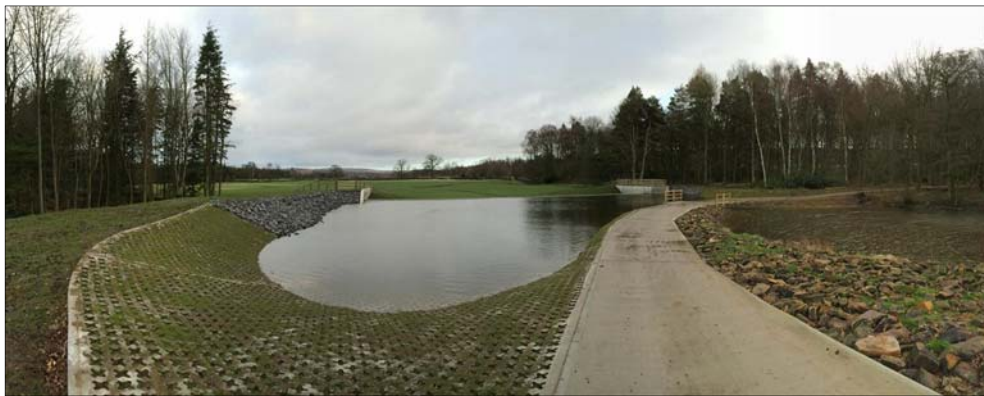
Figure 12 – Completed Causeway and Weir Structure at Emperor Lake

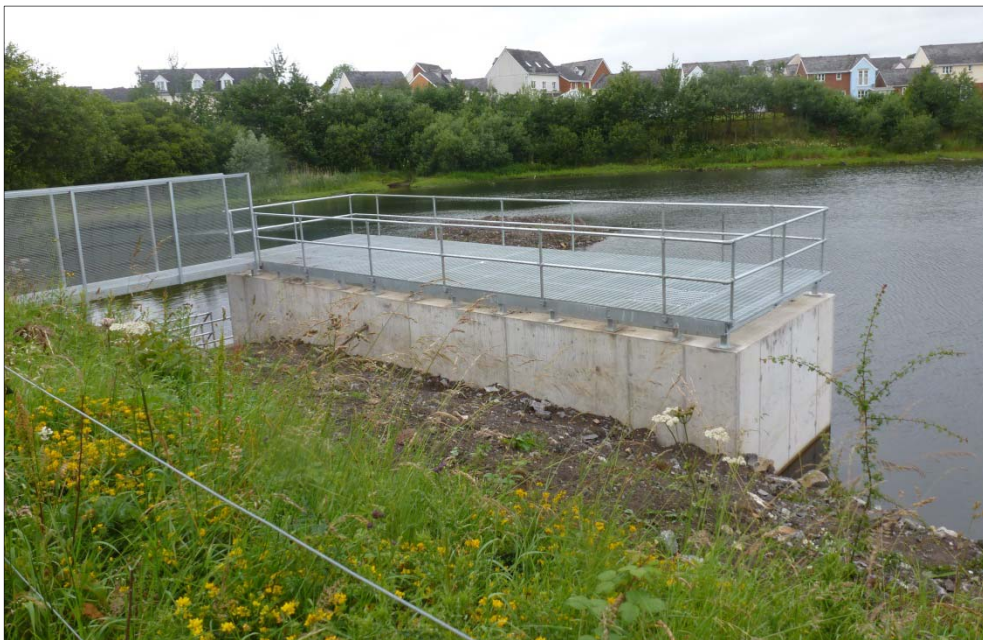
Figure 2. Completed overflow inlet

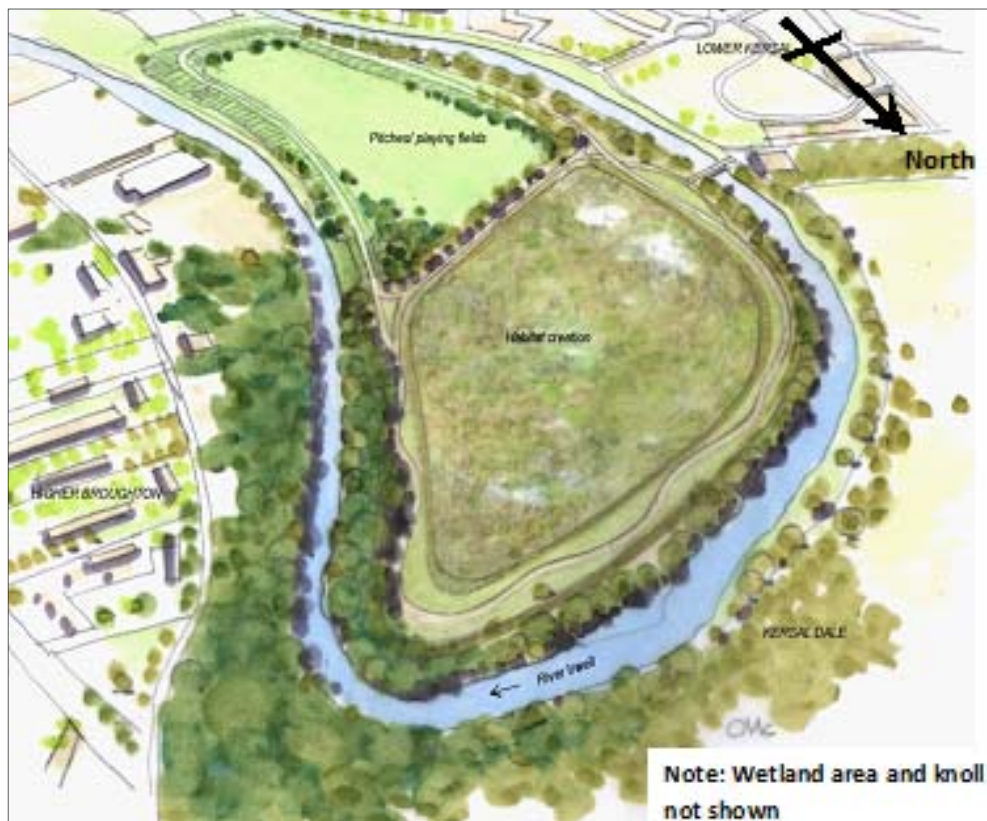
- **Outlet control structure** - Following an impounding event the impounded water below the level of the inlet spillway will drain back into the river via an outlet structure in the northeast corner of the site. The outflow from this structure is controlled by two automated penstocks.
- **Reservoir Basin** - The reservoir basin is divided into two areas as shown in Figure 1. The slightly larger area to the south comprises sports pitches for the University of Salford to replace those previously on the site, whilst the lower lying area at the northern end has been designed as a new area of permanent wetland habitat with an elevated knoll at the end.

Figure 1. Birds-eye view artists impression of the Castle Irwell Flood Basin

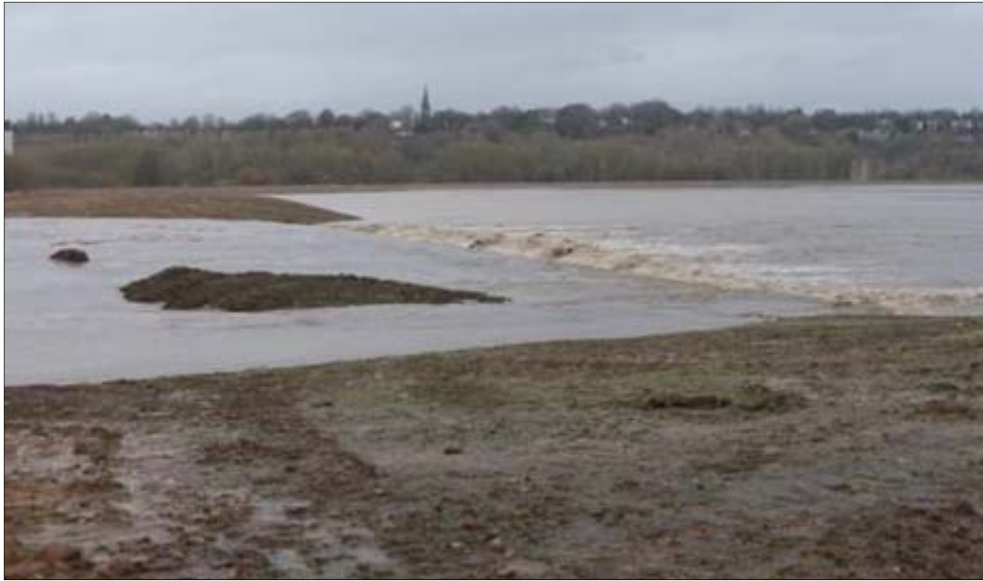
Figure 5. Inlet Spillway, Boxing Day Floods 2015

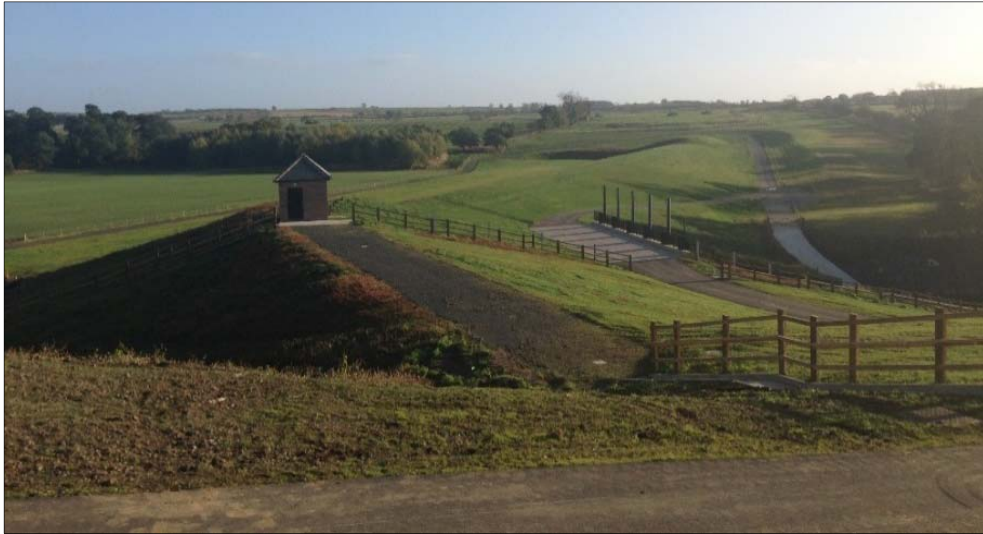
Figure 2. View of Mitford Dam from left abutment

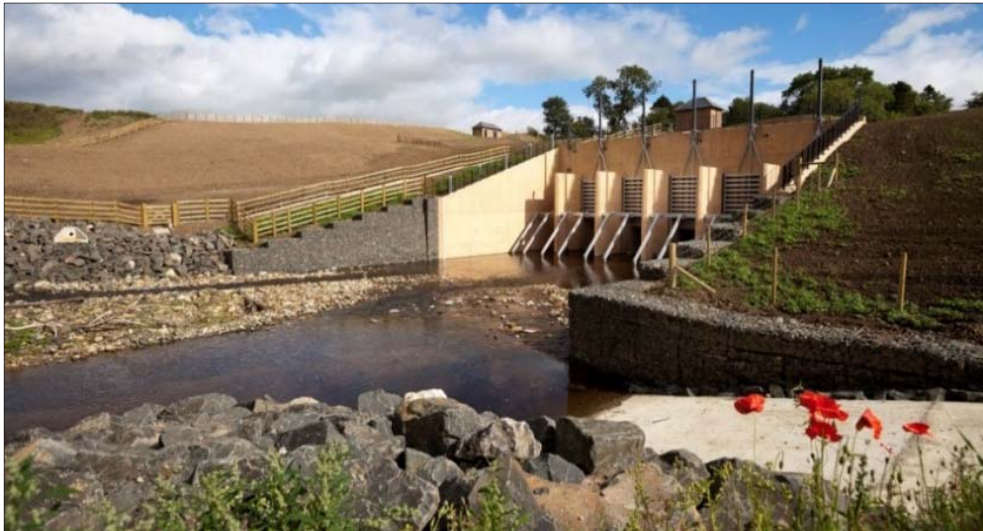
The culverts are all formed from precast units. There are in-situ inlet and outlet structures at either end of the culverts. The wingwalls on the inlet and outlet structures are extended to river bed level with gabion retaining walls. There are coarse debris screens immediately upstream of the culvert inlets.

The penstocks are located at the culvert inlets and are powered by hydraulic actuators which can be submerged. They are controlled automatically according to operating rules enforced by a programmable logic controller (PLC) located in a dedicated control building overlooking the dam. A hydraulic power pack located in a plant room on the embankment crest provides power.

Figure 5. Culvert inlet structure and penstocks

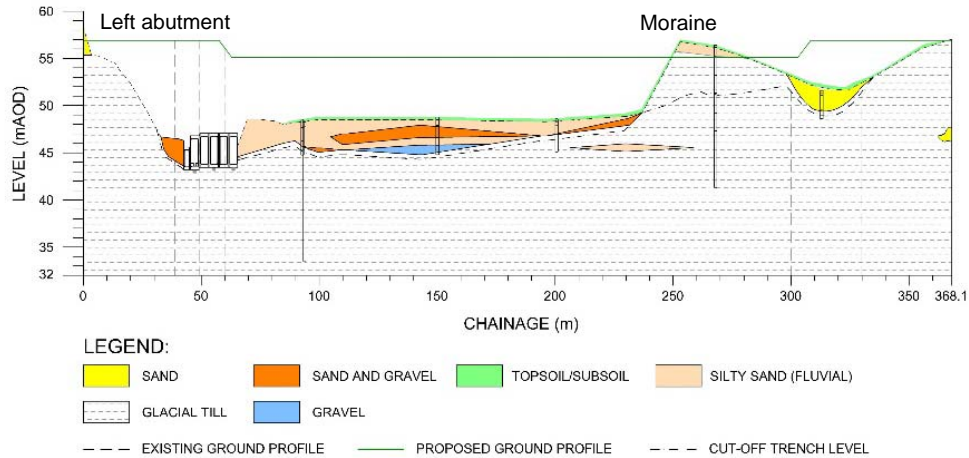
Figure 7. Longitudinal section of dam site

The glacial moraine was found to comprise an upper layer of very gravelly clay, with occasional lenses of sand. This was underlain by a high strength grey sandy clay. The mound contained occasional water strikes. It was determined that the upper portion of the mound was insufficiently impermeable to be incorporated into the dam, although the lower part could remain in-situ. The properties of this horizon were similar to the underlying glacial clay.

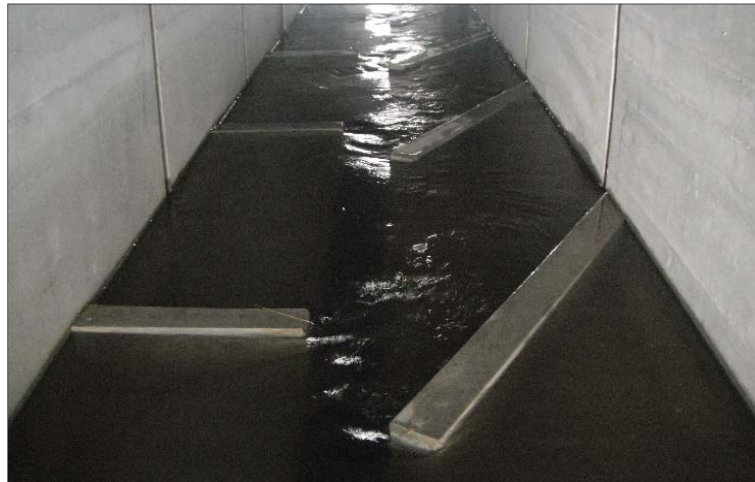
Offset baffles, fabricated within the culvert units, were provided through Culvert #1 using guidance from SEPA (SEPA, 2010), to manage velocities in the culvert. The features gave a measured average culvert velocity of 0.4m/s for a river flow of $1.2\text{m}^3/\text{s}$. Since the velocity will reduce with lower flows, the target value of $<0.5\text{m/s}$ at Q_{50} (Lucas *et al*, 2010) will be achieved.

Figure 8. Baffles in Crayfish Culvert (Culvert #1)

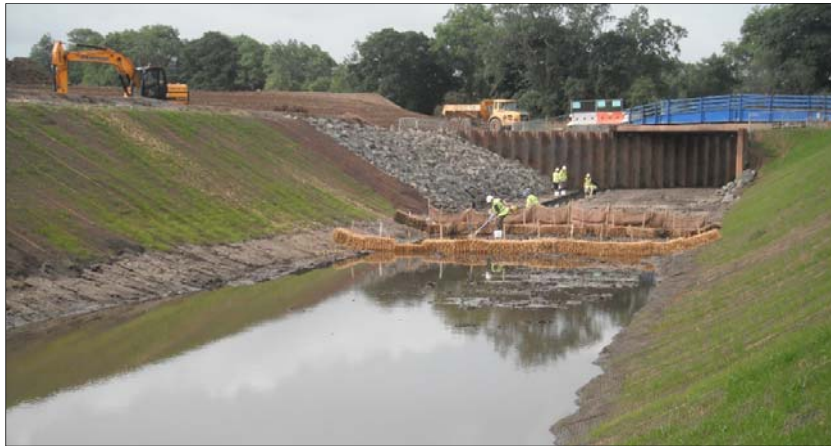
During the construction of the dam the River Wansbeck was first diverted through a temporary channel which was designed to convey the 1 in 10 year flow. The channel was lined with 150mm stone sitting on a geotextile underlayer. A temporary bridge was placed over the diversion channel to provide access to the culverts and left abutment.

Figure 9. Diversion channel

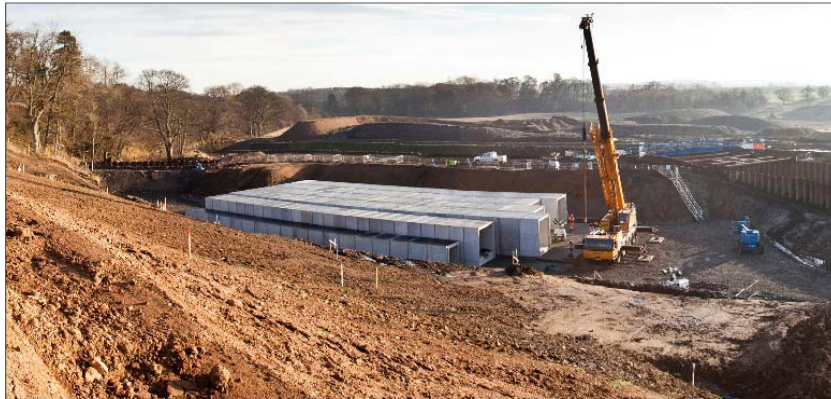
With the diversion in place the culverts were constructed behind temporary bunds in the river channel. The culverts were placed with 500mm gaps between adjacent units across the width of the structure. These gaps were backfilled with mass concrete. There is an inclined mass concrete haunch on the exposed faces of the outer culverts to limit the potential for cracking to develop between the fill and the concrete structure. There is a sand filter collar around the culverts about 4m downstream of the dam centreline which is designed to intercept any seepage running along the contact of the fill / culvert and hence reduce the potential for piping failure along the contact.

Figure 10. Culvert construction with diversion channel behind

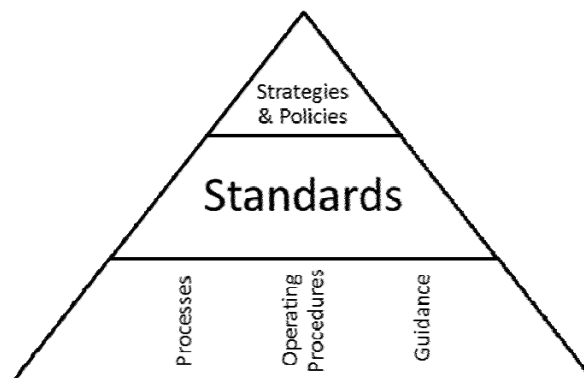
STW is split into two operating areas; East and West, reporting to the Director of Wholesale. Routine inspections of SRs are conducted by operational personnel based in the Wholesale directorate. Overseeing compliance with the Act, effectively operating in an assurance role, the Reservoir Safety Team reports into a separate directorate, headed by the Chief Engineer. This provides full independence of reporting and is a refinement, post re-structuring, to the previously reported structure (Hope, 2012).

Figure 2. STW's Operational Strategy

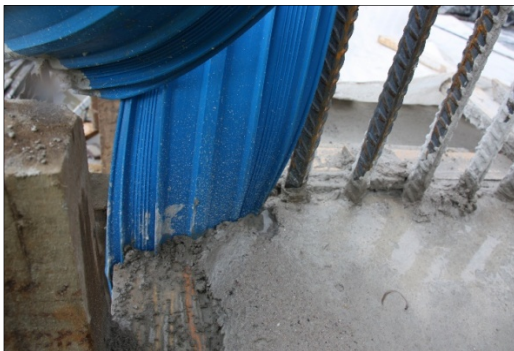
during casting if not adequately fixed, as shown in Figure 4..

Figure 4. An example of water bar movement after base and wall kicker pour requiring breaking out and re-setting. The process of repair can itself introduce potential flaws to tank integrity,

Water bar is supplied on rolls with junctions welded on site. Correct weld temperatures and a proper standard of workmanship are crucial to achieving a water tight joint. The condition of water bar, cast into a concrete joint or buried beneath a reservoir floor cannot be readily verified, potentially hiding poor workmanship. Water bar will move

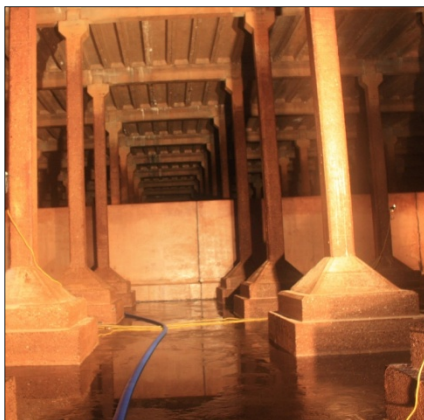
Taking a cell of a SR out of service for cleaning and inspection can be complicated by other system demands and lack of appropriate valving. For older reservoirs in particular, part height division walls impact on system operability by reducing available water storage by over 75% rather than 50% as in the case of a full height division wall.

Figure 5. An example of a part height division wall at Erdington SR.

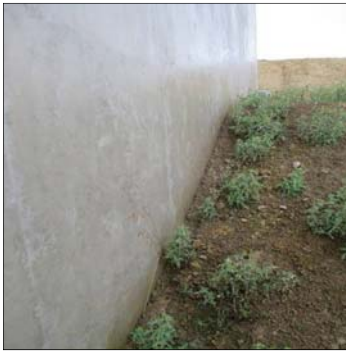
Figure 6. A newly constructed reservoir, backfilled contrary to specification, without drainage membrane. The omission of a membrane allows the backfill to support an elevated ground water level with potential to introduce contamination if a movement joint fails or a wall cracks.

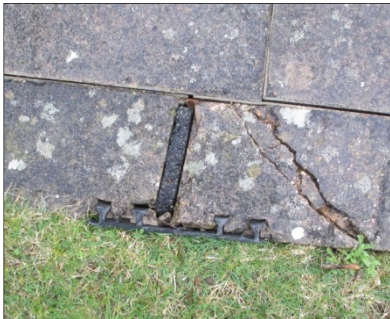
Figure 7. A further illustration of poor workmanship where the expansion joint, unusually employing rear guard water stop, has moved during construction. Furthermore the exposed detail allows ingress down the wall joint and into the reservoir.

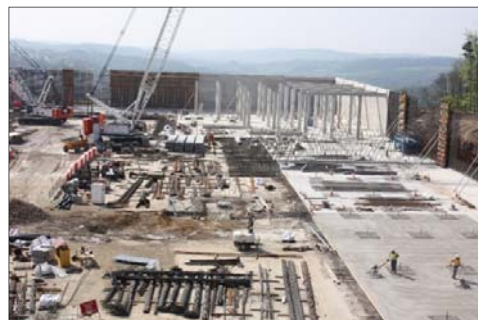
Figure 8. The new Ambergate No. 1 reservoir under construction in 2015, employing conventional techniques.

As part of STW’s £43m investment at Ambergate, an 87MI SR (No. 1) is being constructed using conventional in-situ concrete base and walls.

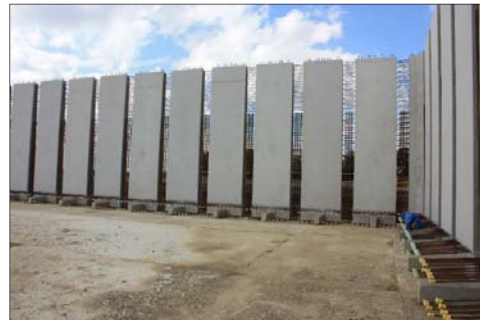
Figure 9. Precast wall units erected prior to casting infill sections

The £27m strategic treated water reservoir constructed for Anglian Water to improve resilience from the Grafham WTW network typifies the trend for walls to be constructed using pre-cast units. Wall joints incorporate hydrophilic water stop which swells following contact with water to provide a watertight joint. Fluctuations in water level may allow the joint filler to dry out and retract. The design life for the hydrophilic strip has been stated as being 120 years. However, there are significantly more joints using this methodology and joint replacement or repair of multiple joints will be costly and may well be inconclusive. Cambridge University's Centre for Smart Infrastructure and Construction has been commissioned to monitor the integrity of the roof using embedded fibre optic cabling. As the cost of these emerging technologies becomes more affordable, the potential applications open up. For example a credible option of wrapping pre-cast tank walls in fibre optic cable at various levels establishes the ability to monitor joint performance and importantly pinpoint deterioration.

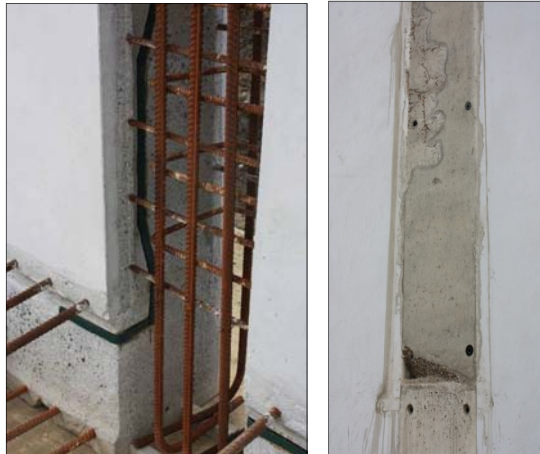
Figure 11. Infill casting between wall panels, completed in two lifts, creating further construction joints

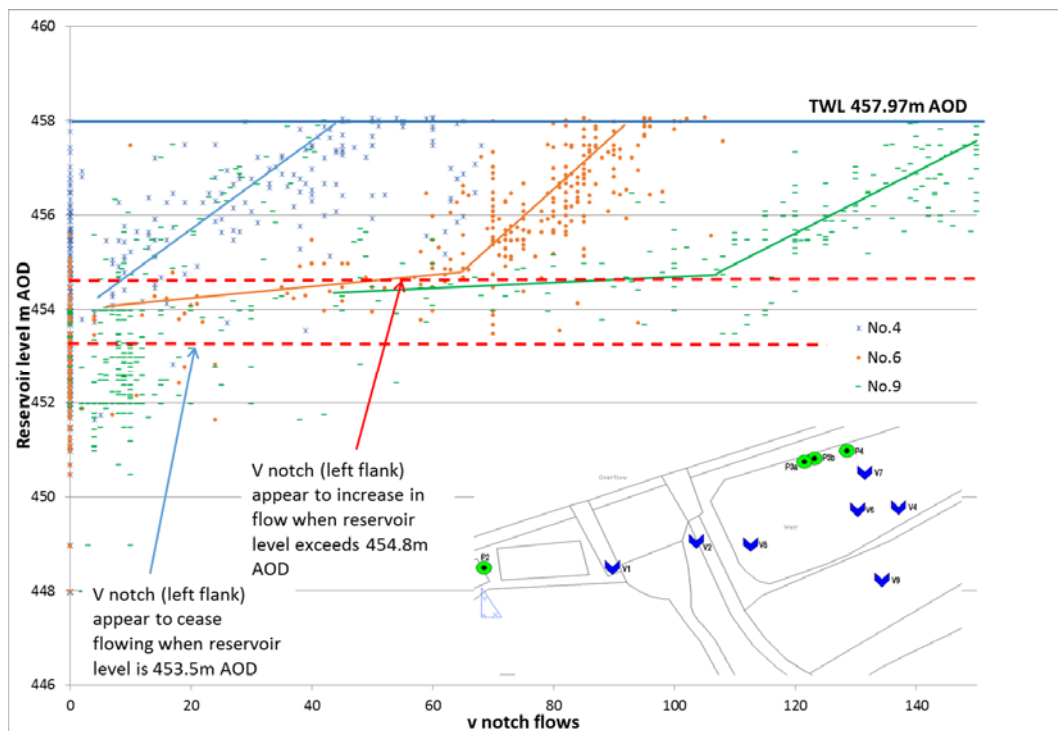
During the January 2014 incident, there were significant and unacceptable leaks issuing from the downstream face of the left embankment. The evidence seemed therefore to suggest that the dam had indeed deflected towards the flanking dam section. The conclusion was that repeated deflections during storm events over many years had exceeded the tensile capacity of the upstream face, in discrete locations. This had resulted in cracks forming and water entering the hearting of the dam. Over time, the internal structure had deteriorated and preferential flow paths through the structure had formed (Figure 3).

Figure 3. Relationship between leakage through dam superstructure related to reservoir level

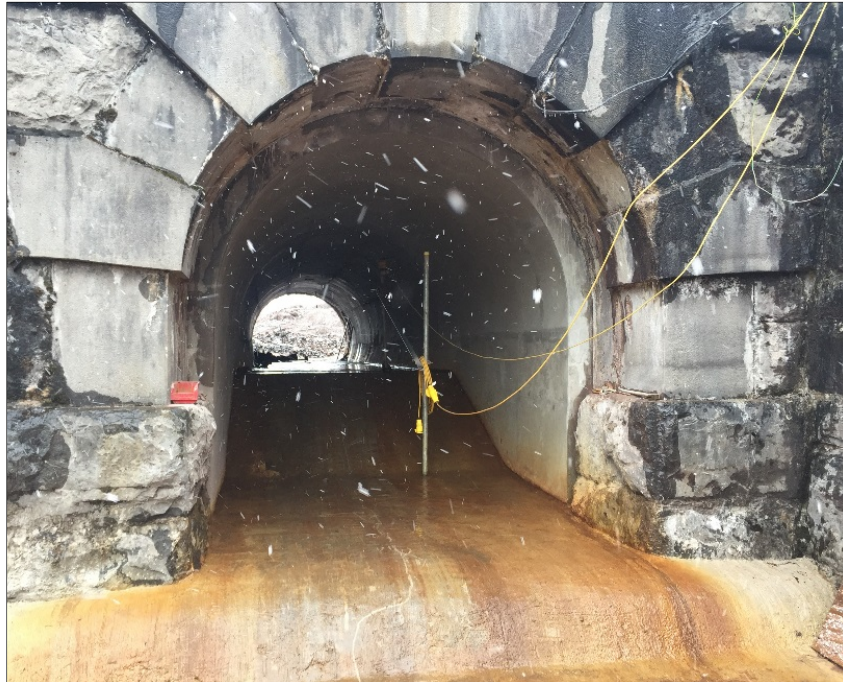
The main construction works were commenced in September 2015 following an extended planning/listed building consent determination process. The works on the downstream side of the dam comprising new masonry apron, retaining wall and tunnel lining progressed well as these works could largely be completed independent of water levels in the reservoir basin (Figure 6). The new 150mm thick reinforced concrete lining was achieved using curved steel formwork panels bolted together to fit the required profile of the tunnel and pumped concrete compacted using bolt-on external shutter vibrators.

Figure 6. Construction stage: tunnel lining from downstream end

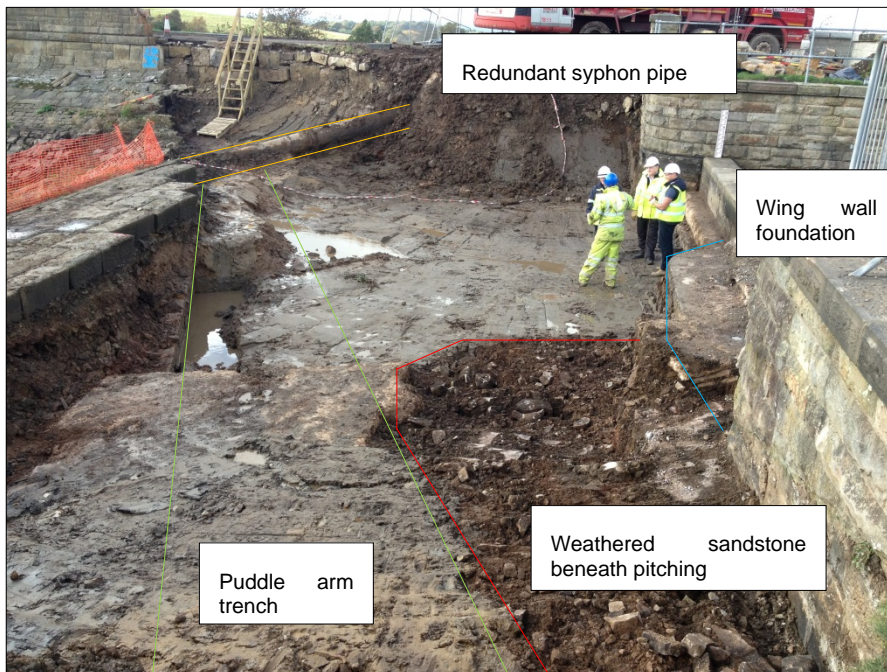
On completion of pitching removal from the spillway apron it became clear that the clay blanket was absent from the majority of the area covered by the 1950s weir extension works. The core arm trench was exposed and found to closely follow the route shown on the historic drawings. Trial pits were carried out to prove the thickness and extent of the clay blanket across the apron. These confirmed the connection between the blanket and puddle arm trench. Evidence of an erosion sink hole through the clay blanket into the underlying sandstone was observed in one location. The extent and thickness of clay, at around 600mm thick, closely matched the 1870s G.H Hill as built drawings. The clay blanket was excavated from the spillway apron and removed from site to expose the sandstone beneath.

Figure 3: Exposed sandstone, wing wall foundation, puddle arm trench and syphon pipe

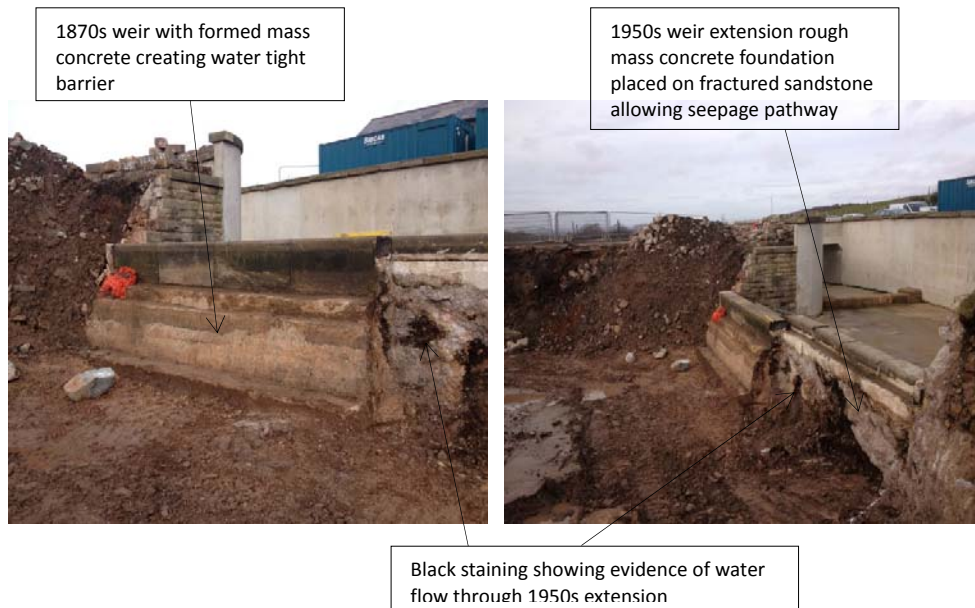
Figure 4: 1870s weir and 1950s weir extension showing evidence of seepage

To confirm the condition of the bed rock below the extended spill weir the 1870s wing wall foundation was removed. The weir extension was found to have been constructed on poor quality mass concrete placed directly on fractured sandstone. Evidence, suggestive of seepage pathways through the weir foundation, was observed by of black staining on both the concrete and sandstone. In contrast, the Victorian weir had been built to high standard, with the dimensions matching the record drawings precisely.

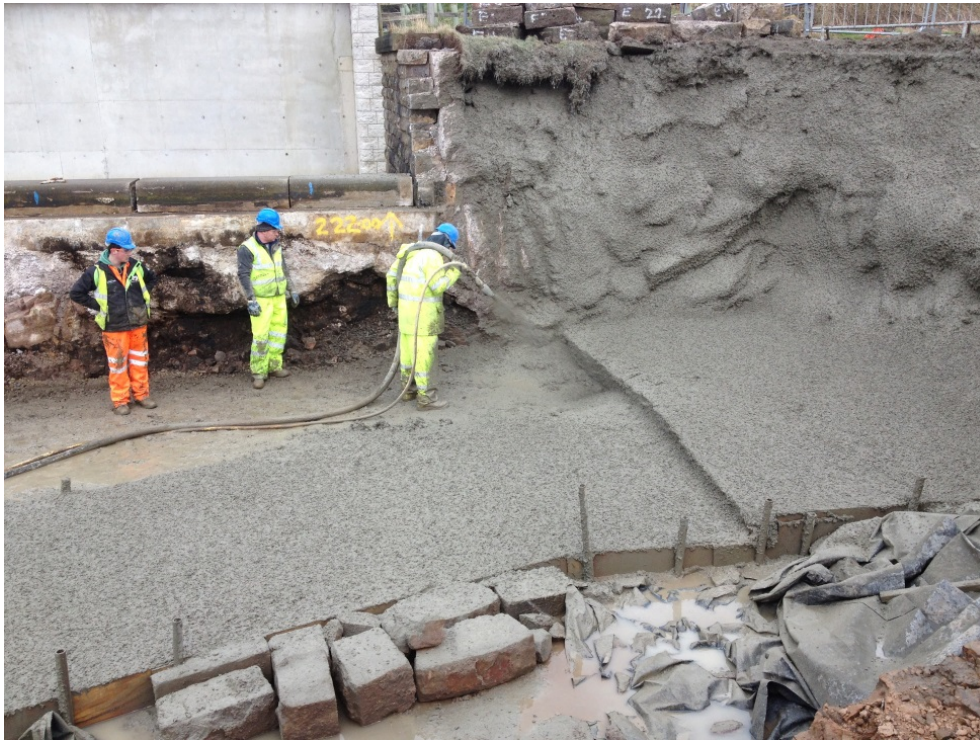
Figure 6: Fibre reinforced concrete installation

On completion of the formation preparation works a specialist contractor was employed to place a 150mm thick layer of blown polymer fibre reinforced concrete to seal fractures within the

sandstone. Particular attention was given to the areas affected by the fault and the highly fractured sandstone beneath the extended weir. The fibre reinforced concrete extended across the entire spillway apron and provided an impermeable barrier which would also reduce the potential development of seepage sink holes which had been observed within the original clay blanket.
