Dams: Benefits and Disbenefits; Assets or Liabilities?

Proceedings of the 19th Biennial
Conference of the British Dam Society
held at Lancaster University from
7–10 September 2016

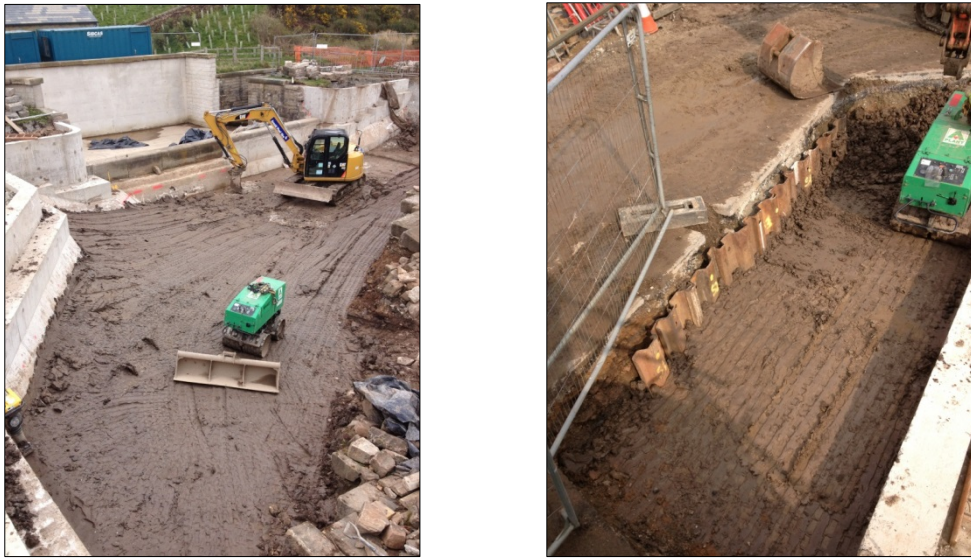
Figure 7. Clay blanket and core reinstatement

A short section of clay core excavated during removal of the wave wall was reinstated in a similar fashion to the clay blanket. Sheet piles were installed along the downstream face of the core to minimise the extent of excavation in that area by providing support to the embankment. The sheet piles were left in place in order to minimise potential damage to the core. The clay blanket and core were protected from desiccation between shifts by covering with plastic sheeting.

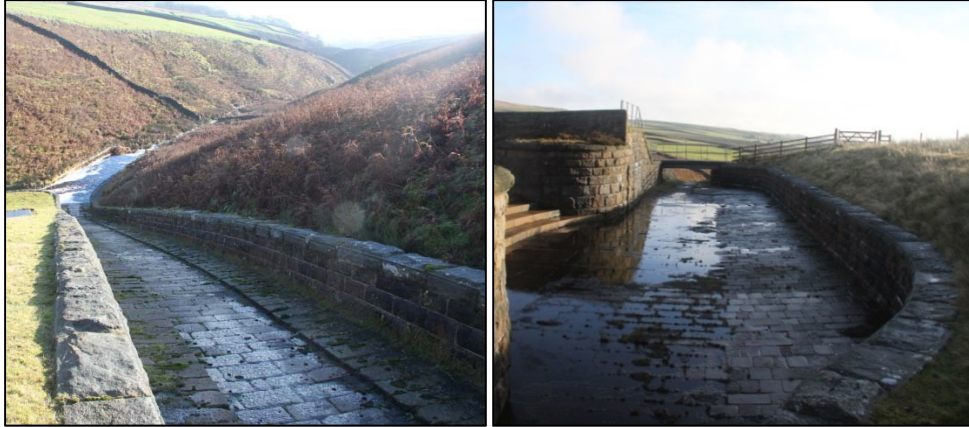
Figure 1. Views of Original Structure

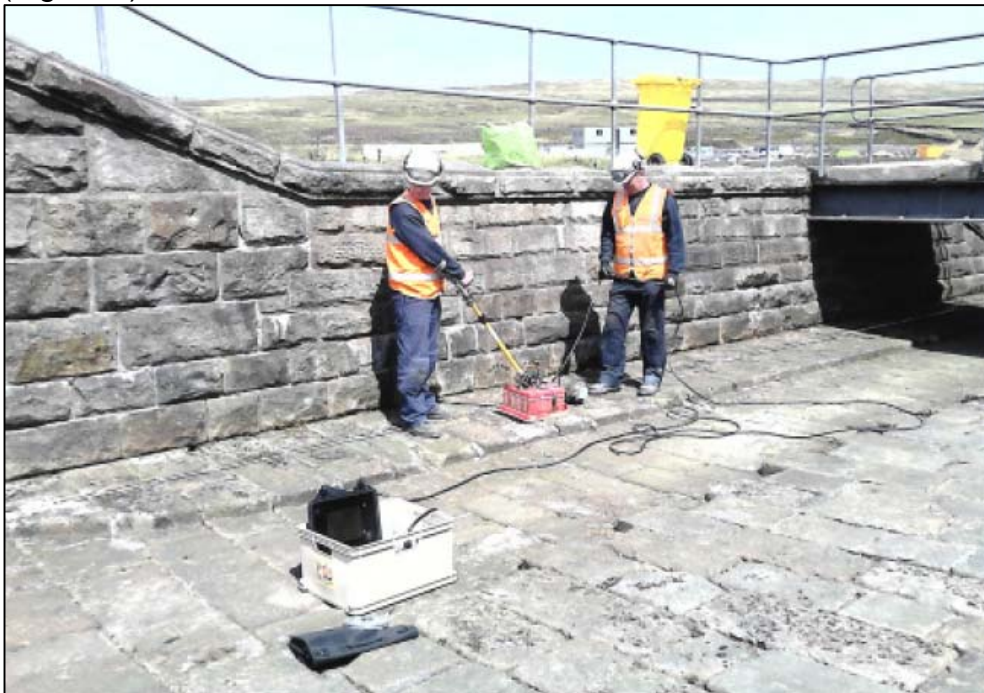
Figure 2. Application of GPR Survey

The GPR system consists of an antenna unit, a signal control and processing unit with a built in monitor, and a graphic recorder. The system is powered from a 12 Volt DC battery source. During survey operations, only the antenna unit is in direct contact with the structure with the remaining equipment typically stored in a waterproof box (Figure 2).

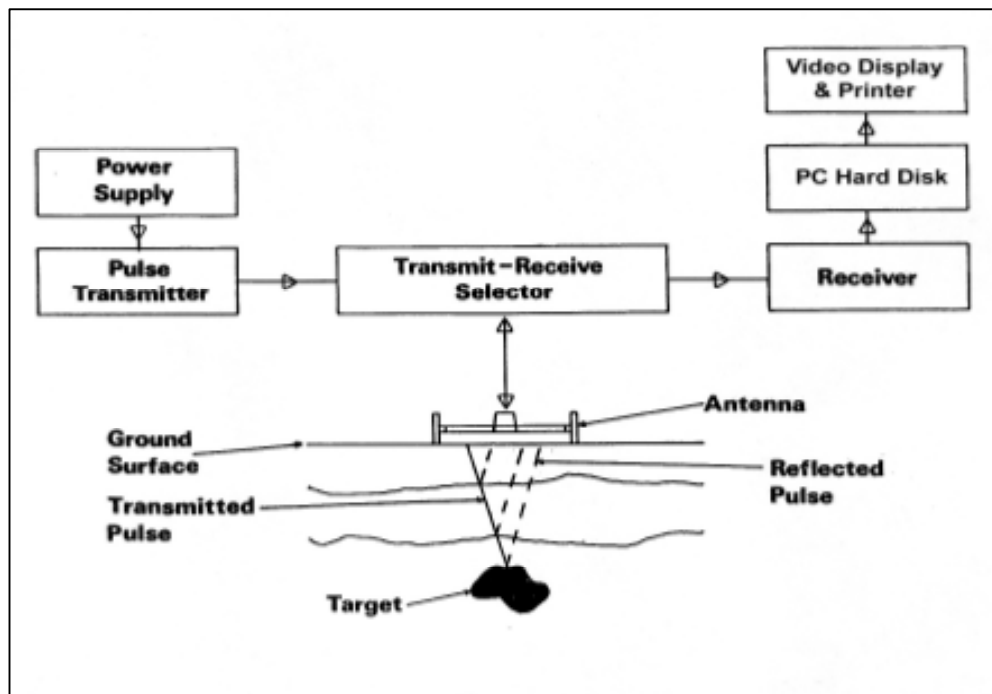
Figure 3. Block diagram of a digital ground probing radar system (courtesy of Subsurface Geotechnical).

GPR is most effective at detecting changes at transitions between two different and distinct materials where a clear contrast is present at the interface. The GPR survey method is typically less effective in identifying gradual or transitional boundaries. The reflected signal can be correlated with physical interfaces within the ground such as layering, air cavities or bedrock when interpreted against intrusive investigations. Figure 3 indicates the main components of a GPR survey showing how radar signals are transmitted and recorded.
